General Service Bulletin (GSB):	Paint Defects / Damage (Warrantable / Non- Warrantable)
GSB Overview:	Use this GSB to help determine (Warrantable / Non-Warrantable) Paint Defect / Damage
NOTE: This information is not intended to replace or supersede any warranty, parts and service policy, Work Shop Manual (WSM) procedures or technical training or wiring diagram information.

Paint Defect / Damage GSB

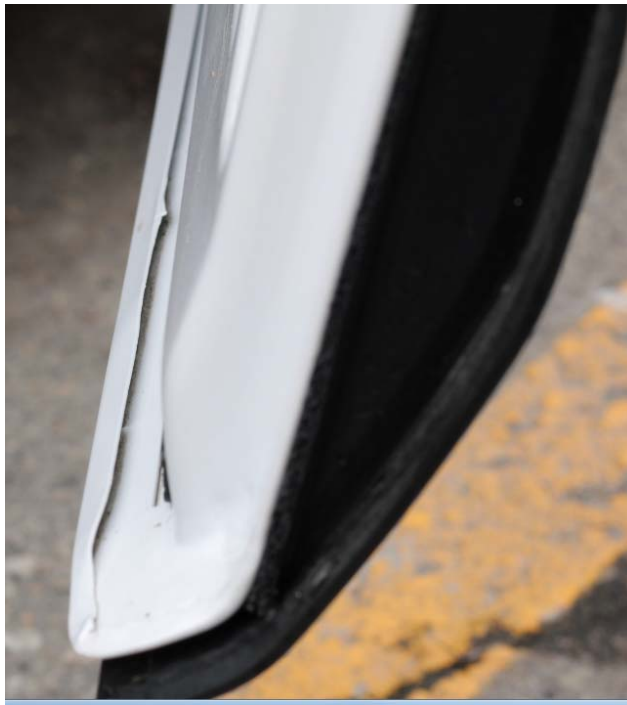
Open Hem Flange

Multiple vehicles may have an open style hem flange, which is a type of manufacturing process found near the bottom of door assemblies. The design of the open hem flange incorporates a gap between the inner reinforcing panel and the outer portion of the exterior panel which appear as a “U” or “V” shape. Seam sealer will not be present in this gap. This open space between outer and inner panels is design intent in an open hem flange structure. No repairs should be attempted to alter factory stamped open hem flange panels. If necessary, compare to a like model year vehicle to determine if an open hem flange is present on the panel in question.

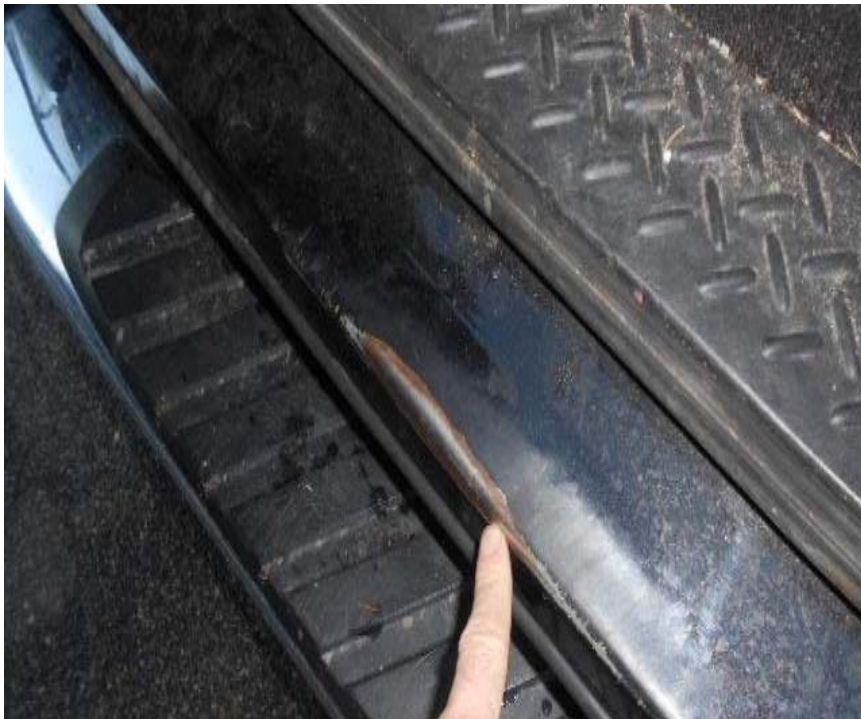
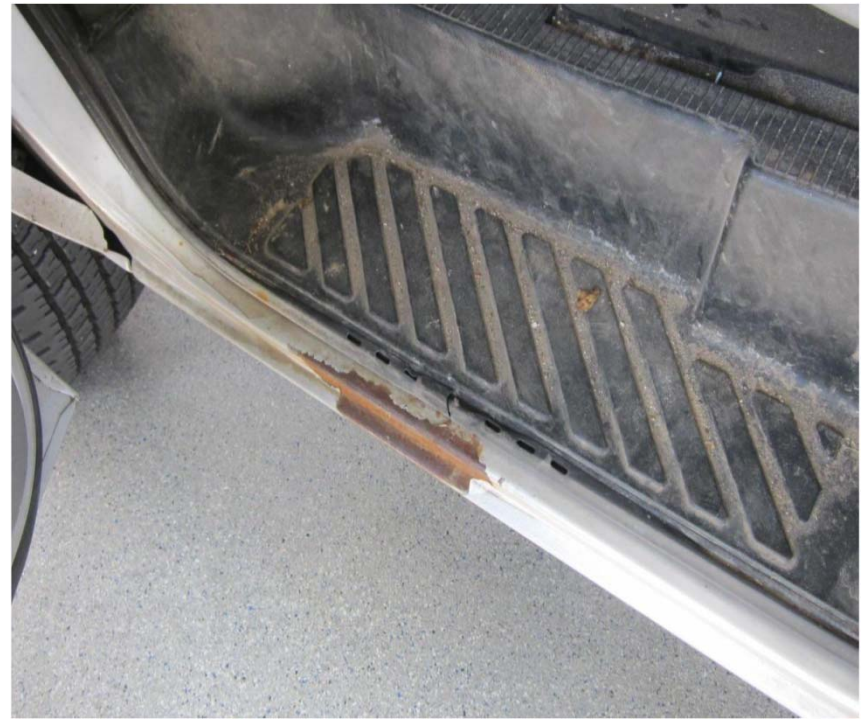
Ingress/Egress Damage

Chips, scratches, and other paint damage from entering or exiting the vehicle is not covered under warranty.

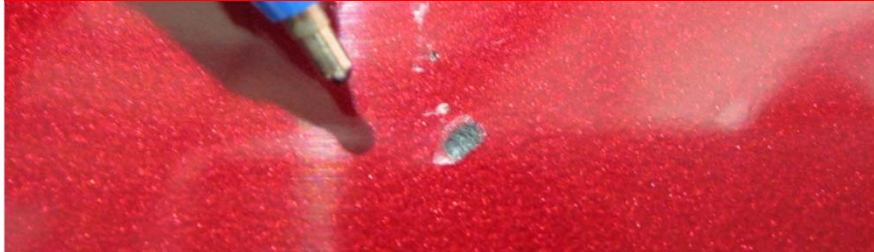
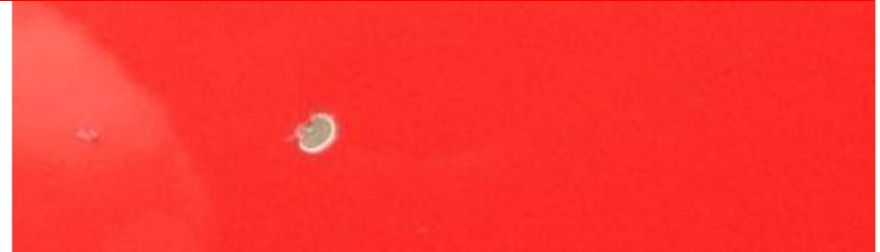
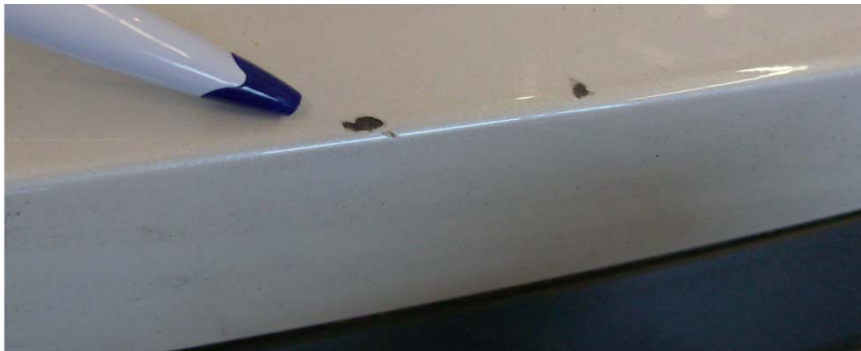
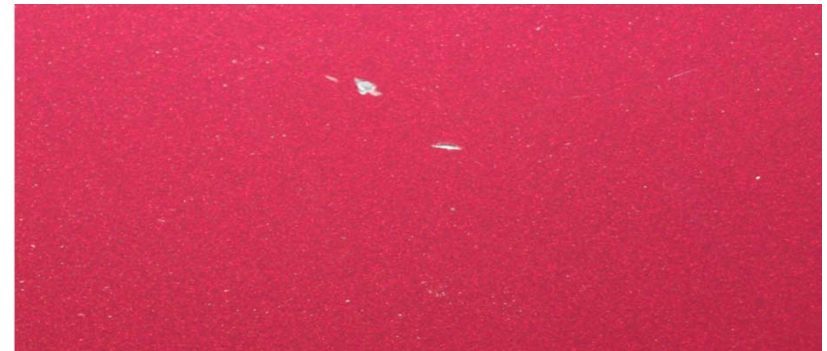
Paint chips are not covered within the New Vehicle Warranty, refer to section 2 & 3 of the W&P Manual. Paint Chips are commonly the result of, but not limited to, stones, road debris, and blunt objects making contact with the finish.

Note: Corrosion that develops from a paint chip or impact to the finish is not warrantable.

Paint Chips or jagged edges with no lifting to indicate peeling.

NOTE: When performing the tape test (refer to Tape Test in reference section) little or no paint will be removed.

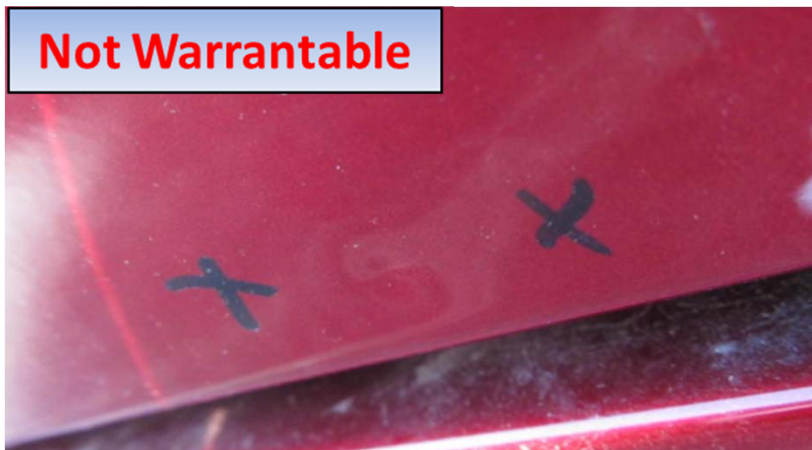
Not Warrantable

- Dents/damage caused by physical impact, with/without paint abrasion are not warrantable, unless present under RapGard without damage to RapGard.
- Inward dents with no paint damage, without evidence of physical impact, abrasion or forced entry smaller than 1"x1" should be claimed as warranty repair only during Pre Delivery Inspection (except for Left Front Door, should be filed as transportation damage)
- Outward dents which are not accessible or do not show damage should be filed as warranty repair

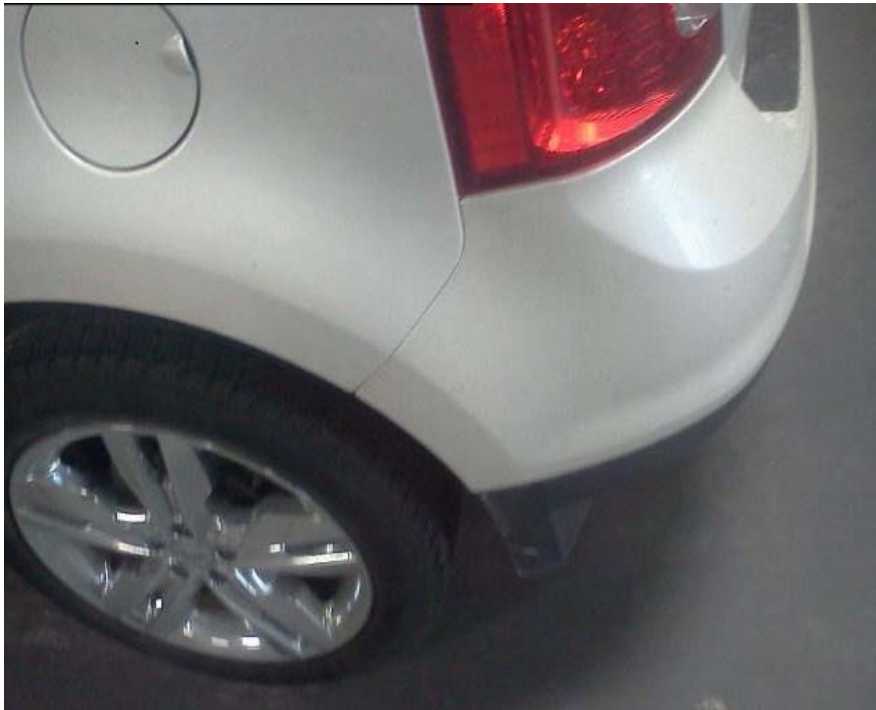
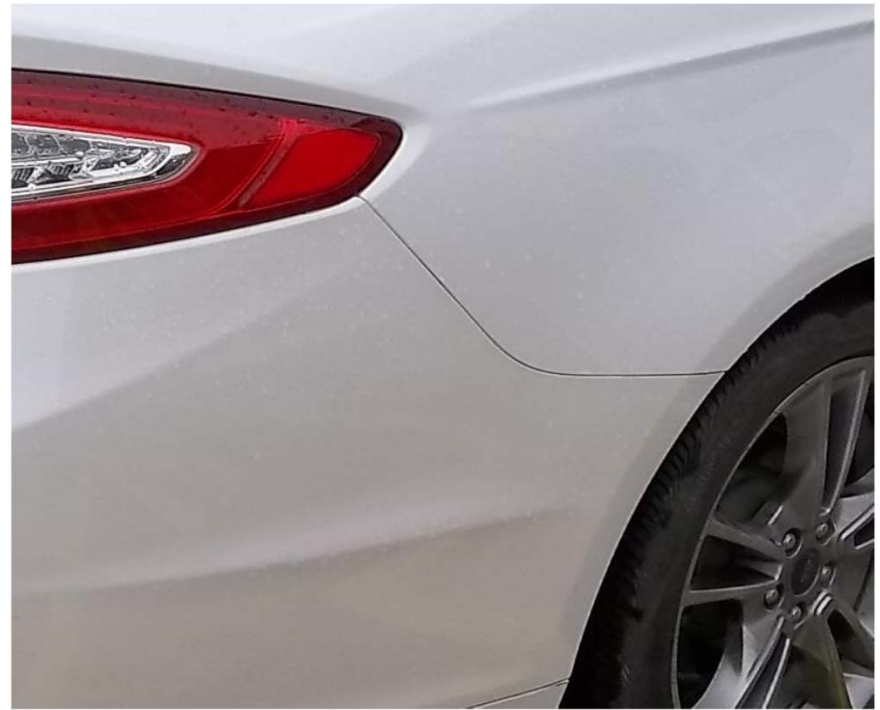
Paint color difference

Urethane and steel body panels have a different paint and curing process, a slight color difference may be seen. This difference can be exaggerated at different angles. If the difference can only be seen at certain angles, the difference is not warrantable.

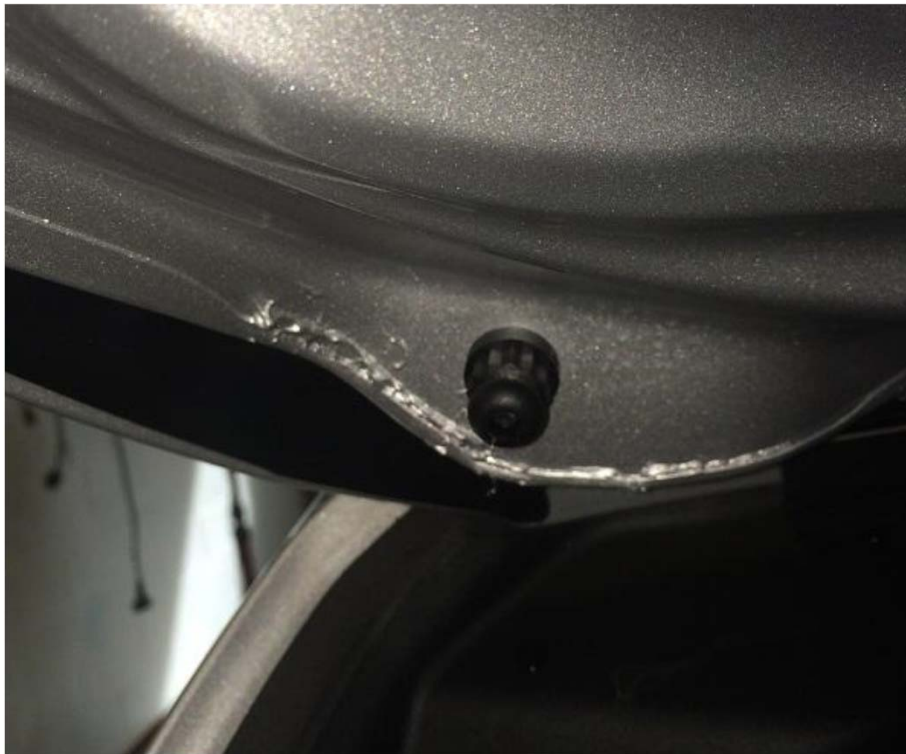
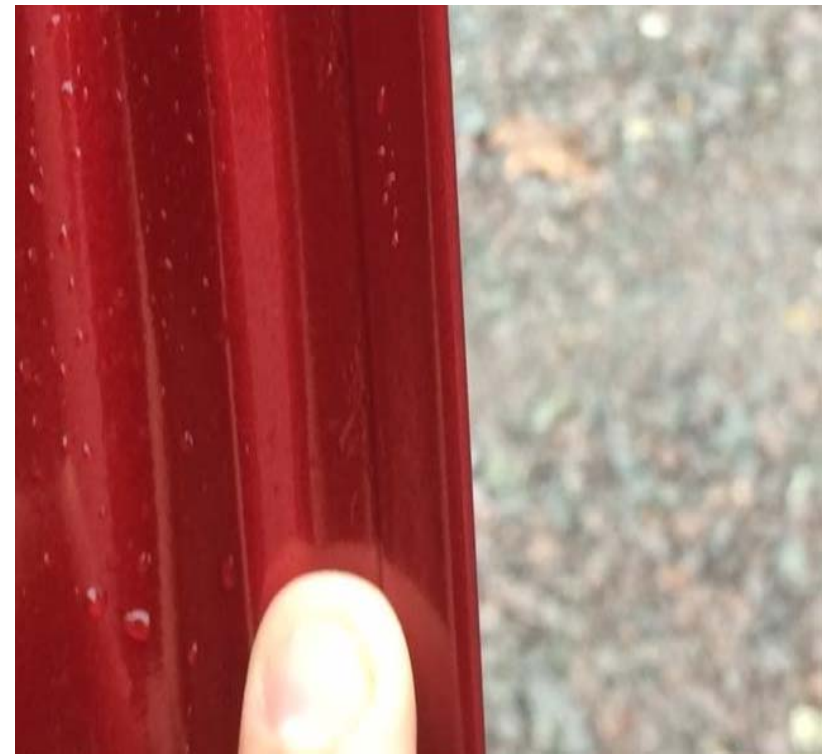
Seam Sealer

Seam sealer along a hem flange may occur during manufacturing of the panel. Seam sealer in a hem flange is a normal manufacturer process and is not warrantable.

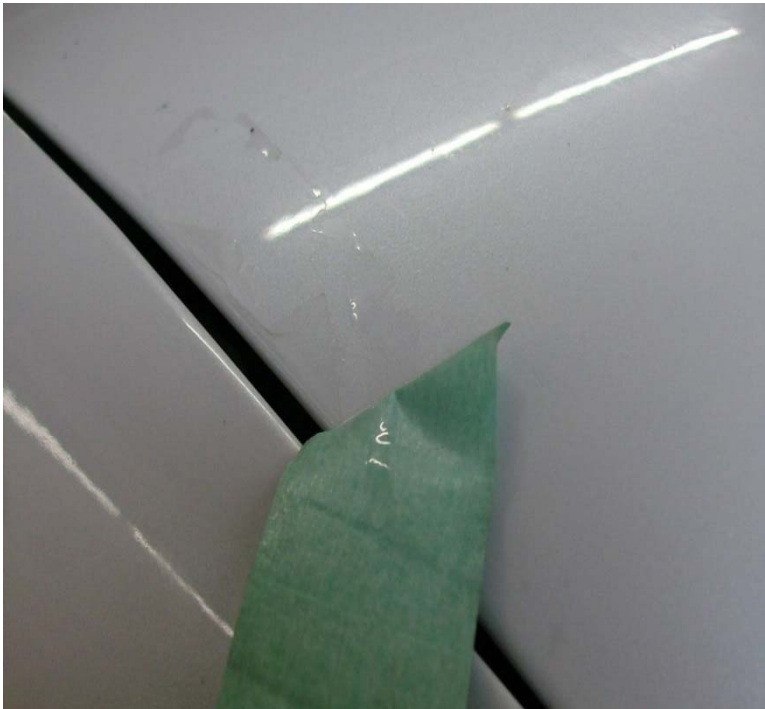
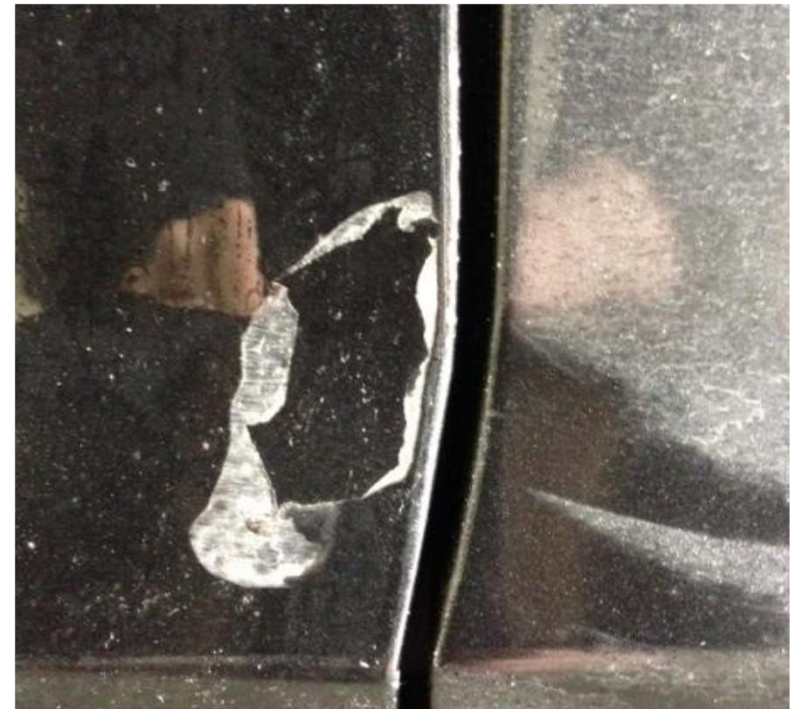
Clear coat peel

Ford uses a “wet on wet” paint process which applies clear coat to an existing wet color coat. These layers dry together creating a chemical bond. This ensures only one layer of paint remains atop the primer surface. This process prevents clear coat from peeling and separating from the base color coat.

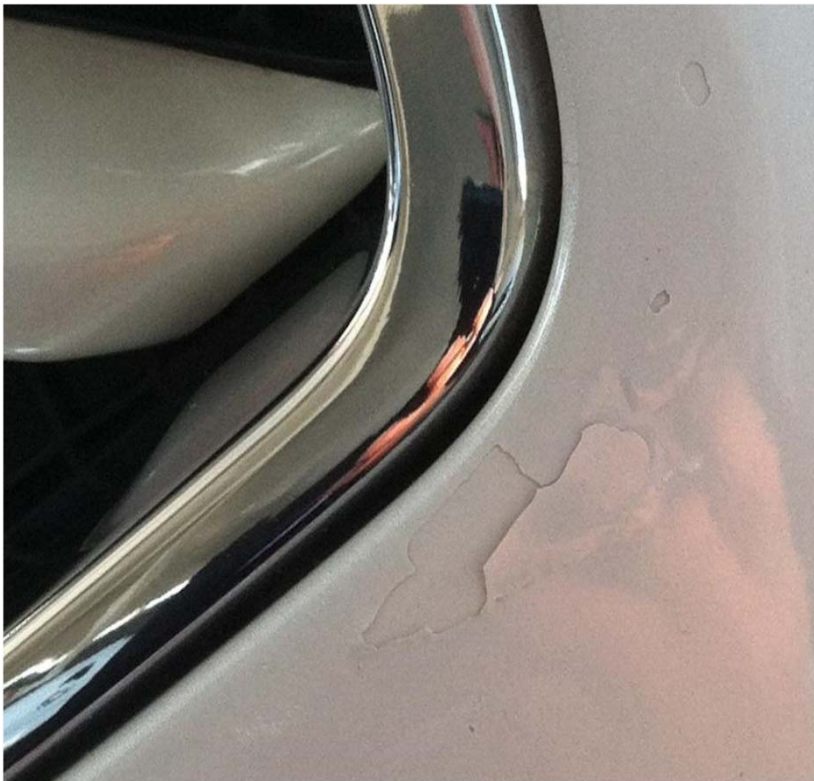
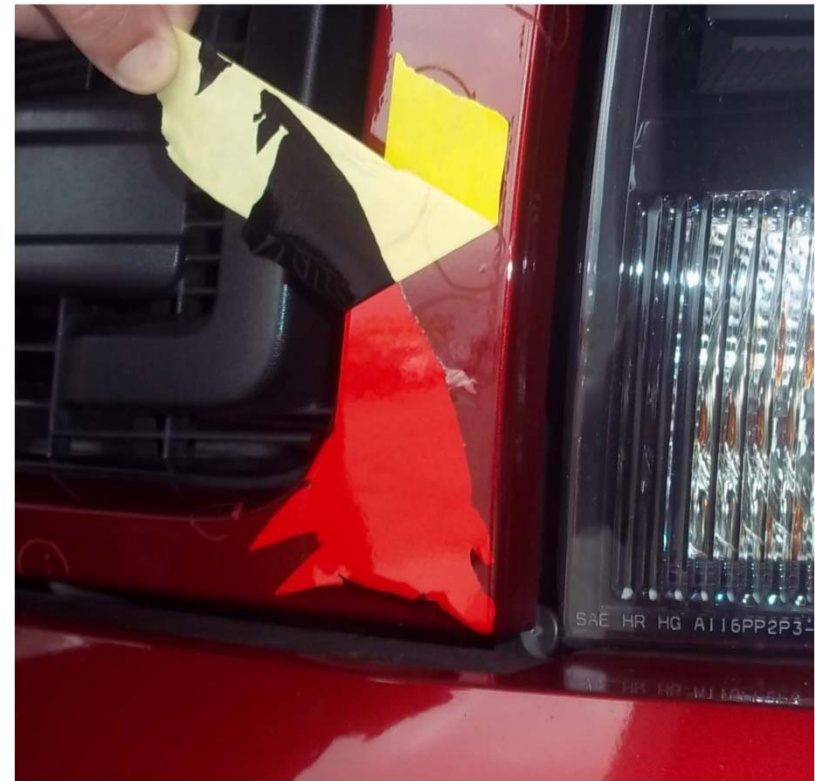
Paint Peeling

Refer to Tape Test in reference section. Paint peeling with the same color paint revealed is an indication of a previous repair. This paint can still be shiny or even another color.

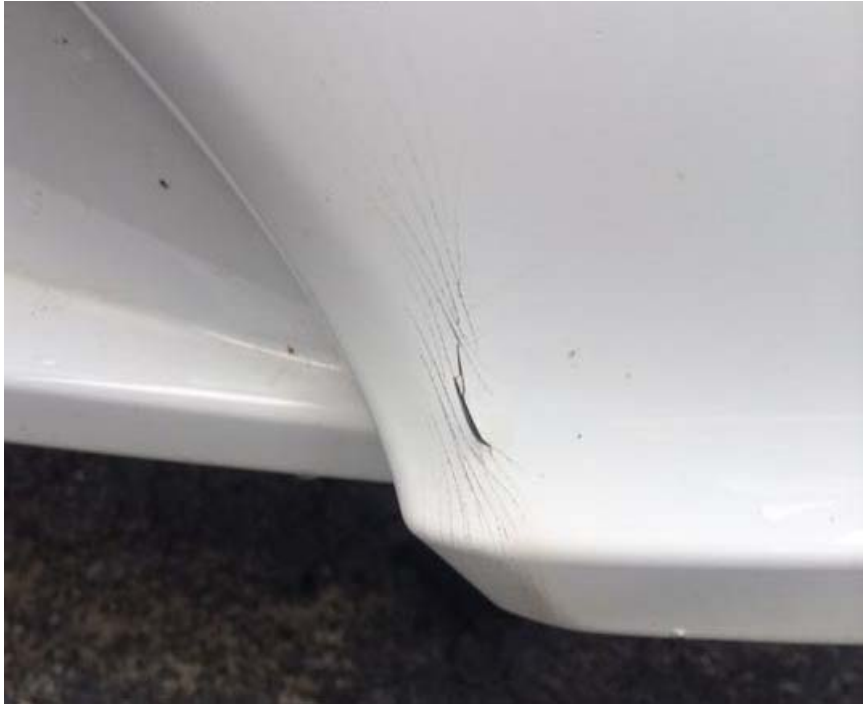
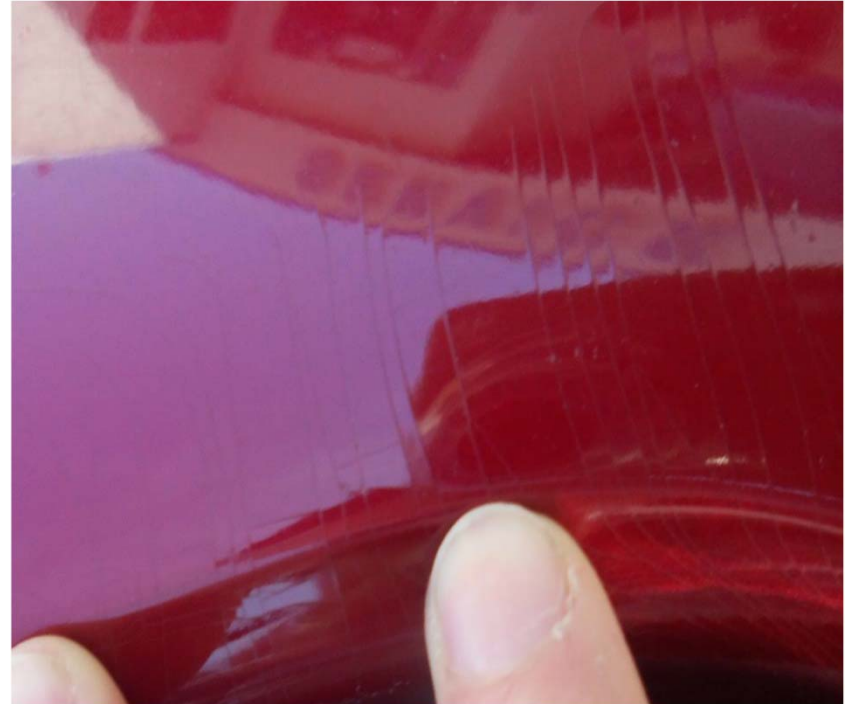
Cracked Paint

The cracks follow where the panel or bumper has been flexed. The pattern of cracks show the panel has been flexed causing the paint to crack.

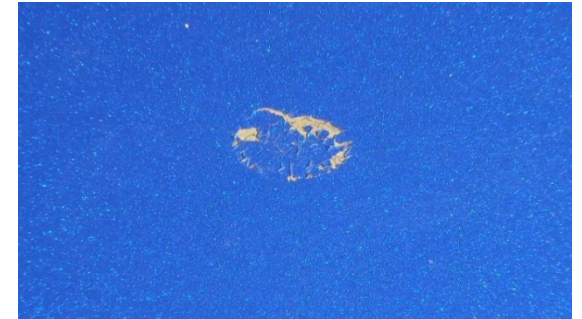
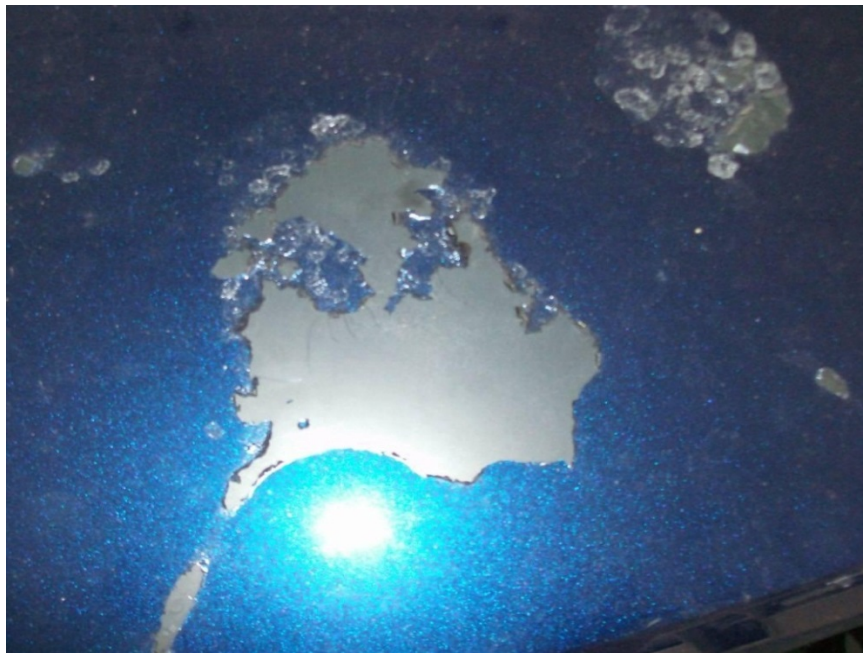
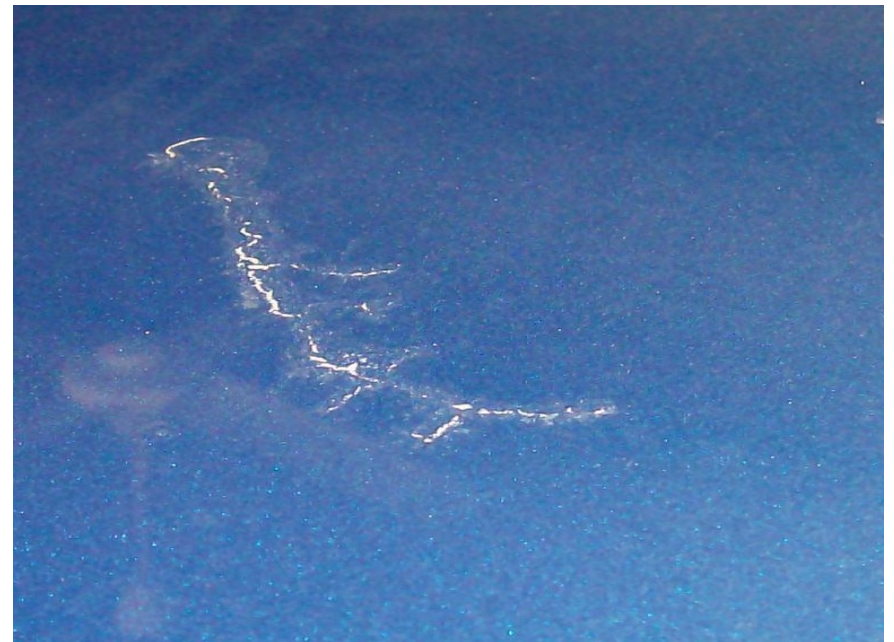
Environmental/Chemical Damage

When paint is etched or damaged from the top, the paint will crack and separate from the E-coat. The cracking in the surface of the paint is an indication that the paint has been damaged. This type of damage will also typically follow a drip or liquid type pattern.

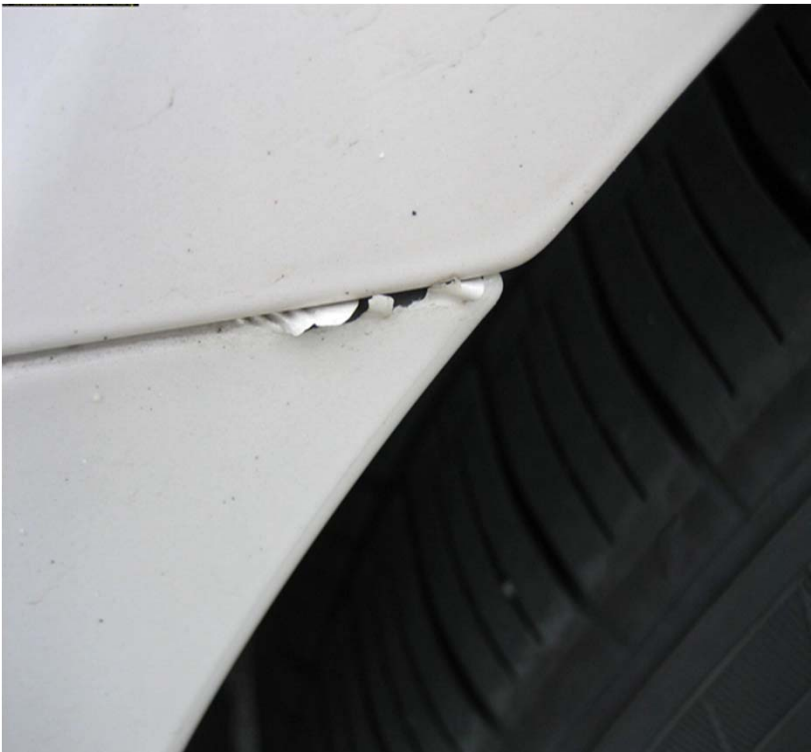
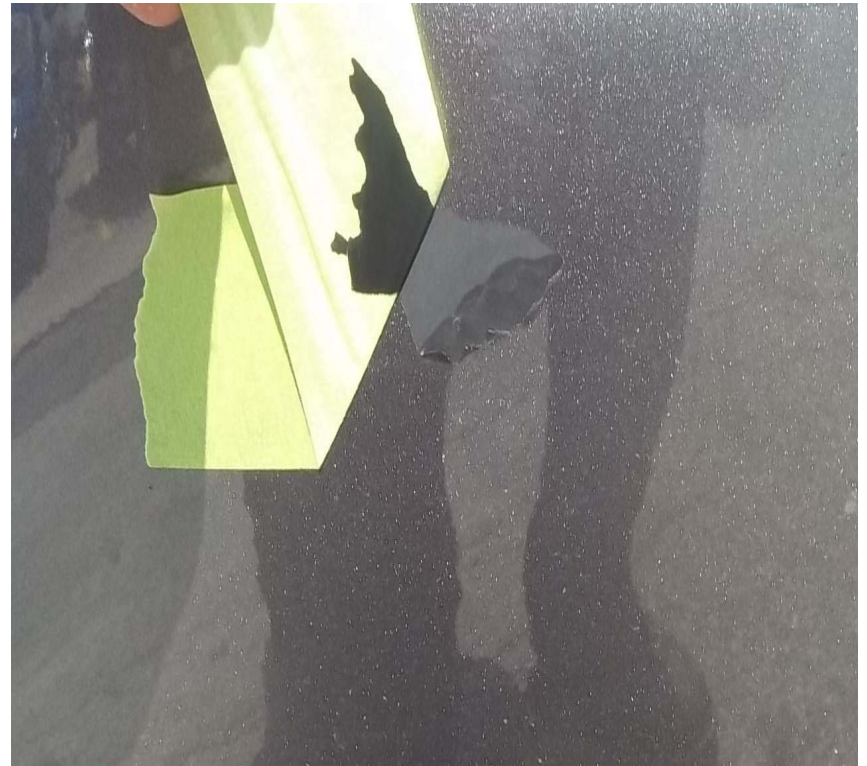
Paint Peeling (original factory paint)

NOTE: Paint Peeling is NOT Warrantable if it originates from damage, i.e. dents, dings, chips, or scratches or is not the original factory paint.

The lifting edges of the paint show that the paint is not adhering properly to the panel. A tape test (refer to Tape Test in the reference section) would determine if a defect is present. Paint will be removed in a large sheet showing a primer surface.

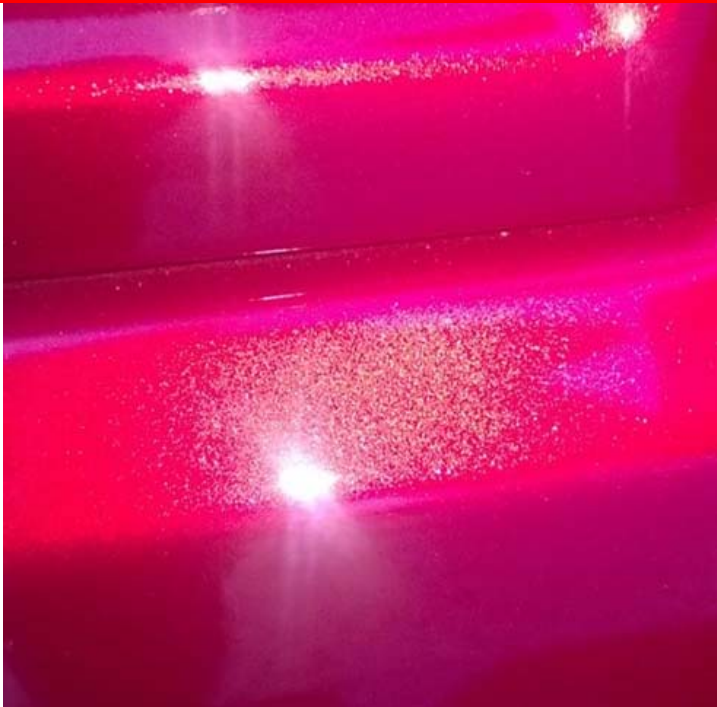
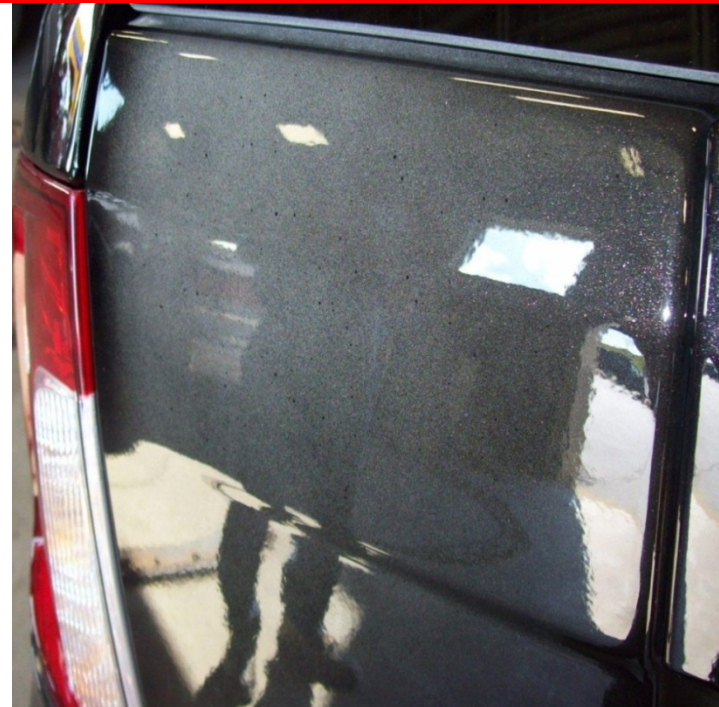
Thin Paint (Original Factory Paint)

Thin paint will have a spray like pattern to the outside edges. It will not generally appear in small spots, but over an area of the entire panel.

NOTE: Thin paint on components with minimal visibility such as under the hood or in an inner wheel well may be manufacturing intent. Compare the finish on the component to several like units before making any repairs.

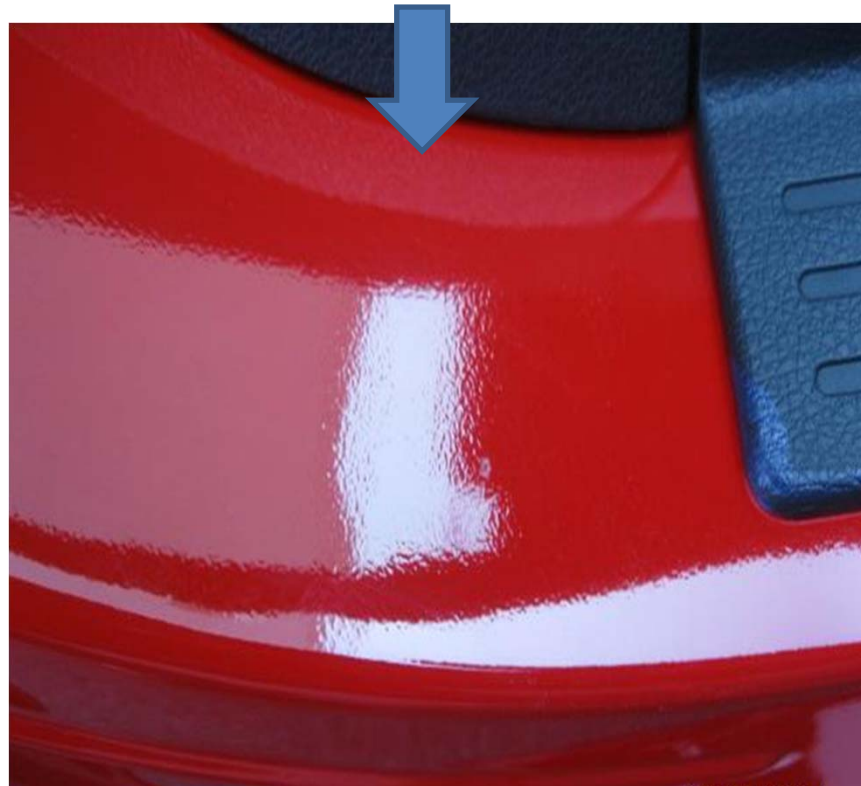
Orange Peel (Original Factory Paint)

Orange peel will appear dull and spotty. Objects in the reflection of the paint will not be able to be identified.

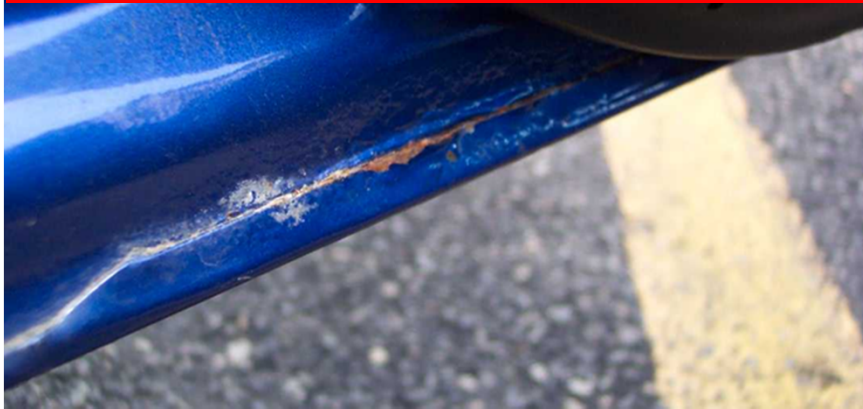
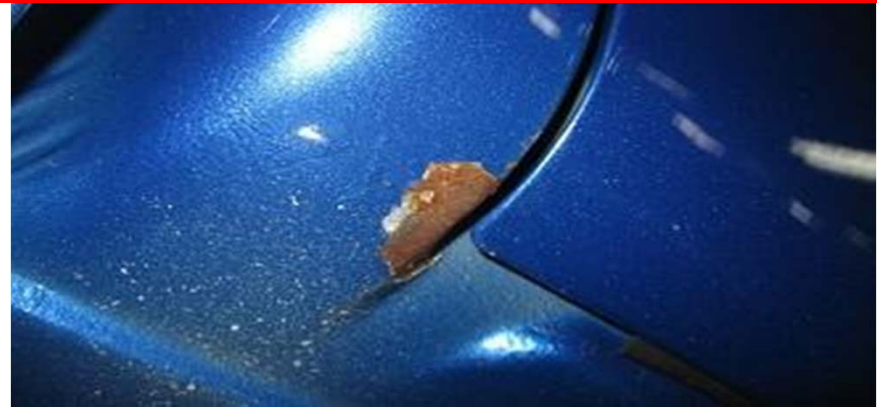
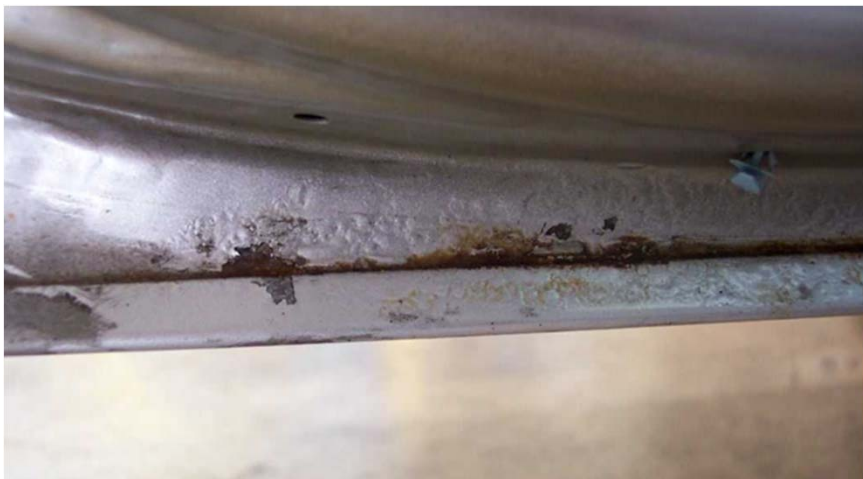
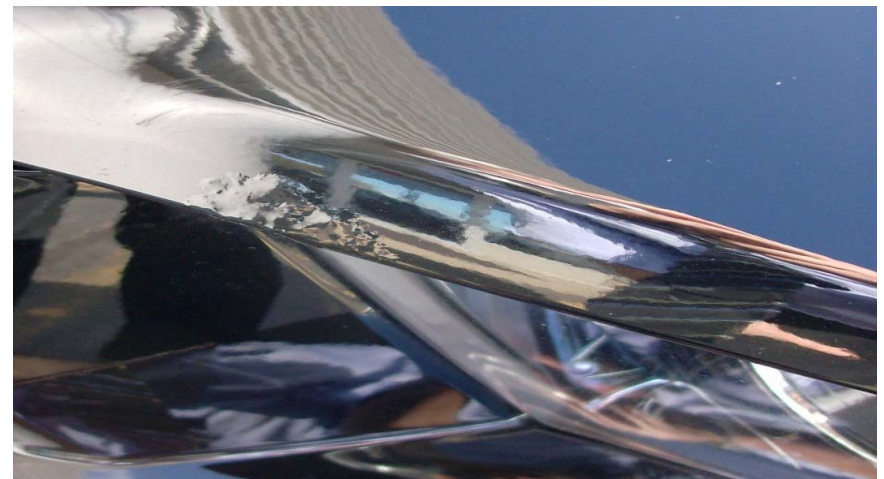
**Surface Corrosion (Original Factory Paint)
Covered under the New Vehicle Warranty**

Body sheet metal that has corrosion damage without perforation

Note: Corrosion that develops from a paint chip or impact to the finish is not warrantable.

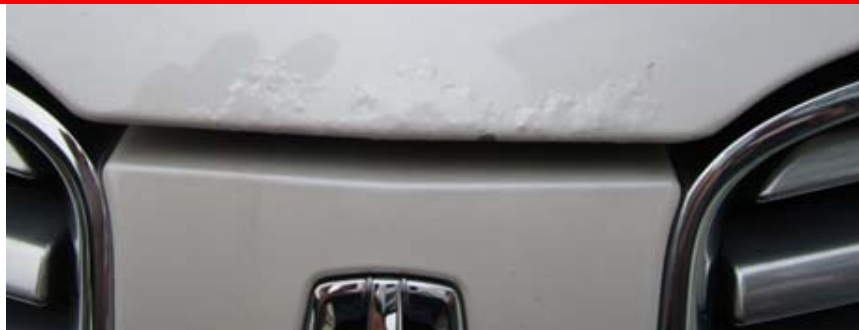
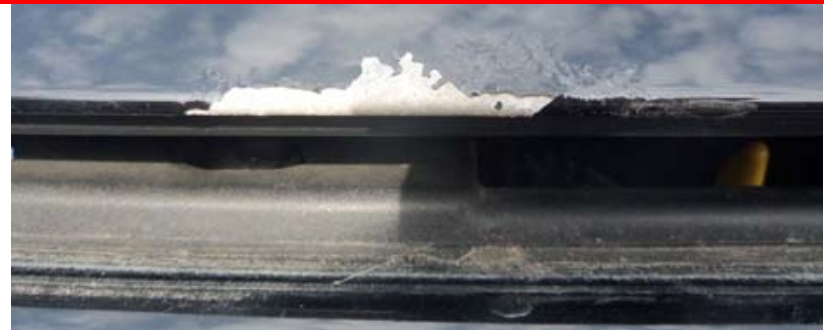
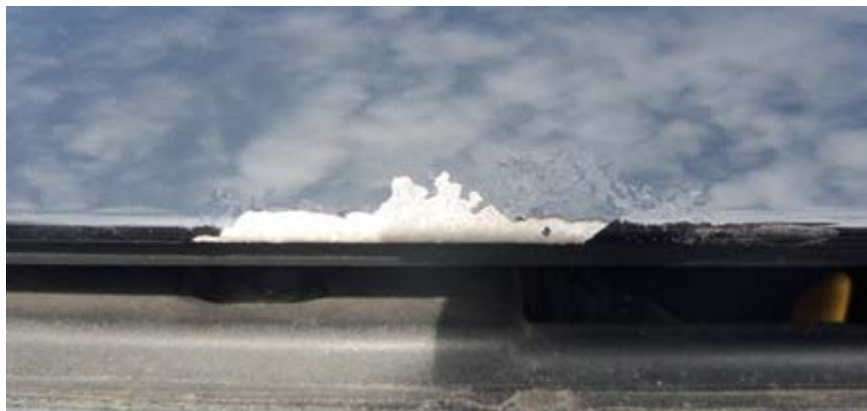
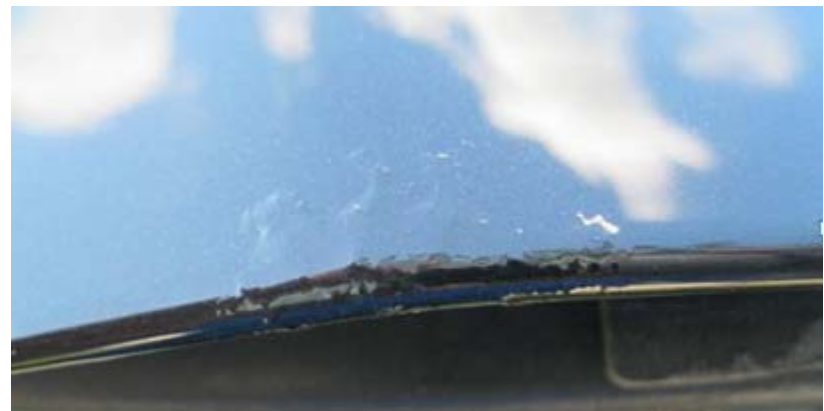
Surface Corrosion Aluminum Panels (Original Factory Paint)

Aluminum Panels – Beginning with the 2015 F150 and for all 2016 and beyond vehicles, Corrosion damage is covered for 5yr/unlimited miles with NO requirement for perforation.

Note: Corrosion that develops from a paint chip or impact to the finish is not warrantable.

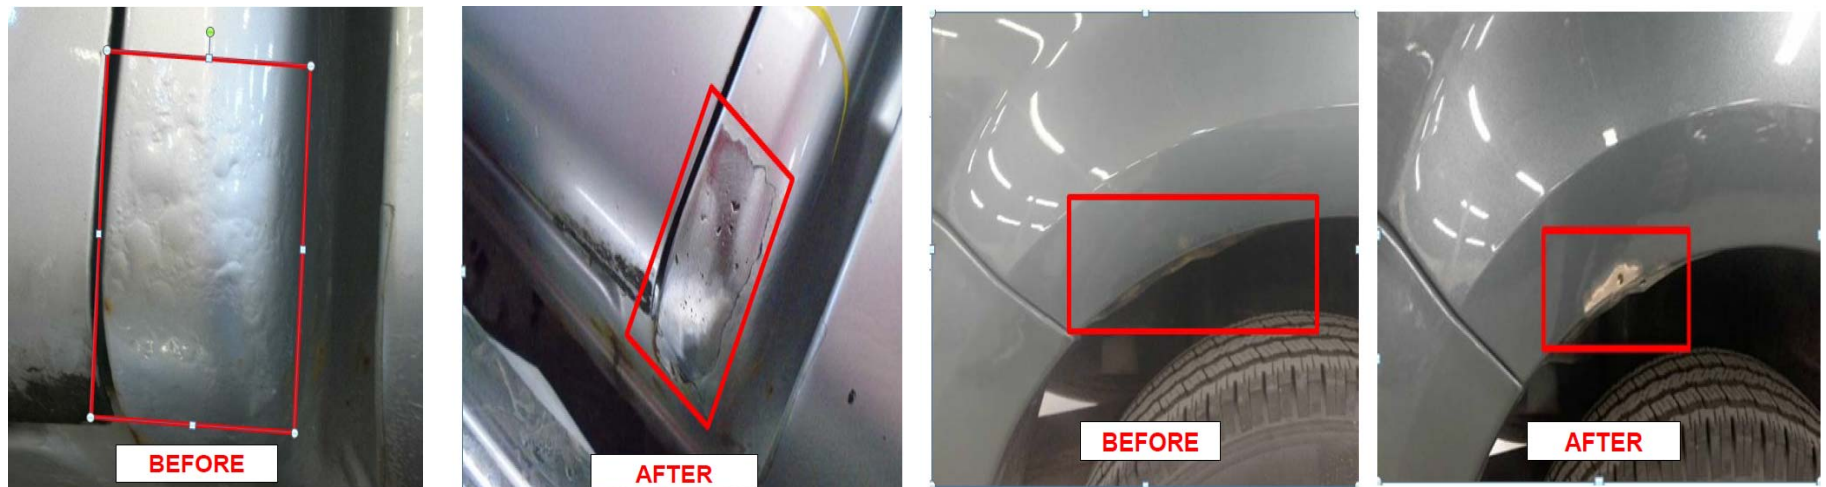
Examples of perforation after light sanding or sandblasting

As per the Warranty and Policy Manual, the 5 Year Unlimited Mile Corrosion Warranty covers naturally occurring corrosion/rust damage resulting in perforation (holes) in sheet metal body panels not influenced by damage or mechanical influence.

In some instances, perforation is only visible after paint removal. If paint removal is necessary to show the perforation, it is crucial to obtain prior authorization from the customer for any costs relating to the diagnosis or repair of the body panel in the event the vehicle does not have naturally occurring perforation. Do not use an implement to push or pierce the metal to accentuate the perforation or utilize an aggressive method such as excessive grinding or sandblasting, as this is considered to be mechanical perforation assistance and not warrantable under the 5-year Corrosion Warranty. If light sanding or sandblasting does not indicate perforation, the concern would not be covered under the 5-year Unlimited Mile Corrosion Warranty. Do not use sand paper grit below P80.

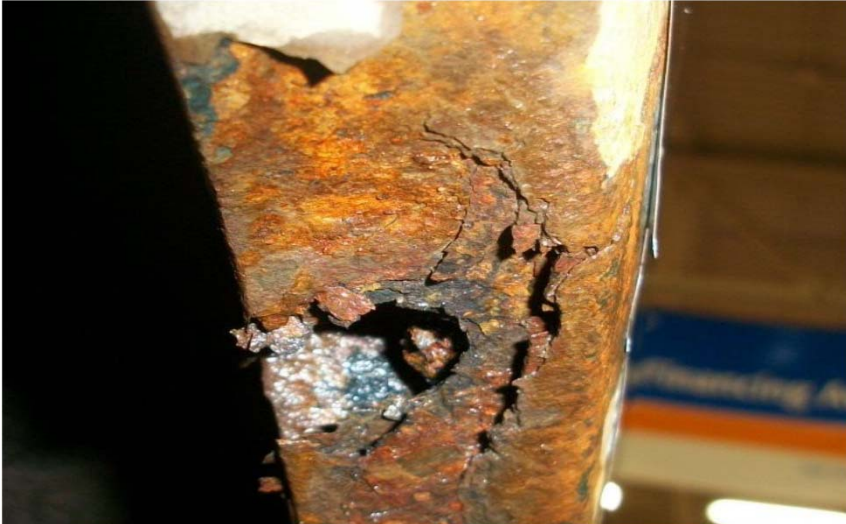
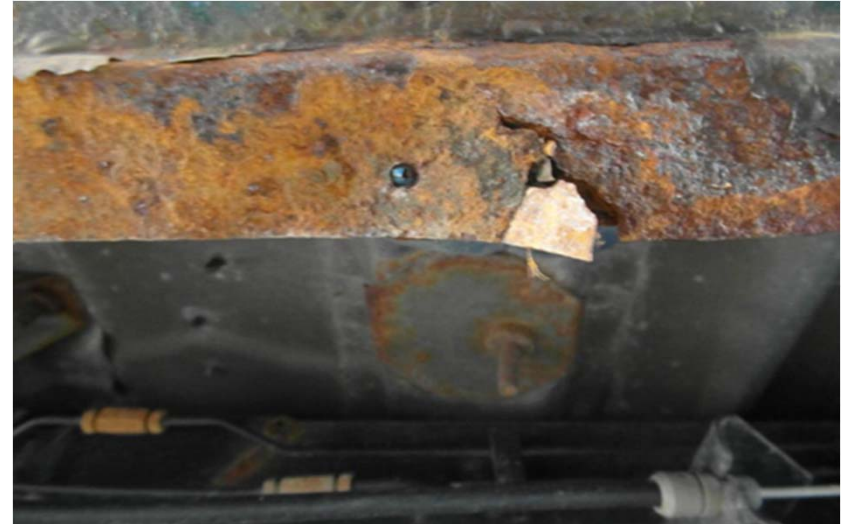
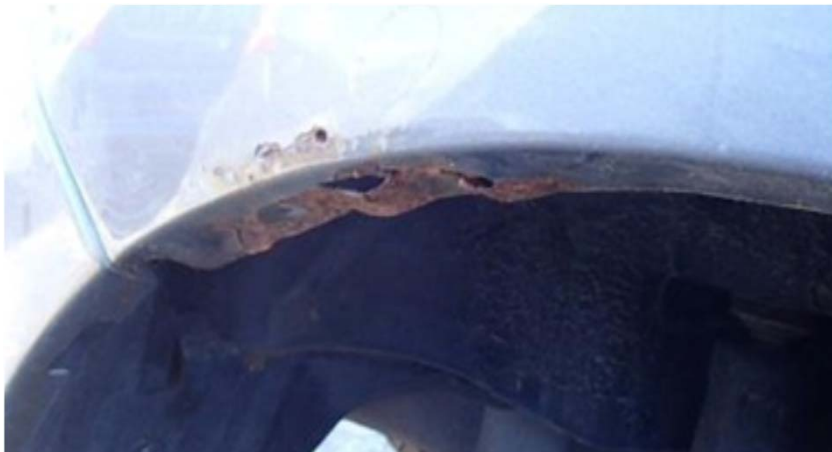
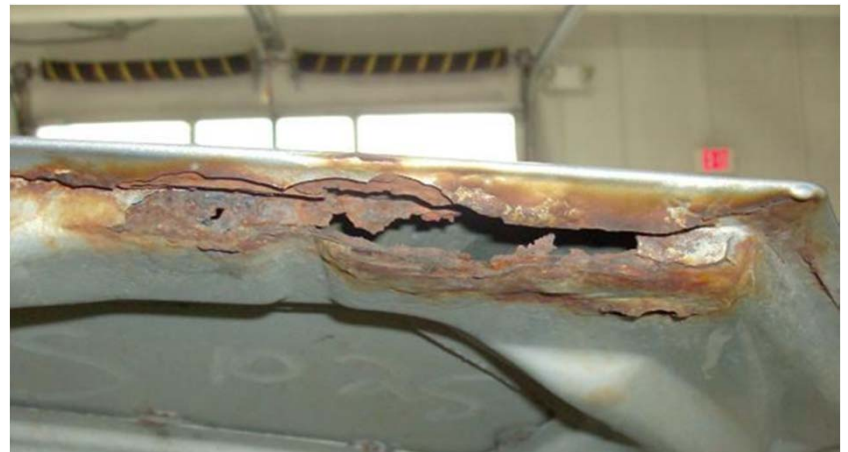
Sheet Metal Perforation

Covered under the Corrosion Warranty
