| General Service Bulletin (GSB): | Instrument Panel Cluster Mask / Lens Warranty | |
| GSB Overview: | Information on warrantable vs non-warrantable conditions along with proper cleaning procedures and how to order replacement displays | |

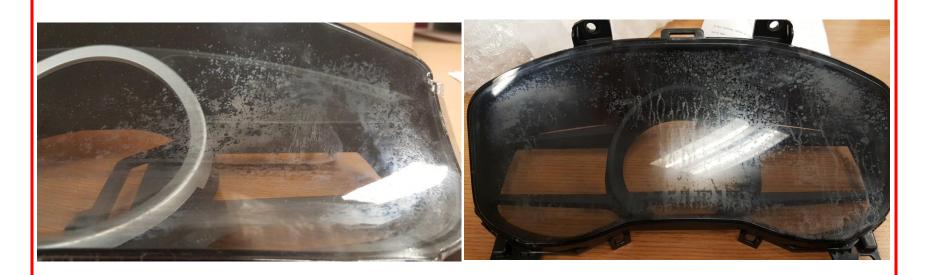
Figure 1

Damage due to improper cleaning solutions or liquid spills

(Figures 1 & 2)

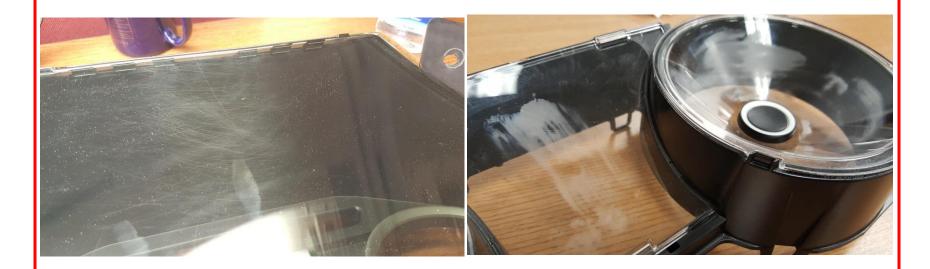
Figure 3

Damage due to improper cleaning

(Figures 3 & 4)

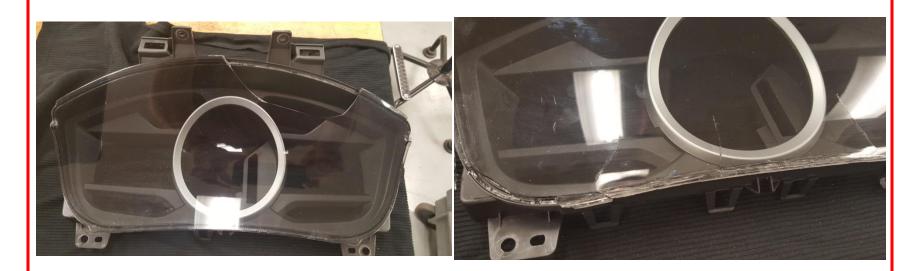
Figure 5

Damage due to excessive force or impact to the Mask / Lens

(Figures 5 & 6)

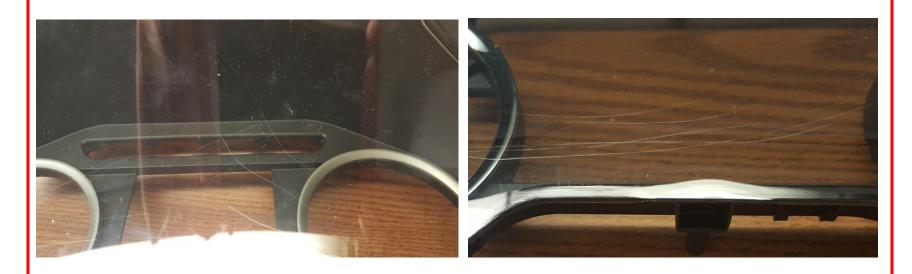
Figure 7

Damage due to scratches on the Outside Surfaces

(Figures 7 & 8)

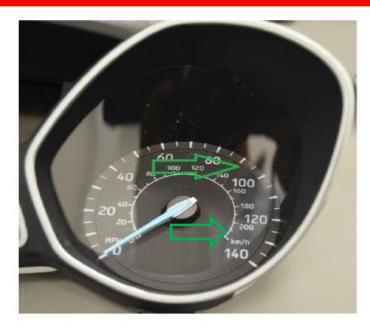
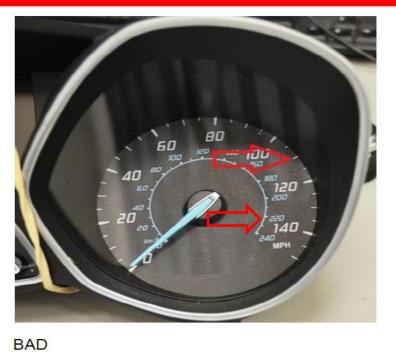
Figure 9

OEM vs Non-OEM Applique (aftermarket speedometer face) 10 MPH increments not consistently bold and/or km/h numbers different color than MPH (light blue) Compare to like vehicle (Figures 9 & 10)
