Police Interceptor Utility One Piece Catalytic Converter Manifold

General Service Bulletin (GSB):	One Piece Catalytic Converter Manifold
GSB Overview:	This Bulletin Provides Additional Information For Making The Correct Warranty Decision When Encountering Cracked One Piece Catalytic Converter Manifolds on 2013 – 2017 Police Interceptor Utility Vehicles With 3.7L Ti-VCT Engine
NOTE: This information is not intended to replace or supersede any warranty, parts and service policy, Work Shop Manual (WSM) procedures or technical training or wiring diagram information.

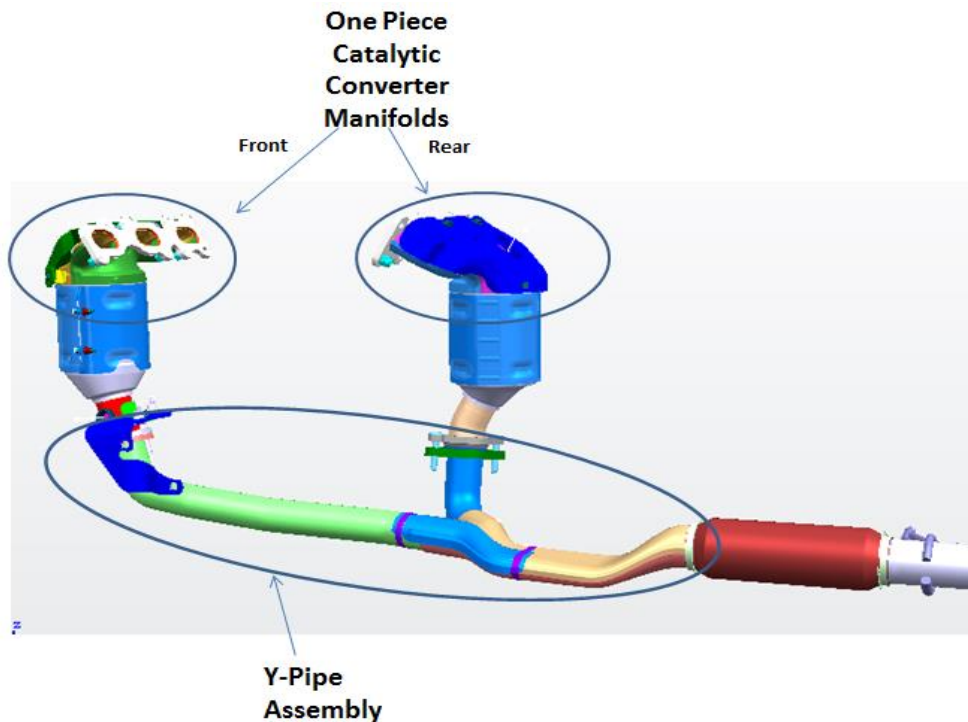
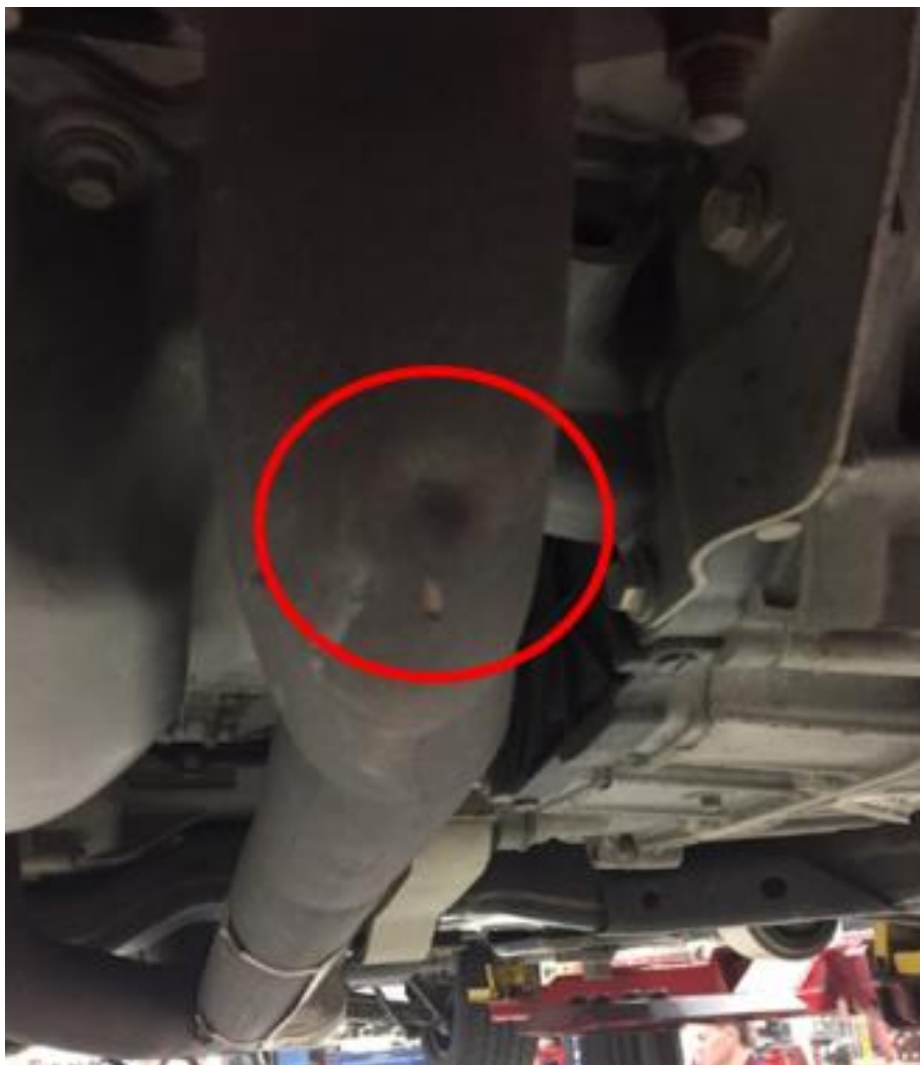
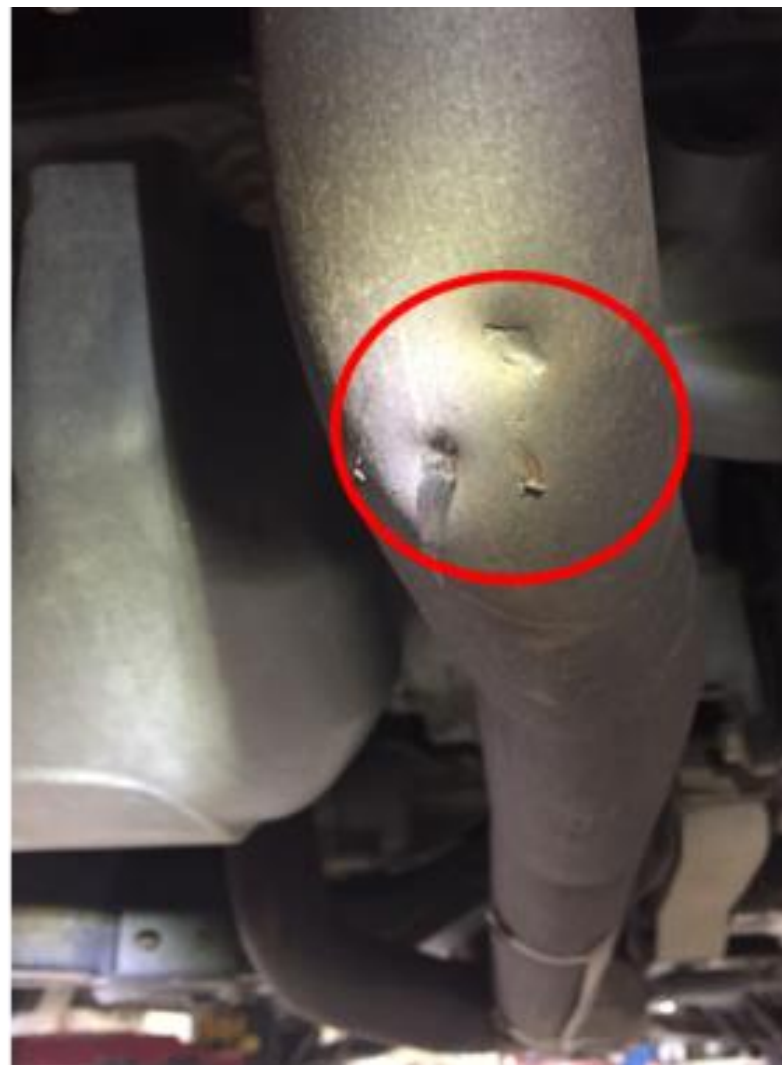
Examples of impact dents to y-pipe assembly

If a 2013 – 2017 Police Interceptor Utility vehicle is found with a cracked one piece catalytic converter manifold, warranty should not be denied or cancelled due to impact damage found on the exhaust Y-pipe assembly. Existing warranty coverage should be honored on the one piece catalytic converter manifold if such a condition is found. This does not extend to any damage found on the Y-pipe and if found the Y-Pipe is not warrantable. Refer to the below images and illustrations.
