General Service Bulletin (GSB):	DPS6 Transmission and Dual Clutch Service
GSB Overview:	This Bulletin is a supplement to existing Workshop Manual (WSM) procedures for the DPS6 Transmission and Dual Clutch assembly.
NOTE: This information is not intended to replace or supersede any warranty, parts and service policy, Work Shop Manual (WSM) procedures or technical training or wiring diagram information.

# DPS6 Transmission and Dual Clutch Service

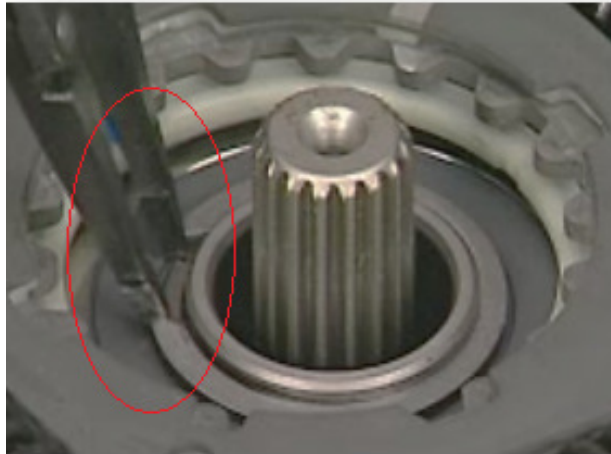
**Concern:** Incorrect hollow input shaft snap ring removal can damage the bearing seal and result in abnormal noises and vibrations in addition to premature clutch or input shaft failure.

Ex: Correct snap ring removal

- **Do:** Remove the snap ring using suitable snap ring pliers.
- **NOTE:** To prevent bearing seal damage, remove special tools 307-675/1 and 307-675/4 after pressing the clutch onto the hollow input shaft and before attempting snap ring removal
- **Don't:** Damage the bearing seal during snap ring removal.

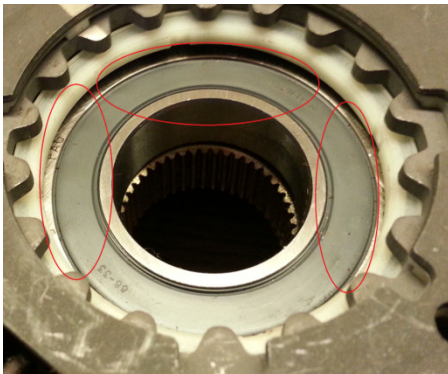
Ex: Intact bearing seal from proper snap ring removal

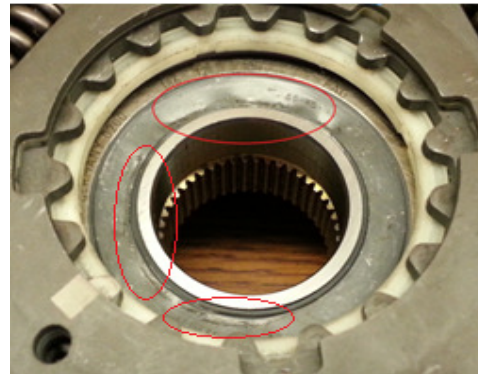
Ex: Bearing seal damage from improper snap ring removal

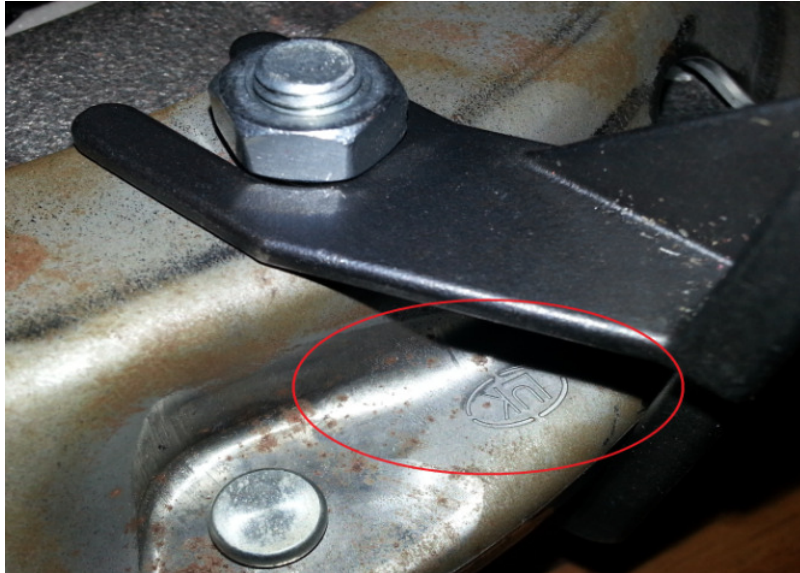
Ex: Correct lifting leg installation

- **Do:** Install clutch lifting legs on the studs adjacent to the “LUK” manufacturing stamps.
- **Don't:** Install clutch lifting legs on the studs that are not adjacent to the manufacturing stamps.

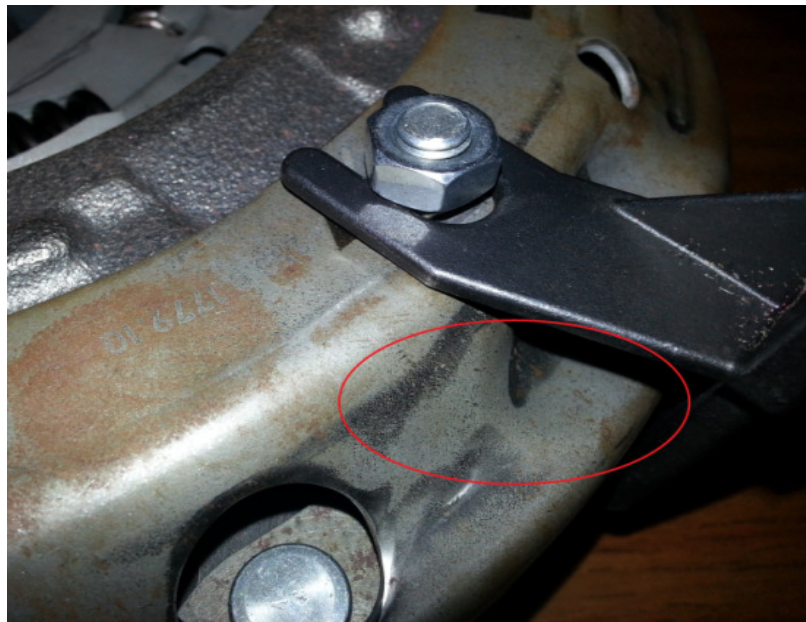
**Concern:** Incorrect placement of the clutch lifting legs can result in damage to the clutch assembly.

Ex: Incorrect lifting leg installation

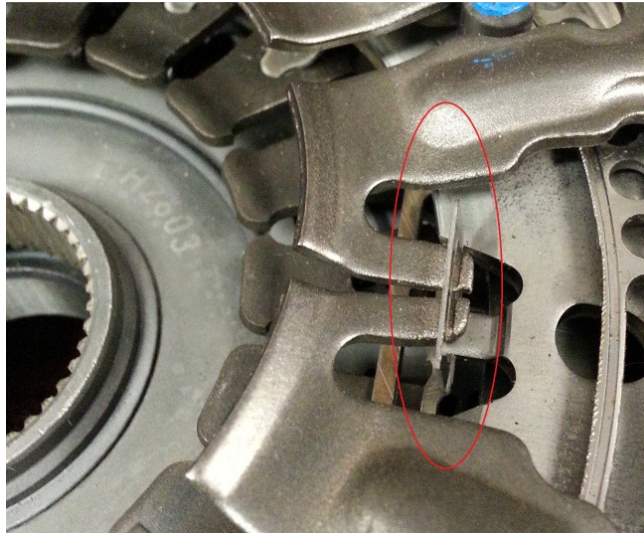
**Concern:** Factory-supplied clutch assemblies are shipped pre-set and locked. Attempting to reset a locked clutch assembly can damage the clutch spring fingers. You must ensure a clutch assembly is unlocked before attempting to reset.

Ex: Locked clutch 1 spring fingers

- **Do:** Verify that all clutch locks are released before attempting reset.
- **Don't:** Attempt to reset a locked clutch.

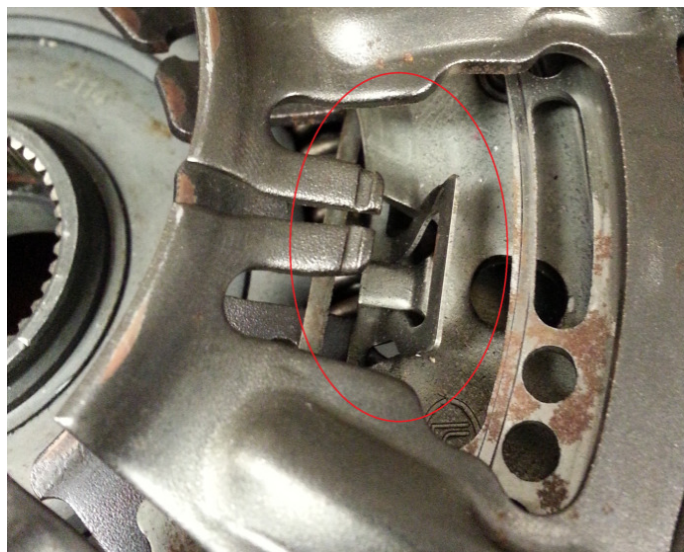
Ex: Unlocked clutch 1 fingers

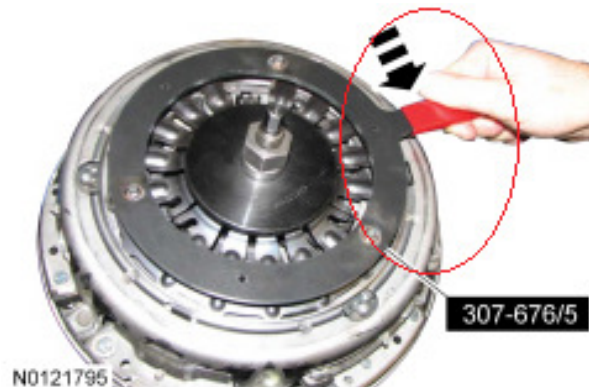
Ex: Proper resetting of clutch 1

- **Do:** Follow the instructions listed in the online Workshop Manual to reset clutch 1.
- **Don't:** Attempt to tighten special tool 307-676/3 before moving the clutch 1 self-adjusters clockwise to their stops using special tool 307-676/5.

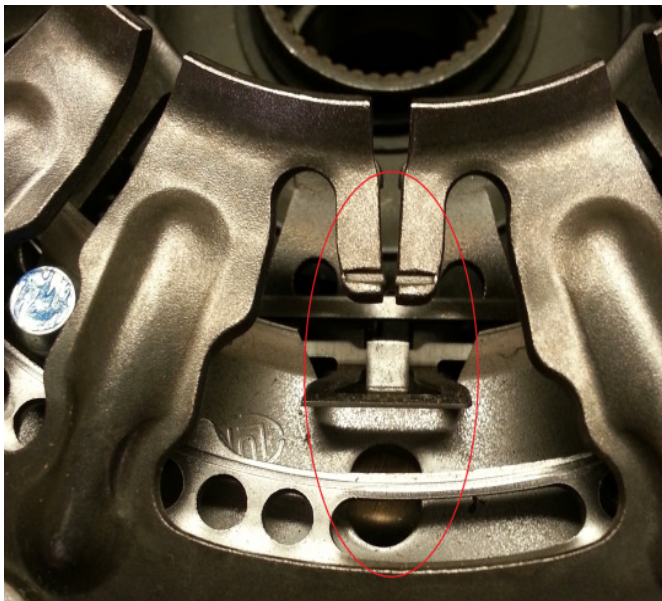
Ex: Clutch 1 locks free from damage

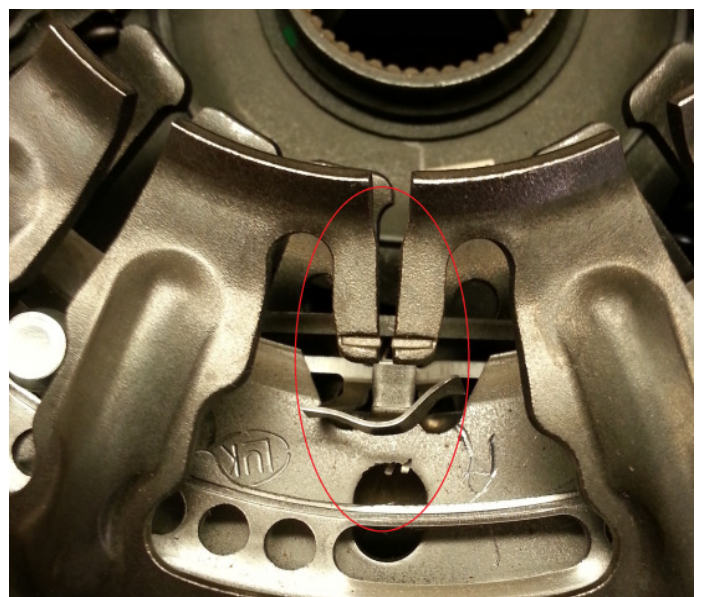
**Concern:** Failure to move clutch 1 self-adjusters to their stops (rotated clockwise) can result in damage to the clutch.

Ex: Damaged clutch 1 lock caused by attempting to lock spring fingers before moving the self-adjusters

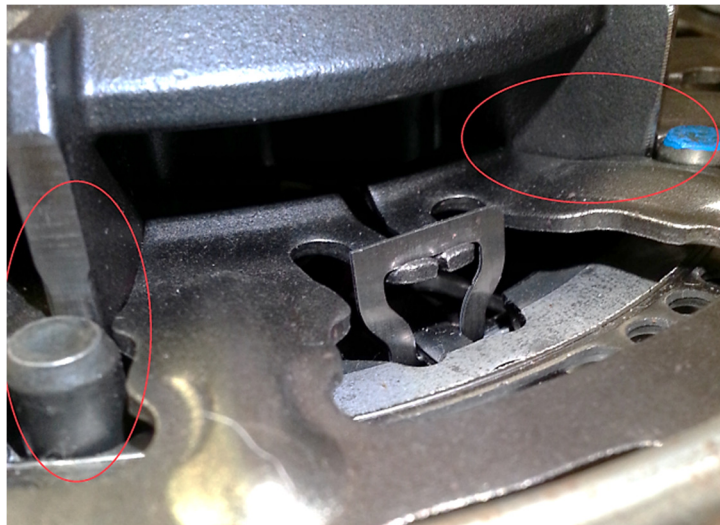
Ex: Proper alignment of tool 307-676/2 (tool falls between clutch 1 spring fingers)

- **Do:** Properly align special tool 307-676/2 before attempting to compress clutch.
- **Don't:** Misalign special tool 307-676/2 or release of clutch 1 locks will occur.

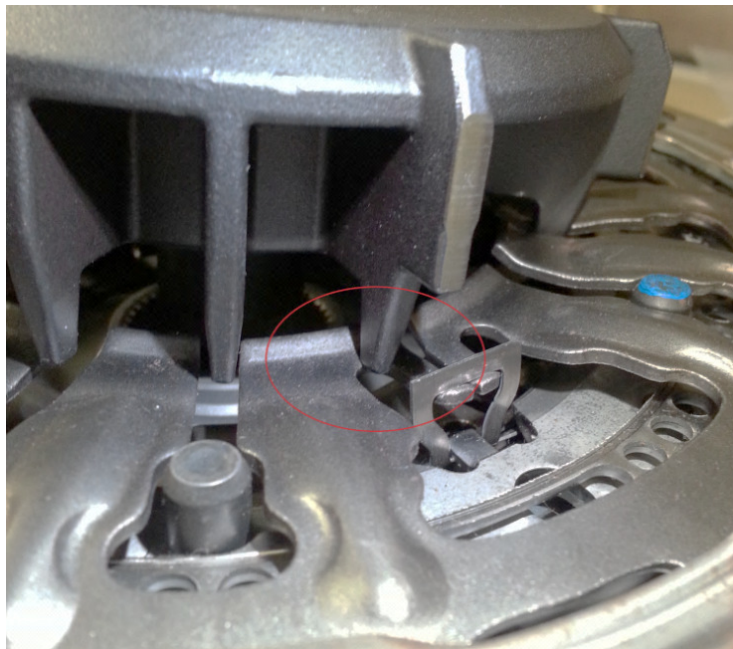
**Concern:** Improper alignment of clutch 2 reset tool 307-676/2 can result in the release of the clutch 1 locks.

Ex: Improper alignment of tool 307-676/2 (tool rests on clutch 1 spring fingers)

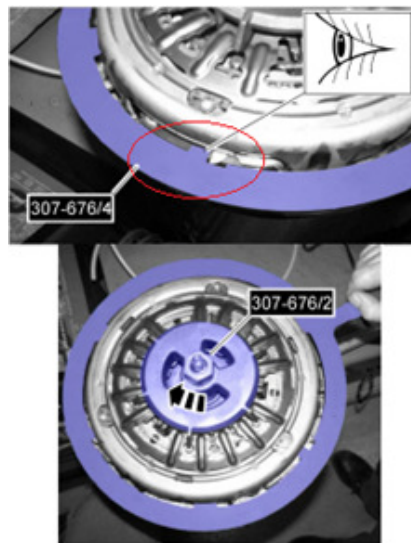
Ex: Proper resetting of clutch 2

- **Do:** Follow the instructions listed in the online Workshop Manual to reset clutch 2.
- **Don't:** Attempt to tighten special tool 307-676/2 before moving the clutch self-adjusters counterclockwise to their stops using special tool 307-676/4.

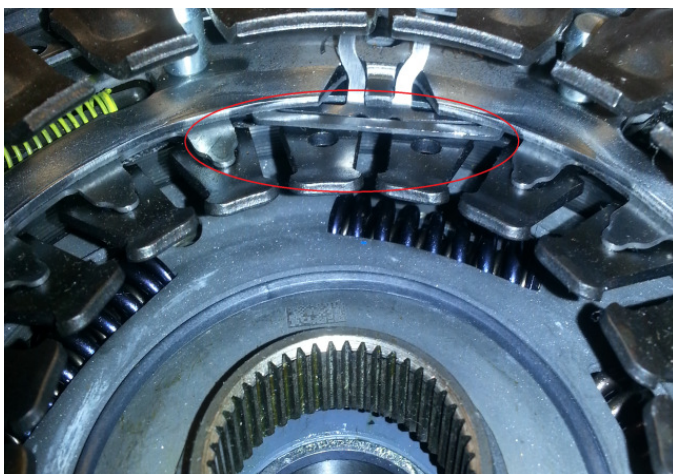
Ex: Clutch 2 locks free from damage

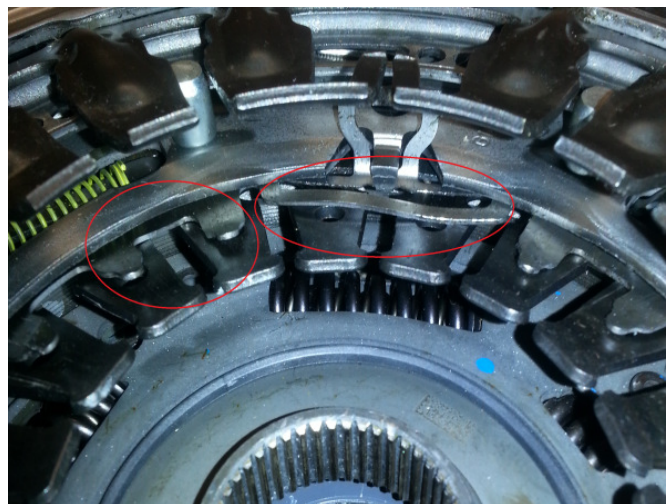
**Concern:** Failure to move clutch 2 self-adjusters to their stops (rotated counterclockwise) can result in damage to the clutch spring fingers.

Ex: Damage to locks caused by improper resetting of clutch 2

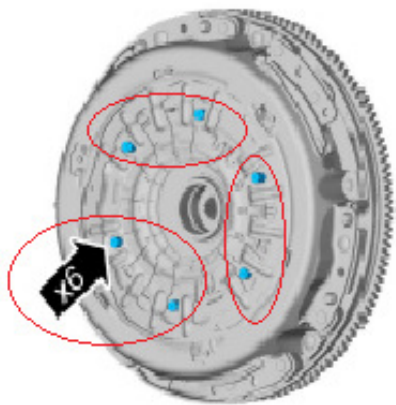
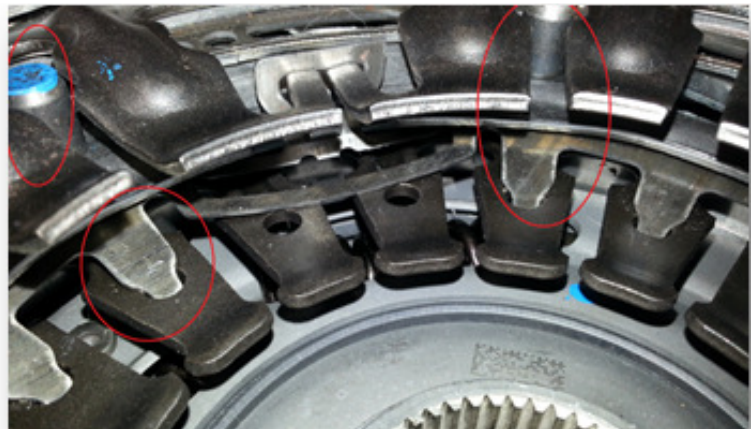
Ex: Properly locked clutch 2

- **Do:** Properly lock at least 6 of the clutch 2 locks. The 6 locks must align with the clutch studs (shown below).
- **Don't:** Attempt installation of the clutch with fewer than 6 clutch 2 locks engaged.

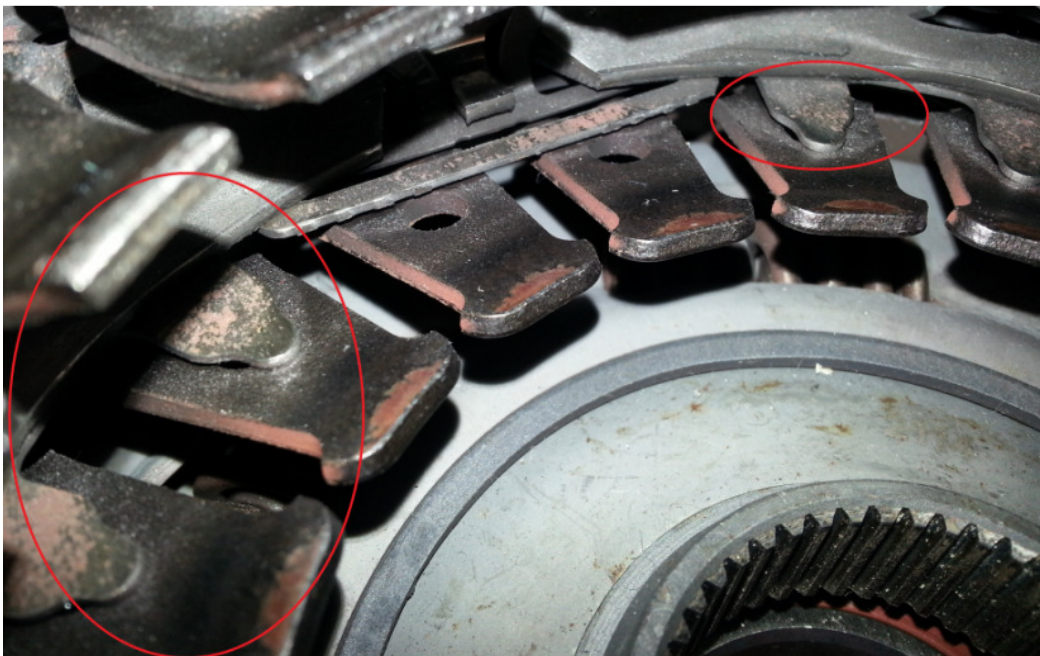
**Concern:** Failure to engage at least 6 of the clutch 2 locks can result in damage to the clutch or engagement system.

Ex: Unlocked clutch 2

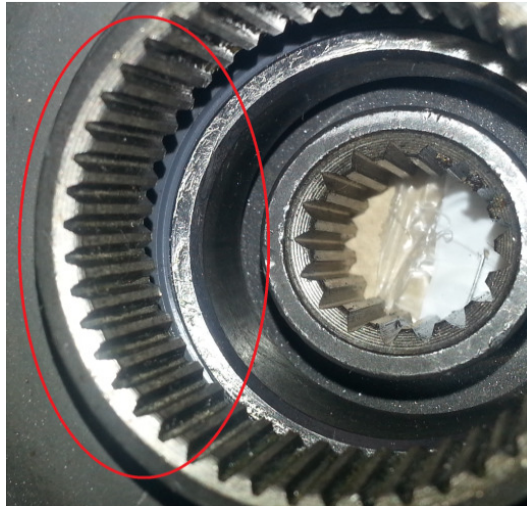
Ex: Normal minimal transfer of grease to the clutch splines from proper application to the input shafts

- **Do:** Remove old grease from input shaft splines. Evenly apply only **1 gram** (approx. 1/3 of packet) of the supplied grease.
- **Don't:** Apply grease on top of the old grease on the input shaft splines or directly on the clutch hub splines.

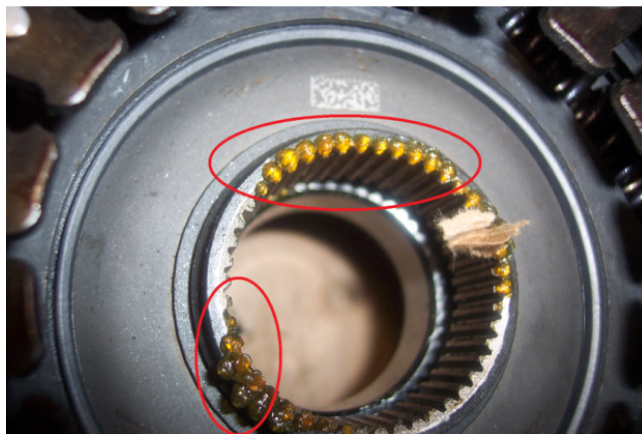
**Concern:** Application of grease in excess of approximately **1 gram** to the input shaft splines can result in excess transfer to, and contamination of, the clutch friction plates.

Ex: Excessive transfer of grease resulting from excessive or uneven application on input shafts

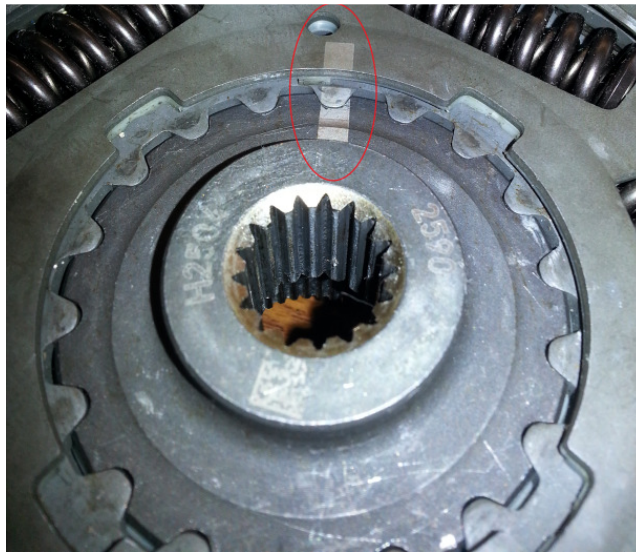
Ex: Properly aligned clutch 1 hub

- **Do:** Align the markings on the clutch 1 hub and clutch 1 friction plate during installation.  
**NOTE: The plastic tab in the snap ring groove should align with the balance marks.**
- **Don't:** Install the hub into the clutch without aligning the markings.

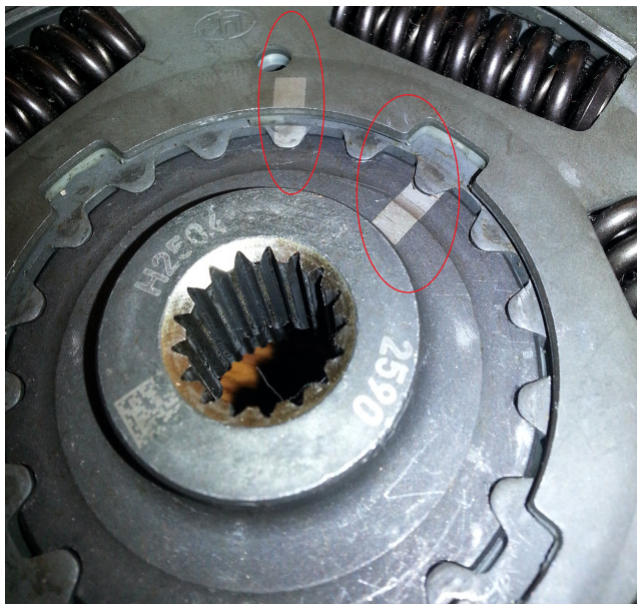
**Concern:** Incorrect alignment of the clutch 1 hub to the clutch 1 friction plate can result in an imbalance that is measured as a 1<sup>st</sup> order engine vibration.

Ex: Improperly aligned clutch 1 hub

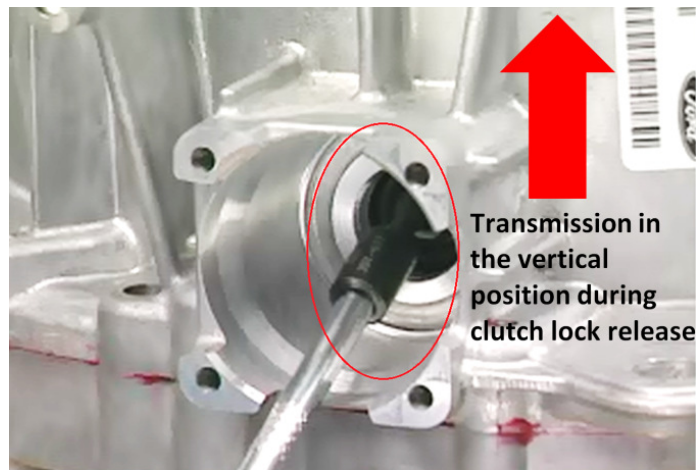
Ex: Proper release of clutch locks

- **Do:** Release the clutch locks before moving the transmission from the vertical position.
- **Don't:** Move the transmission from the vertical position before releasing the clutch locks.

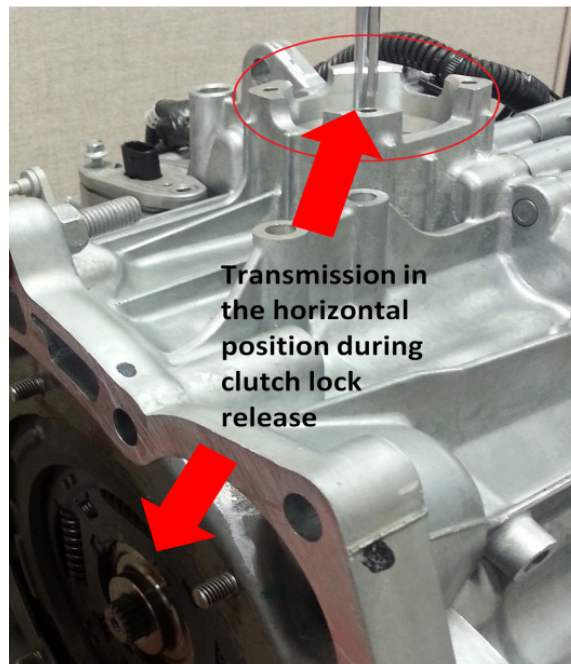
**Concern:** Misalignment of the clutch engagement system Z-washers caused by moving the transmission to the horizontal position before releasing the clutch locks.

Ex: Improper release of clutch locks

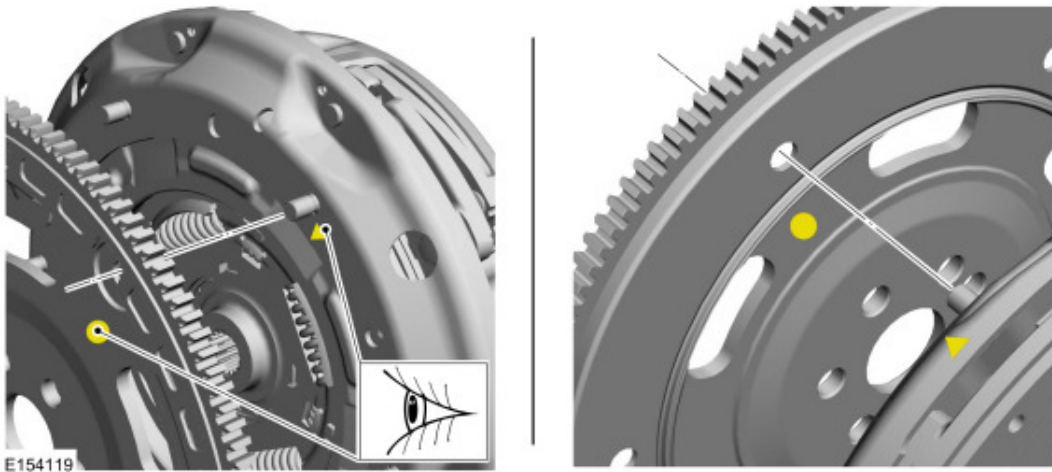
Ex: Properly indexed flexplate and clutch

- **Do:** Align the index marks on the flexplate and clutch during transmission installation.
- **Don't:** Misalign the index marks on the flexplate and clutch during transmission installation.

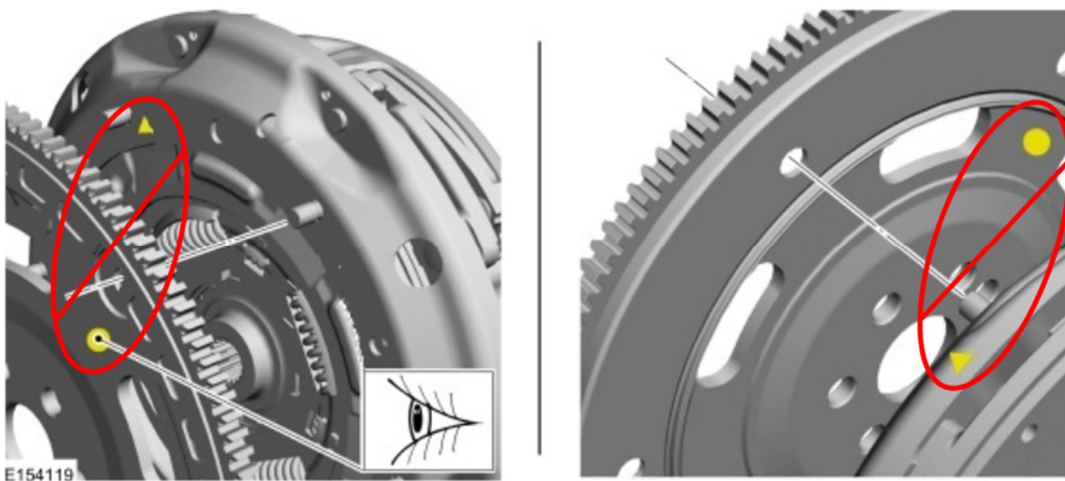
**Concern:** Severe powertrain vibration caused by improperly indexed flexplate and clutch.

**NOTE:** Index markings on the clutch or flexplate may be difficult to see. Adding paint dots near these markings prior to transmission installation can aid proper indexing. Failure to properly index the clutch can induce a severe 1<sup>st</sup> order engine vibration.

Ex: Improperly indexed flexplate and clutch

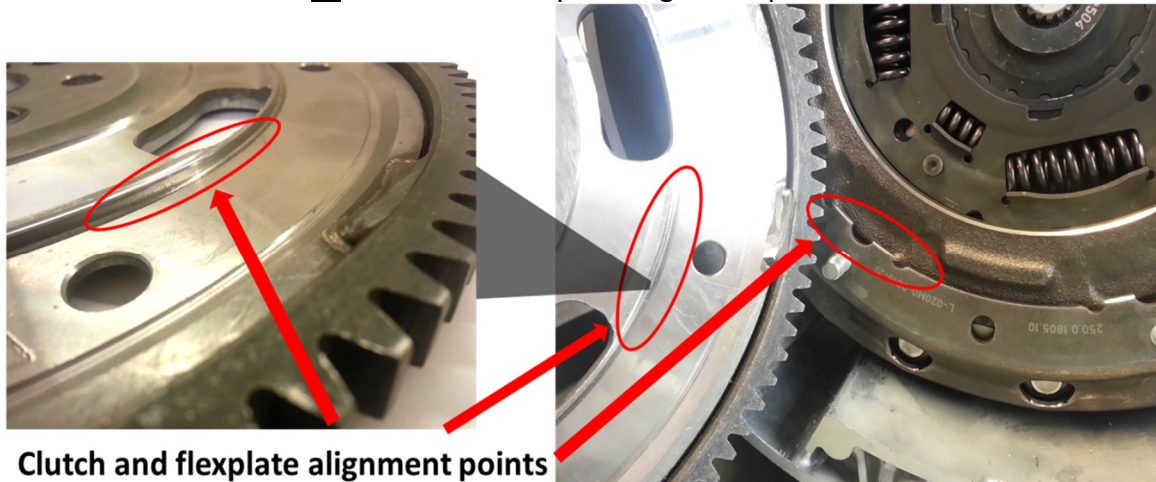
- **Reference:** The following photos highlight the chamfered alignment points on the flexplate and clutch. The flexplate-to-clutch nut tightening sequence found in the Workshop Manual allows the chamfered alignment points to center and fully seat the clutch onto the flexplate.

Ex: Clutch and flexplate alignment points

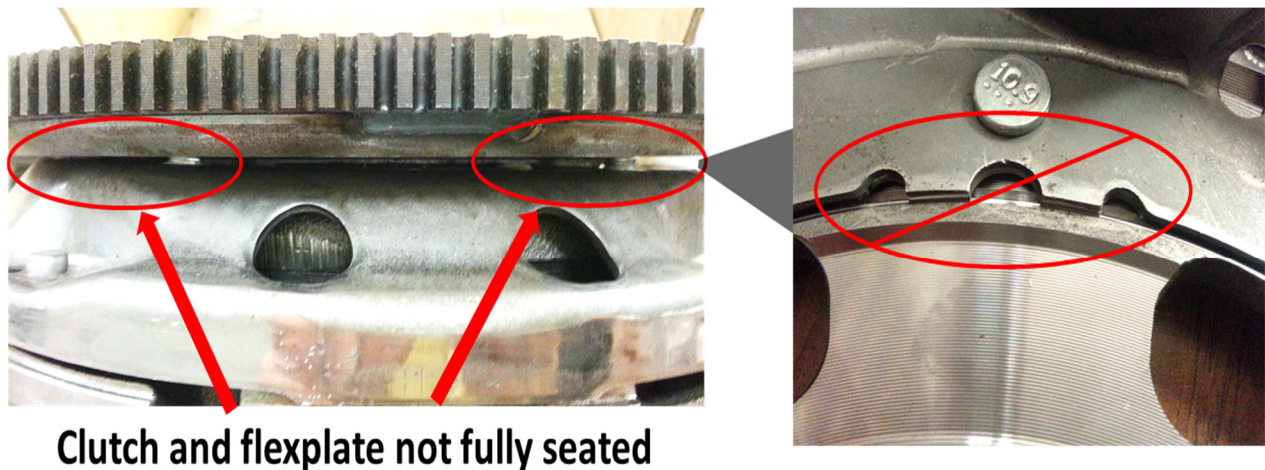
**Concern:** Severe powertrain vibration and/or engine misfire DTCs caused by improperly seated flexplate and clutch.

Ex: Improperly seated clutch\*- Interference of alignment tabs

\*Clutch has been disassembled to educate GSB users about the root cause of post-repair vibrations. During transmission installation, this area of the clutch will not be visible. Pictures used in the examples were taken from the perspective of the clutch facing the engine.

**NOTE:** If excessive powertrain vibration is present after clutch installation, remove the flexplate-to-clutch nuts and ensure the clutch studs *move freely*. Follow the installation and torque procedures again as outlined in the WSM and this GSB. Seating the clutch properly to the flexplate should correct the vibration concern.

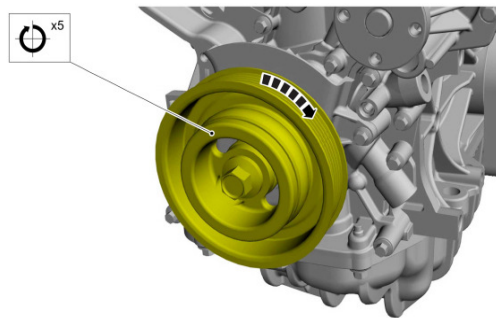
Ex: Proper crankshaft rotation (clockwise)

- **Do:** Rotate Crankshaft **CLOCKWISE** 5 times as listed in the online Workshop Manual and ensure the clutch studs *move freely* prior to flexplate-to-clutch nut installation. Install and tighten the flexplate-to-clutch nuts following the 2 torque stages listed in the online Workshop Manual.

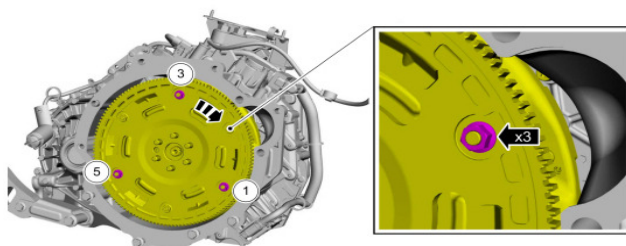
Stage 1 torque sequence

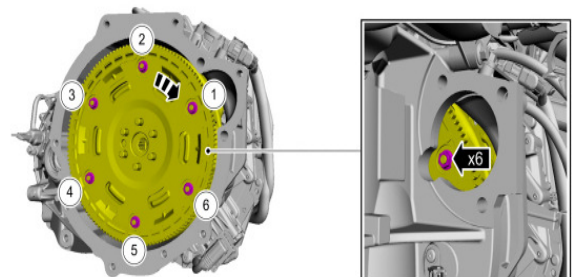
Stage 2 torque sequence

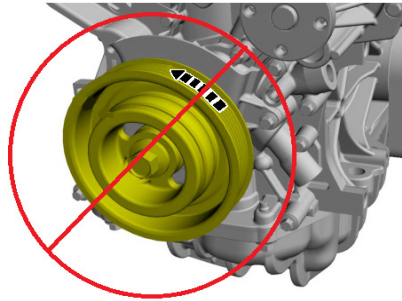
**NOTE:** Failure to follow the Crankshaft rotation step, flexplate-to-clutch nut tightening sequence, or over-tightening the nuts during the first stage of the torque sequence, will cause the clutch and flexplate alignment points to bind and prevent the clutch from fully seating.

Ex: Improper crankshaft rotation (counter clockwise)

- **Don't:** Rotate the engine improperly or tighten the flexplate-to-clutch nuts in any order but the prescribed sequence in the WSM and this GSB.

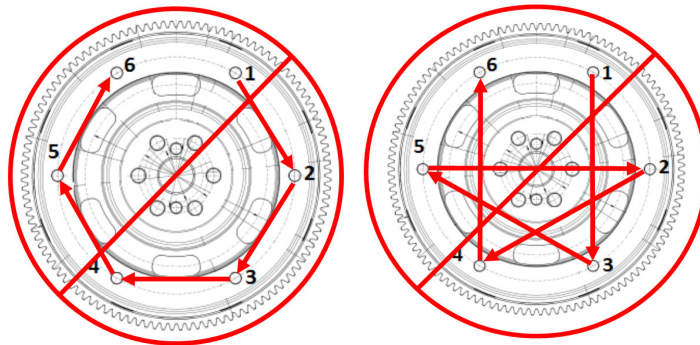
Ex: Improper tightening sequence

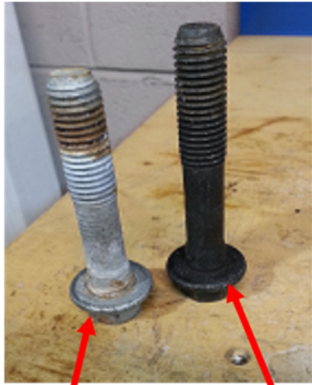
Ex: Proper roll restrictor bolt usage

Subframe to roll restrictor bolt (shorter)

Transmission to roll restrictor bolt (longer)

- **Do:** Use the shorter bolt to attach the roll restrictor to the subframe.
- **Don't:** Use the longer bolt to attach the roll restrictor to the subframe.

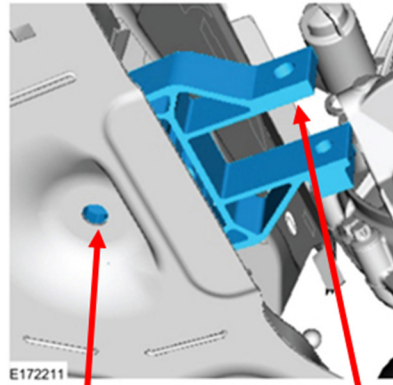
Ex: Correct location of roll restrictor bolts

Subframe to roll restrictor bolt (shorter)

Transmission to roll restrictor bolt (longer)

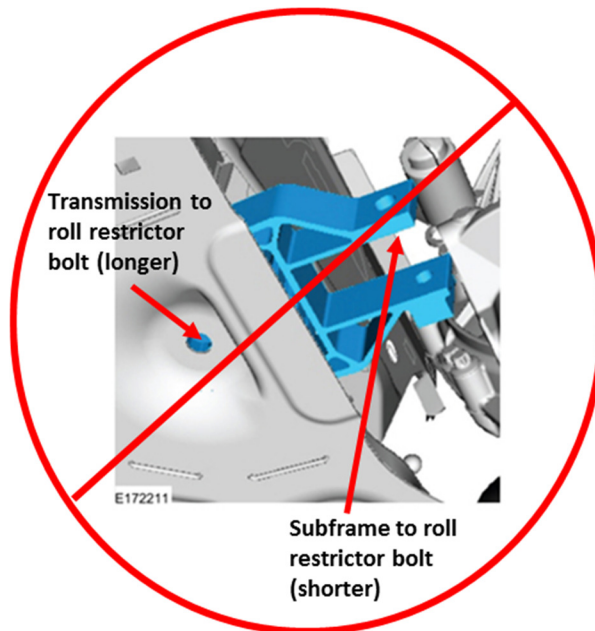
**Concern:** Failure to install the roll restrictor bolts in the proper location may result in a vibration that is most noticeable in Reverse with the engine off idle.

Ex: Incorrect location of roll restrictor bolts

Transmission to roll restrictor bolt (longer)

Subframe to roll restrictor bolt (shorter)
