Tesla, Inc. Service Bulletin		<i>Rework Glove Box</i>
SB-25-14-001 June 12, 2025				
Classification		Section/Group	Mobile Service	
Repair Bulletin		14 - Instrument Panel	Can Perform (where permitted)	All
Model	Model Year	Country/Region	Build Location	
Model Y	2025	United States	Fremont	
The model(s) and model year(s) listed are a general approximation of the affected VIN list. Refer to the VIN/Bulletin Tracker or Customer/Vehicle profile to determine applicability of this bulletin for a particular vehicle.

On certain Model Y vehicles, the glove box might not open because the retention force of the magnets in the glove box door is too strong due to the airgap between the magnets being too small.

Rework the glove box.

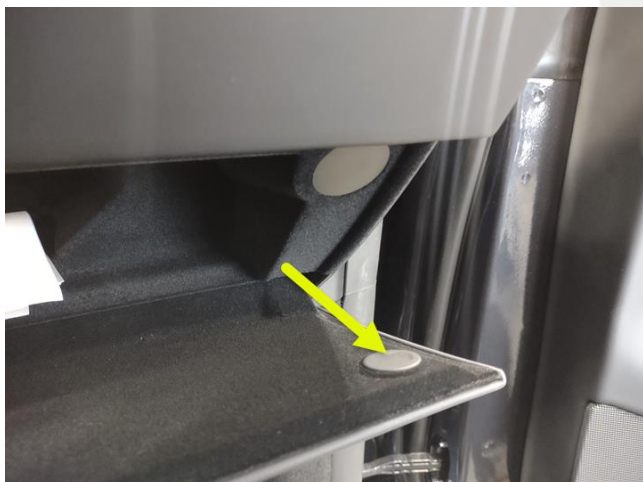
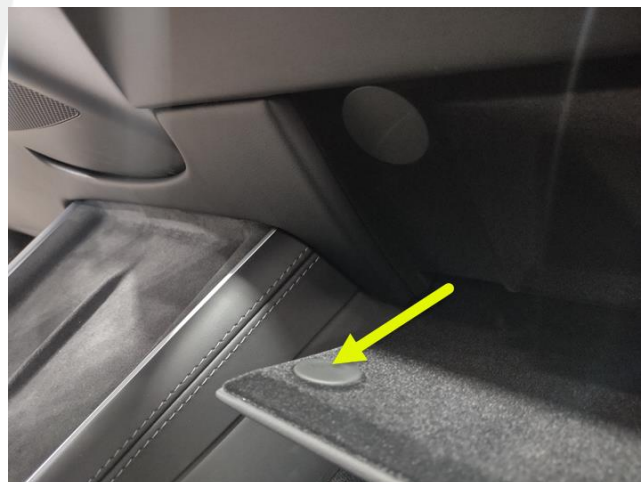
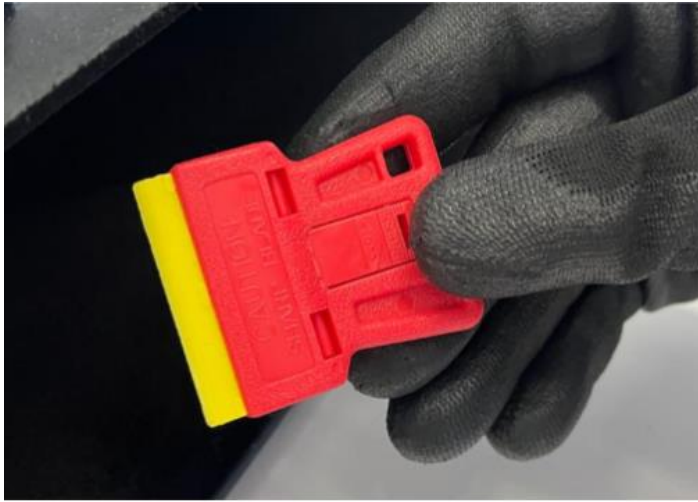
Figure 5 – Use the corner of the plastic razor to make an incision in the foam

3. Use the corner of the plastic razor (PN: 2218504-00-A) to make an incision through the foam layer on the glove box door magnets (x2) (Figures 2–5).

**CAUTION:** Do not install these shims on the glove box door magnets (Figures 2 and 3).

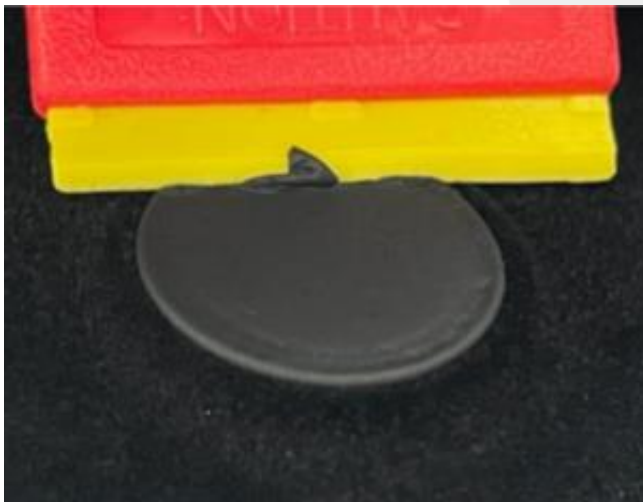
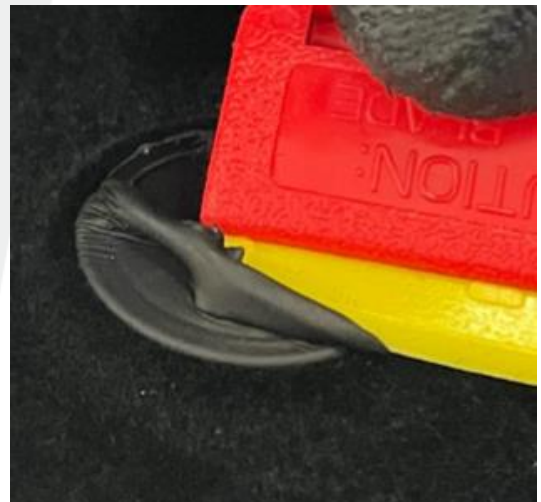
4. Use the long edge of the plastic razor to remove the foam from the glove box door magnets (x2) (Figures 6 and 7), and then remove the remaining foam with fingers (Figure 8).

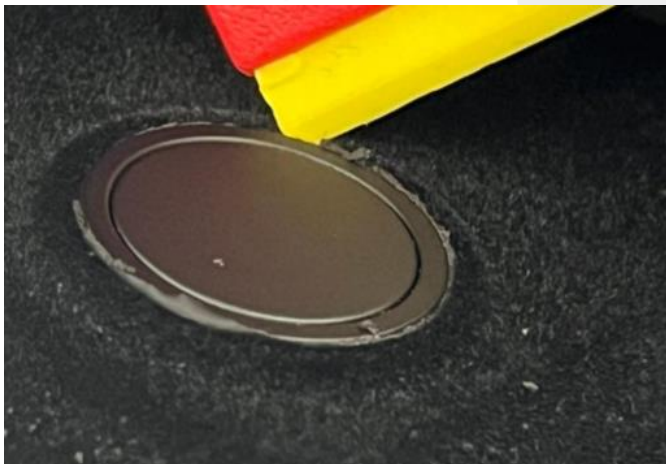
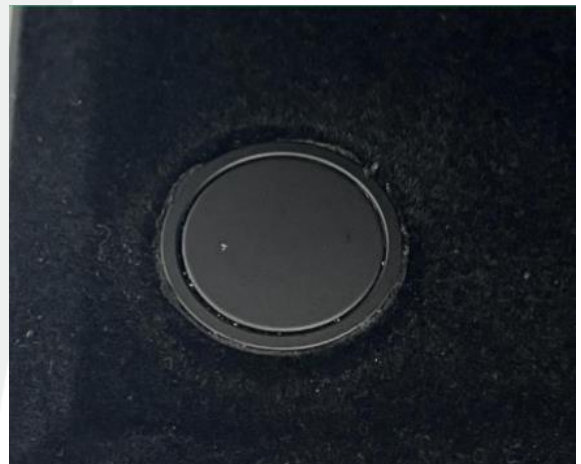
Figure 9 – Any remaining foam must be removed

5. Use the corner of the plastic razor to remove any remaining foam from the glove box door magnets (x2) (Figures 9–11).

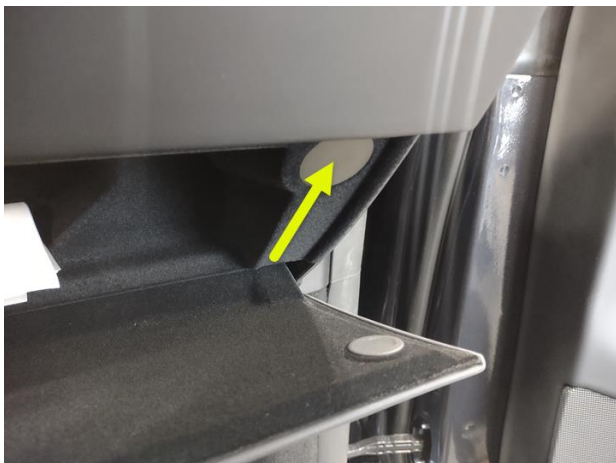
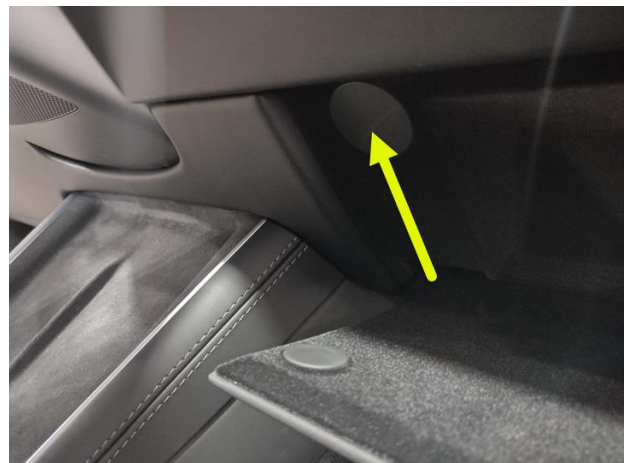
6. Use IPA wipes to clean any remaining foam from the glove box door magnets. Allow the IPA 1 minute to dry.
7. Use IPA wipes to clean the surface of the magnets on the glove box side (Figures 12 and 13). Allow the IPA 1 minute to dry.

8. Remove the shims from the adhesive backing roll, and then install the shims (x2) onto the magnets (x2) on the glove box side (Figures 12 and 13).

**CAUTION:** DO NOT use 24mm shims (PN: 2223223-00-A) in this location for this rework. Using 24mm shims in this location will cause the glove box to fail to open.

**NOTE:** Make sure the shim is correctly aligned. Once aligned, apply firm pressure to the shim to ensure adhesion.
