Tesla, Inc. Service Bulletin		<i>Inspect Front And Rear Chassis Abnormalities (Tire Pressure, Bolted Joint, Wheel Alignment)</i>	
SB-25-31-004 June 24, 2025					
Classification		Section/Group		Mobile Service	Configuration
Repair Bulletin		31 - Suspension		Cannot Perform	All
Model	Model Year	Country/Region		Build Location	
Model 3	2017+	North America, Australia		Giga Shanghai, Fremont	
Model Y	2020+				
The model(s) and model year(s) listed are a general approximation of the affected VIN list. Refer to the VIN/Bulletin Tracker or Customer/Vehicle profile to determine applicability of this bulletin for a particular vehicle.

Condition

A firmware diagnosis feature is being introduced on Model 3 and Model Y vehicles that monitors wheel alignment over time. This feature detects changes in wheel alignment that may be related to incorrect tire pressures, degraded ball joints, bushings or damaged suspension links.

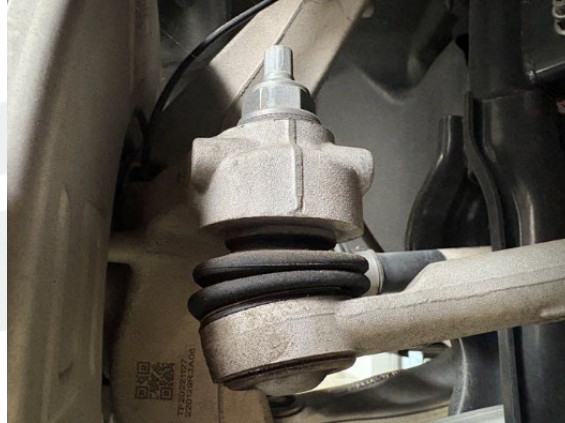
1. Check the vehicle tire pressure and adjust if needed.
2. Remove the rear wheels (refer to Service Manual procedure: [2017-2023 Model 3](#), [2024+ Model 3](#), [2020-2024 Model Y](#), [2025+ Model Y](#)).
3. Inspect the ball joints in the following components for cracks, grease leakage, improperly seated boots, or punctured boots. Use a pry bar to verify that the ball joint does not rotate freely. Note your findings:
 - a. The LH and RH tie rod ends.

Figure 1 – RH tie rod end, LH similar

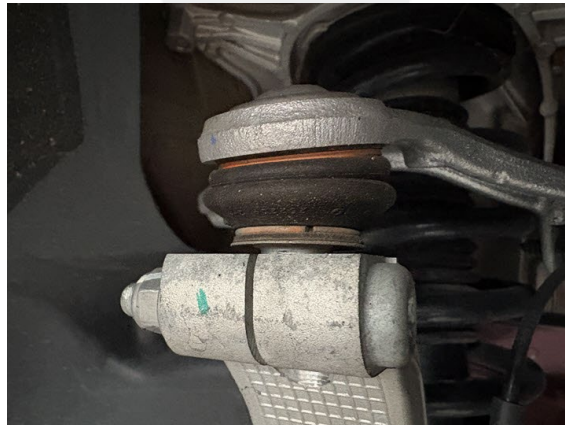
- b. The LH and RH front upper control arms.

Figure 2 – RH upper control arm, LH similar

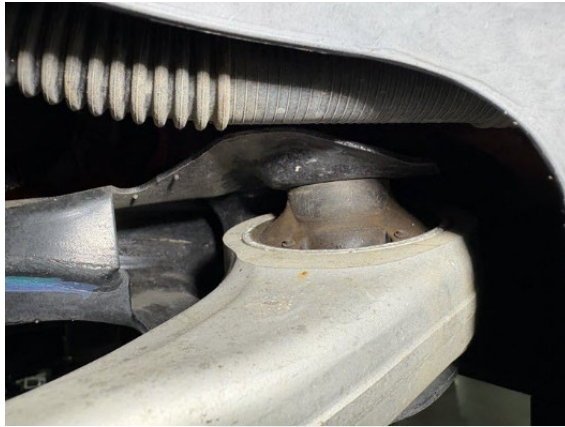
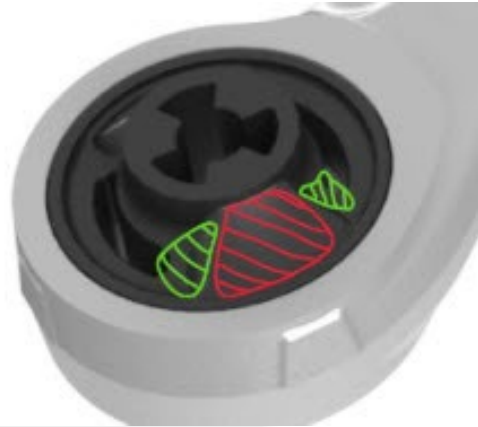
NOTE: If cracking is observed in the red area outlined in the images below, replace the component.

- a. The LH and RH front compliance links.

Figure 3 – LH front compliance link, RH Similar Figure 4 – Cracking in compliance link

4. Remove the front aero shield panel (refer to Service Manual procedure: [2017-2023 Model 3](#), [2024+ Model 3](#), [2020-2024 Model Y](#), [2025+ Model Y](#)).
5. Inspect the inner bushings in the following components for unusual cracks. Use a pry bar to verify that there is no excessive movement. Note your findings:

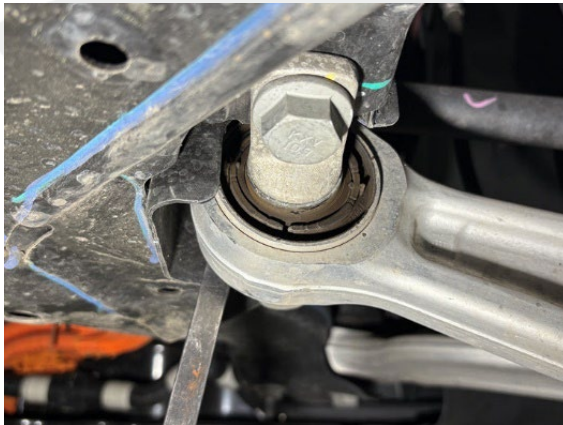
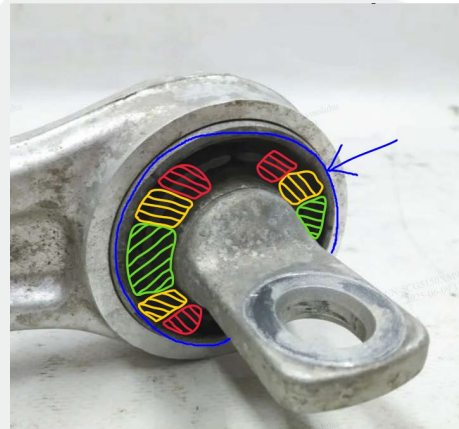
- b. The LH and RH front lower lateral links.

Figure 5 – RH front lower lateral link, LH similar Figure 6 – Cracking in lateral link

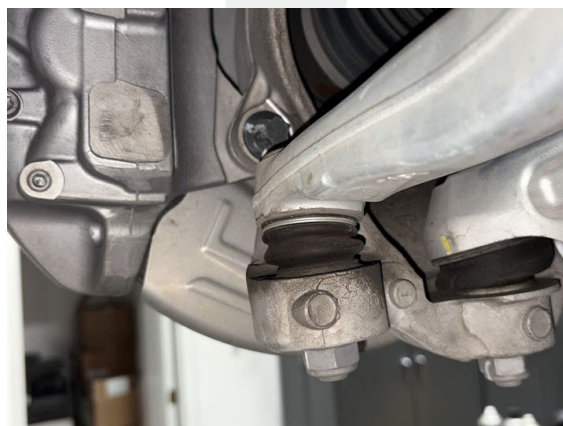
6. Inspect the ball joints in the following components for cracks, grease leakage, improperly seated boots, or punctured boots. Use a pry bar to verify that the ball joint does not rotate freely. Note your findings:
- a. The LH and RH front compliance link to knuckle ball joints.

Figure 7 – LH front compliance link to knuckle ball joint, RH similar

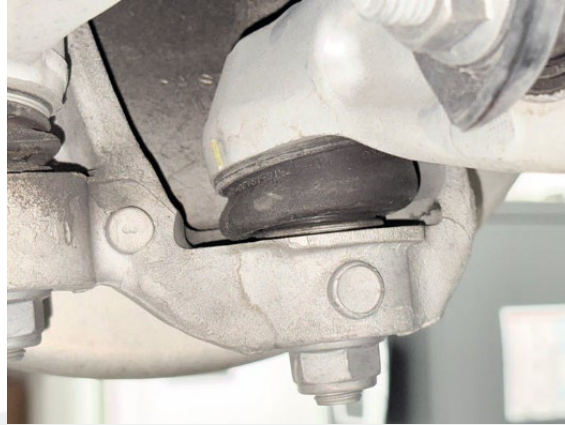
- b. The LH and RH front lower lateral link to knuckle ball joints.

Figure 8 – LH front lower lateral link to knuckle ball joint, RH similar

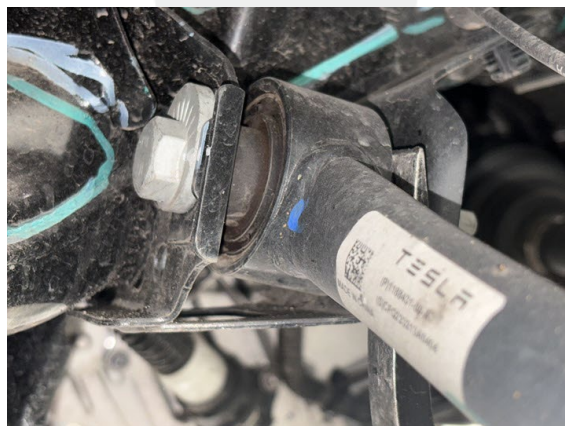
- 7. Remove the mid aero shield panel (refer to Service Manual procedure: [2017-2023 Model 3](#), [2024+ Model 3](#), [2020-2024 Model Y](#), [2025+ Model Y](#)).
- 8. Remove the LH and RH rear suspension covers (refer to Service Manual procedure: [2017-2023 Model 3](#), [2024+ Model 3](#), [2020-2024 Model Y](#), [2025+ Model Y](#)).
- 9. Inspect the bushings in the LH rear toe link for unusual cracks. Use a pry bar to verify that there is no excessive movement. Note your findings:
 - a. The inner bushing of the LH rear toe link to the subframe.

Figure 9 – Inner bushing of the LH rear toe link

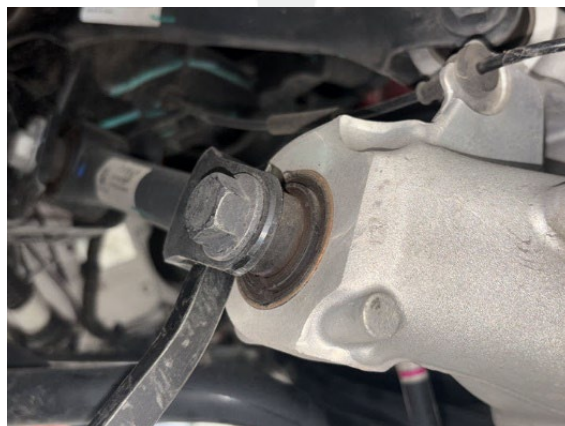
- b. The outer bushing of the LH rear toe link to the knuckle.

Figure 10 – Outer bushing of the LH rear toe link

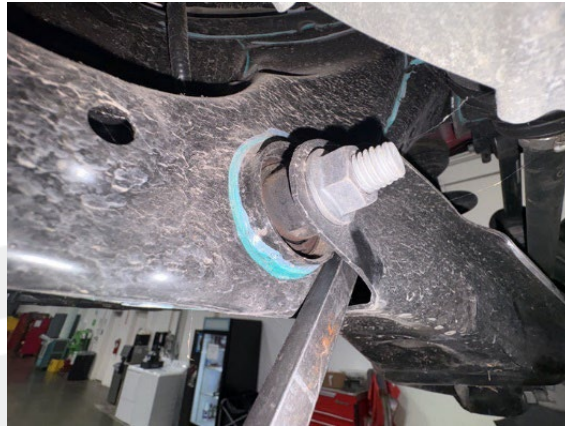
- a. The inner bushing of the LH rear lower aft link to the subframe.

Figure 11 – Inner bushing of the LH rear lower aft link

10. Inspect the bushings in the LH rear lower aft link for unusual cracks. Use a pry bar to verify that there is no excessive movement. Note your findings:

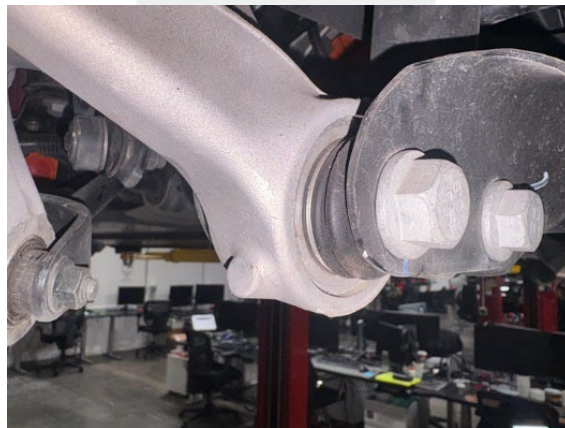
- b. The outer bushing of the LH rear lower aft link to the knuckle.

Figure 12 – Outer bushing of the LH rear lower aft link

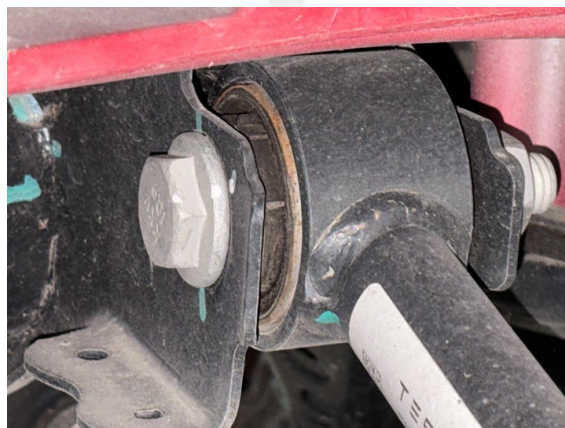
- a. The inner bushing of the LH rear upper aft link to the subframe.

Figure 13 – Inner bushing of the LH rear upper aft link

11. Inspect the bushings in the LH rear upper aft link for unusual cracks. Use a pry bar to verify that there is no excessive movement. Note your findings:

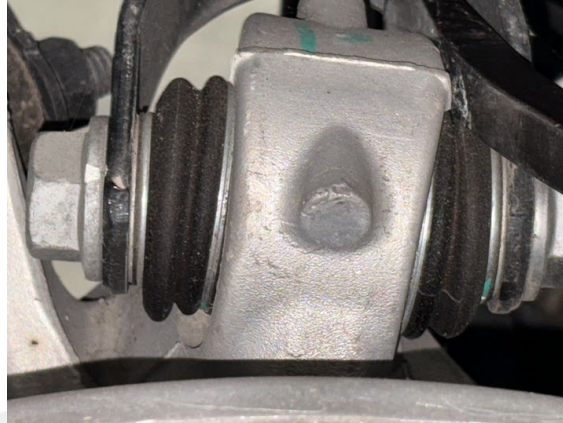
- b. The outer bushing of the LH rear upper aft link to the knuckle

Figure 14 – Outer bushing of the LH rear upper aft link

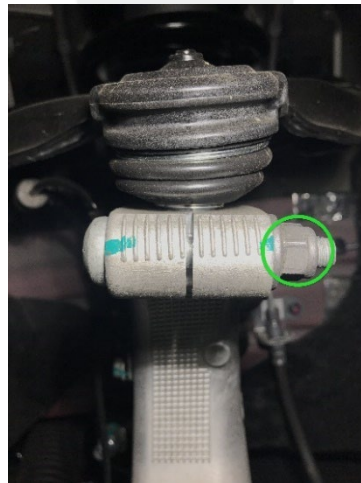
- The nut that attaches the LH front upper control arm to the front knuckle. Refer to the Service Manual Procedure: [2017–2023 Model 3](#), [2024+ Model 3](#), [2020–2024 Model Y](#), [2025+ Model Y](#).

Figure 15 – Nut that attaches the LH upper control arm to the knuckle

- If the fasteners rotate less than 180 degrees, torque the fasteners to standard value listed in the service manual.
- If the fasteners rotate more than 180 degrees, remove the fasteners and check their associated components for damages. Install new fasteners and replace any damaged components as needed.

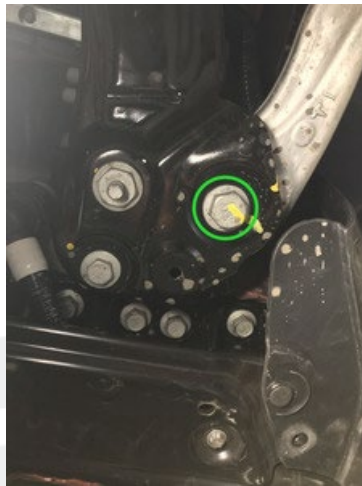
- The bolt that attaches the LH front lower compliance link to the front subframe. Refer to the Service Manual Procedure: [2017–2023 Model 3](#), [2024+ Model 3](#), [2020–2024 Model Y](#), [2025+ Model Y](#).

Figure 16 – Bolt that attaches the LH front lower compliance link to the subframe

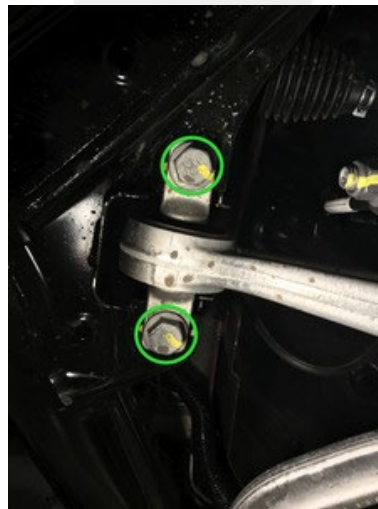
- The bolts (x2) that attach the LH front lower lateral link to the front subframe. Refer to the Service Manual Procedure: [2017–2023 Model 3](#), [2024+ Model 3](#), [2020–2024 Model Y](#), [2025+ Model Y](#).

Figure 17 – Bolts that attach the LH front lower lateral link to the front subframe

NOTE: If the bolt rotation is less than 180 degrees, retighten the bolts to 135 Nm; otherwise replace the bolts and tighten them to the standard torque value listed in the service manual.

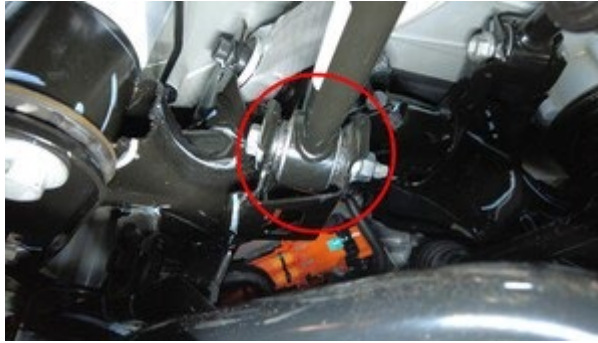
- The nut that attaches the LH rear toe link to the rear subframe. Refer to the Service Manual Procedure: [2017–2023 Model 3](#), [2024+ Model 3](#), [2020–2024 Model Y](#), [2025+ Model Y](#).

Figure 18 – Nut that attaches the LH rear toe link to the rear subframe

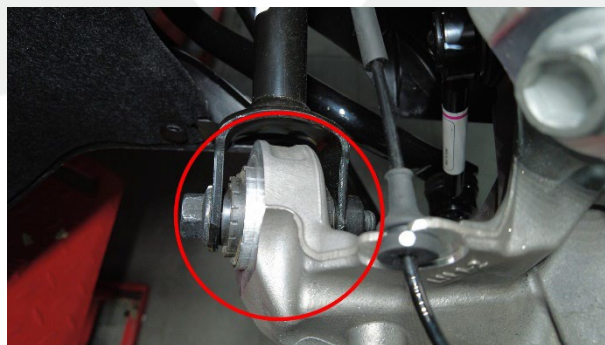
- The bolt that attaches the LH rear toe link to the rear knuckle. Refer to the Service Manual Procedure: [2017–2023 Model 3](#), [2024+ Model 3](#), [2020–2024 Model Y](#), [2025+ Model Y](#).

Figure 19 – Bolt that attaches the LH rear toe link to the rear knuckle

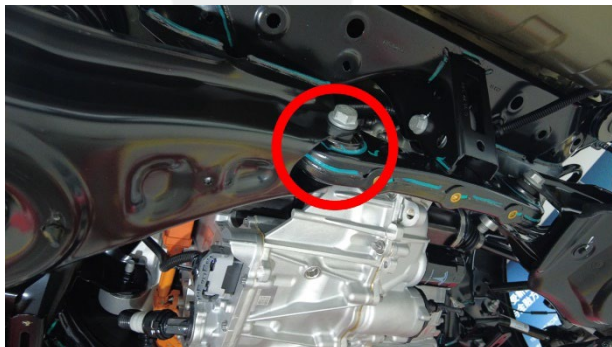
- The bolt that attaches the LH rear lower aft link to the rear subframe. Refer to the Service Manual Procedure: [2017–2023 Model 3](#), [2024+ Model 3](#), [2020–2024 Model Y](#), [2025+ Model Y](#).

Figure 20 – Bolt that attaches the LH rear lower aft link to the rear subframe

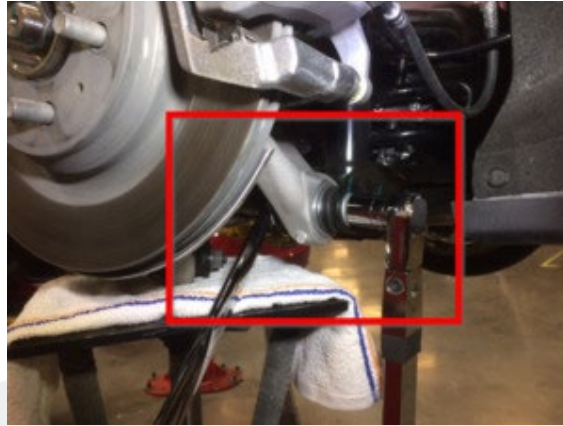
- The bolt that attaches the LH rear lower aft link to the rear knuckle. Refer to the Service Manual Procedure: [2017–2023 Model 3](#), [2024+ Model 3](#), [2020–2024 Model Y](#), [2025+ Model Y](#).

Figure 21 – Bolt that attaches the LH rear lower aft link to the rear subframe

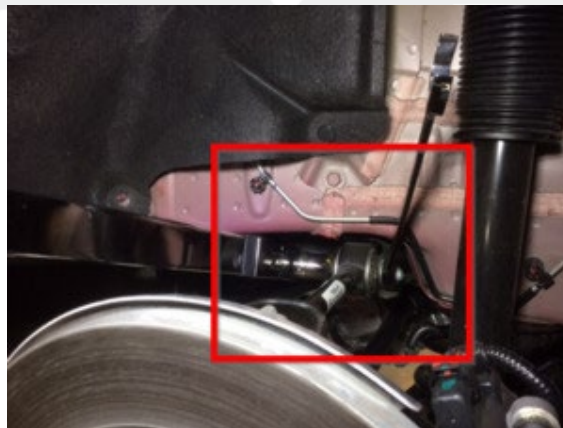
- The bolt that attaches the LH rear upper aft link to the rear subframe. Refer to the Service Manual Procedure: [2017–2023 Model 3](#), [2024+ Model 3](#), [2020–2024 Model Y](#), [2025+ Model Y](#).

Figure 22 – Bolt that attaches the LH rear upper aft link to the rear subframe

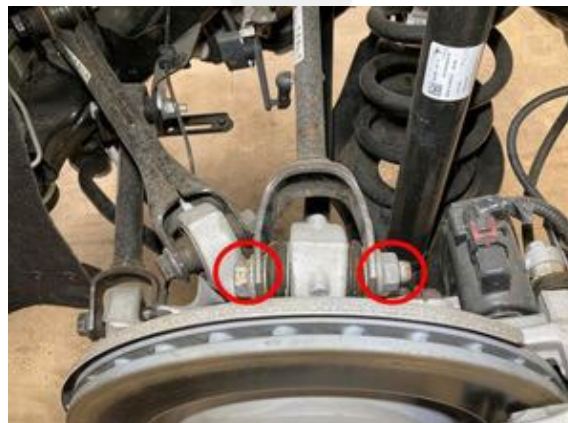
- The bolt that attaches the LH rear upper aft link to the rear knuckle. Refer to the Service Manual Procedure: [2017–2023 Model 3](#), [2024+ Model 3](#), [2020–2024 Model Y](#), [2025+ Model Y](#).

Figure 23 – Bolt that attaches the LH rear upper aft link to the rear knuckle
