# Service Bulletin

Bulletin No.: PIT6412

**Subject:** Tap Tick Rattle Flutter Noise From Dealer Installed Assist Steps

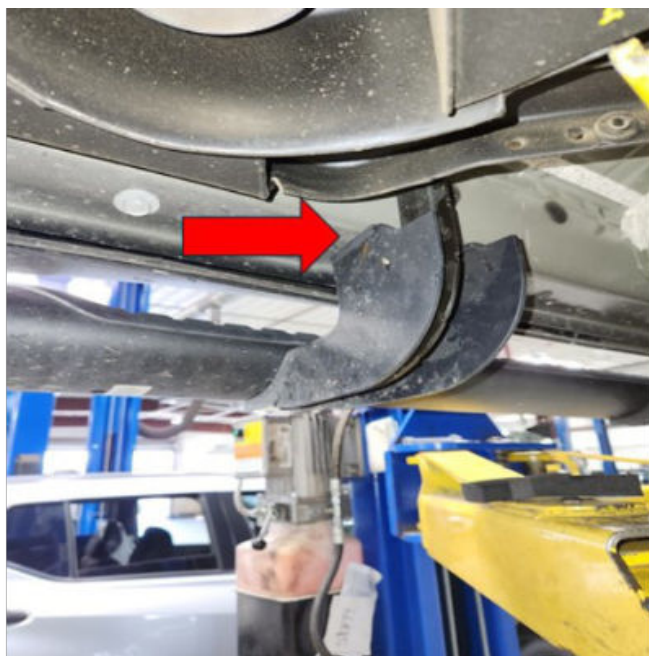
6976939

Involved Region or Country	North America
Additional Options (RPO)	BVZ
Condition	Some customer may notice a light tap/rattle/tick/flutter noise heard on the right and/or left side door areas at highway speeds.
Cause	The plastic cover that protects the assist step mounting bracket could be contacting the bottom of the truck body below the rocker panel causing the noise

Place a split 5/16 rubber hose on the top of the 6 plastic step covers on each step mount. This will prevent the plastic cover from contacting the body and creating the noise.
