Subject	Slide Roller Relocate and Glide Bar Repair.					Number	25-002
						Date	7/21/2025
						Model	Lineage 25FW
						Build Date	05/06/24-07/25/25
Circulate To:	Service Manager	X	Parts Manager	X	Technician	X	
	Warranty Admin	X	Sales Manager	X	Part Number(s)		570316, 570844, 641484, 961144, 960062, 961817, 961819
Concern:	Slide-Out may not fully retract at the bottom, causing water intrusion.						
Remedy:	Relocate rollers (if needed), install nylon rub bar on bed base						
Flat Rate:	Slide roller re-location (if needed)- 6 Hrs.- Flat Rate Code- M920012 Glide Bar Repair- 1 Hr. – Flat Rate Code- M920013

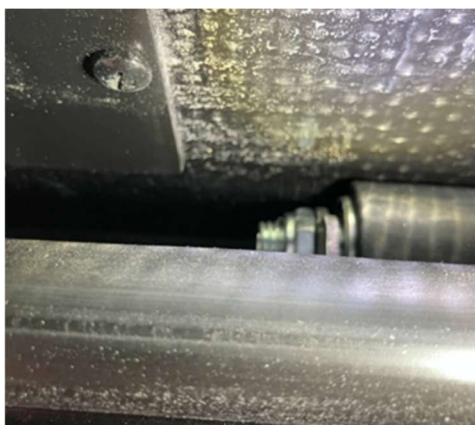
Figure 1.2

- 1) Extend the slide until it is 12-18” from the closed position
- 2) Inspect under the slide to see if slide rollers are in line with the seatbelt brackets, which could keep the slide from closing properly (**Figure 1.2**).
- 3) **If the rollers are correct, proceed to Section 3.**
- 4) The 2 rollers that could make contact are the front roller and the 2nd from the rear before the step up.
- 5) If the rollers contact the seatbelt brackets, proceed to **section 2**.

- 1) With tape or a paint pen, mark the bottom wipe seal where the rollers will move to avoid the seat belt brackets.
- 2) Retract the slide.
- 3) Auto-Level the unit.
- 4) Extend the slide until it is 12-18” from the closed position.
- 5) Remove the slide topper (part # 810712)
 - a. Insert a retaining pin in each end of the topper (**Figure 2.5a**).
 - b. Remove the large silver screw on both ends (**Figure 2.5b**).
 - c. Pull the topper out of its bracket and place it on the roof of the slide box (**Figure 2.5c**).
