Parktronic Sensor Holders Missing from Rear Bumper Cover, Lower Section, With SA Code 773

| Topic number | LI88.20-P-080034 |
| Validity | Model series 192 with SA code 773 |

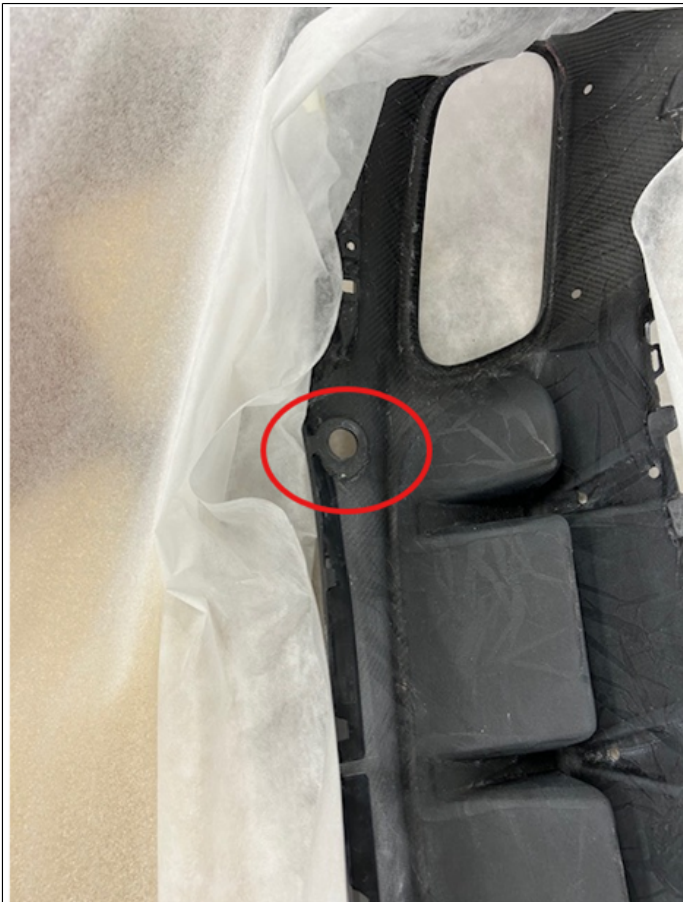
Replacement rear lower carbon bumper cover is delivered without Parktronic (PTS) sensor holders.

This is observed during part replacement when the bumper is received without holders included.

| Attachments | |
|---|---|
| PTS-Halter fehlen.png | Complaint: PTS holders are missing from the purchase order and delivery |

When replacing the rear lower carbon bumper cover, the PTS sensor holders must be ordered separately.

- A1928883700 PTS holder, left
- A1928883800 PTS holder, right

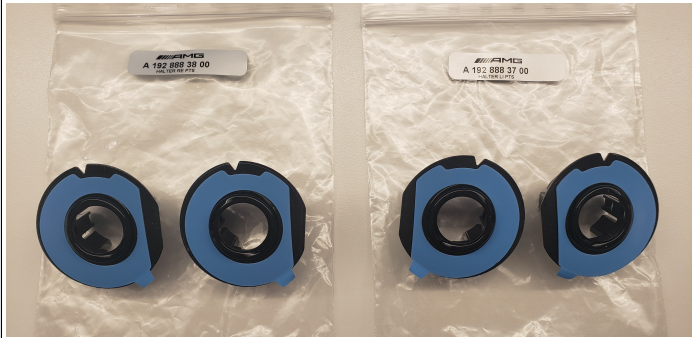
| Attachments | |
|---|---|
| <a href="#">PTS holders.png</a> | Must be ordered separately, each number contains 1 each |

PTS holders are supplied with adhesive tape and positional markings.

Ensure the bonding surface of the bumper trim is clean and dry.

Position the PTS holder correctly and apply firm, even pressure to ensure proper adhesion and secure bonding.
