| | BOD | 2026MY<br>EV9 (MV1a) |
| | 354 | May 2026 |
| SUBJECT: SERVICE ACTION: FRONT SEAT SLIDE MOTOR NOISE (SA647) | | |

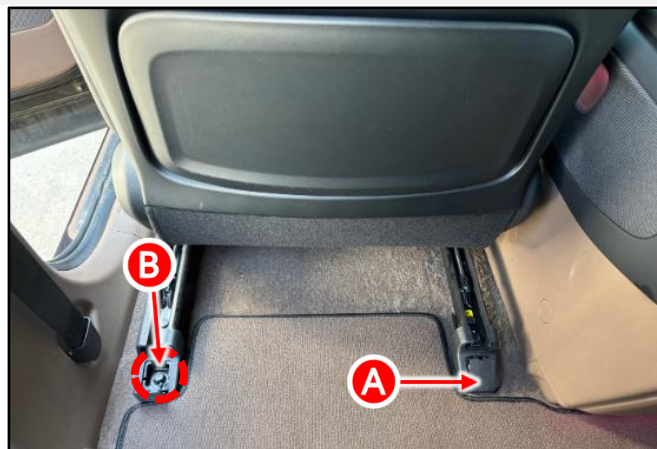
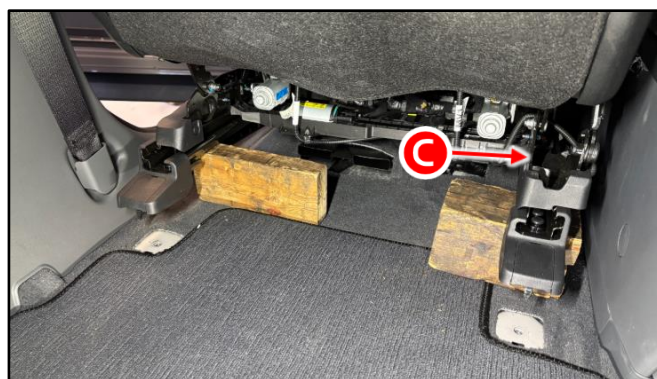
1. Open the rear seat bolt caps (A) of the driver seat.
2. Loosen the two (2) rear seat bolts (B).

3. Place a piece of wood under each seat rail (C) to lift the rear end of the driver seat.

**Tightening torque for bolts (B):**  
32.5 - 43.4 lb.ft (44.1 - 58.8 N.m)

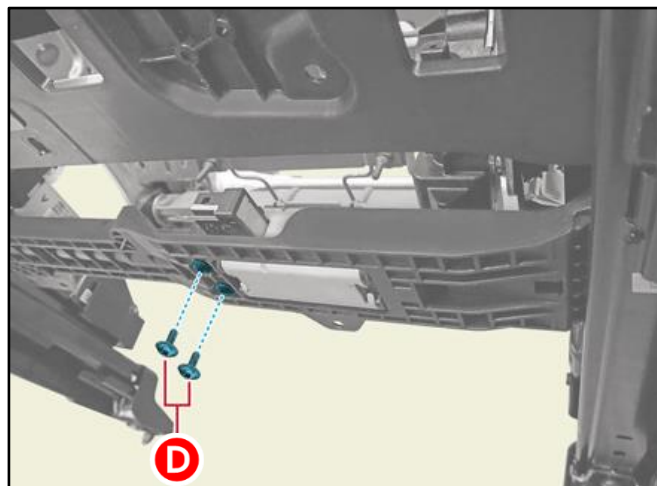
4. Loosen the two (2) screws (D) to remove the sliding motor.

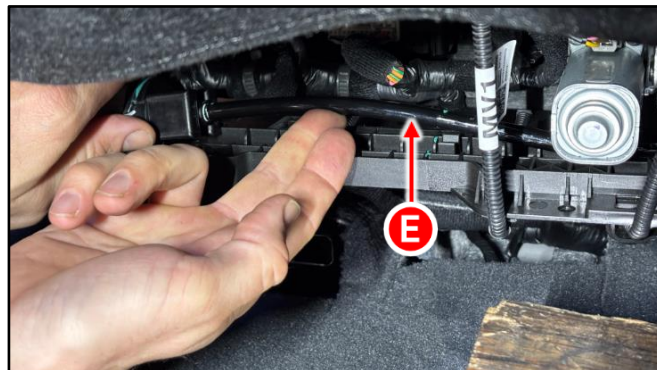
- 5a. Lift the sliding motor cable (E).

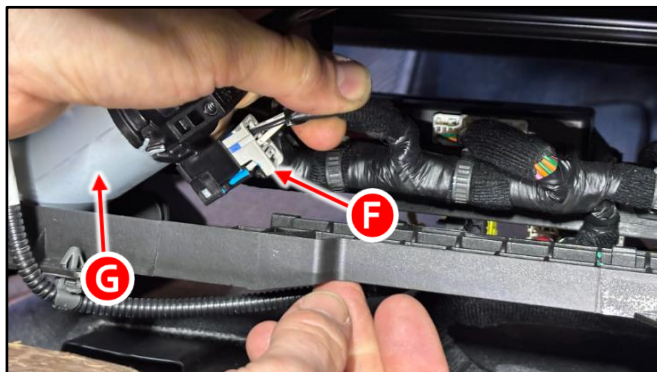
5b. Disconnect the sliding motor connector (F).

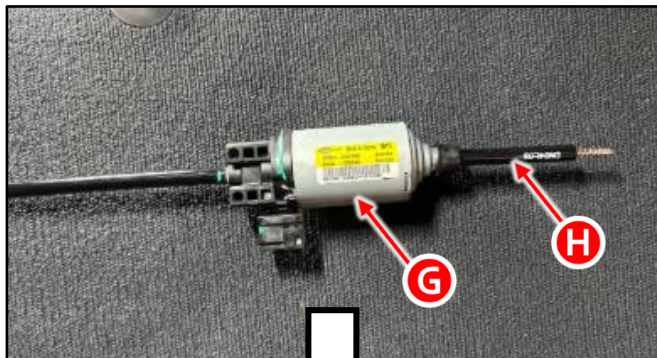
5c. Remove the sliding motor (G).

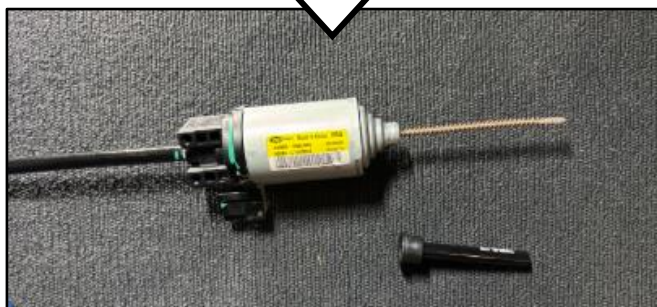
6a. Remove the sliding motor tube (H) off the sliding motor (G) and discard.

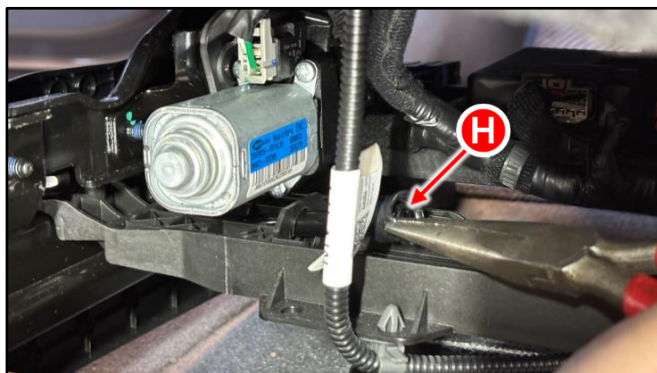
6b. If the sliding motor tube (H) does not come out with the sliding motor, use needle-nose pliers to remove the sliding motor tube (H).
