Knocking noise from the rear axle steering when driving on rough terrain due to functional play

| Topic number | LI46.80-P-080662 |
| Function group | 46.80 - Auxiliary rear axle steering, auxiliary steering axle (ZL), electro-hydraulic auxiliary steering (EHZ) |
| Validity | Model 206, 214, 254 with option code 201 (rear axle steering) |

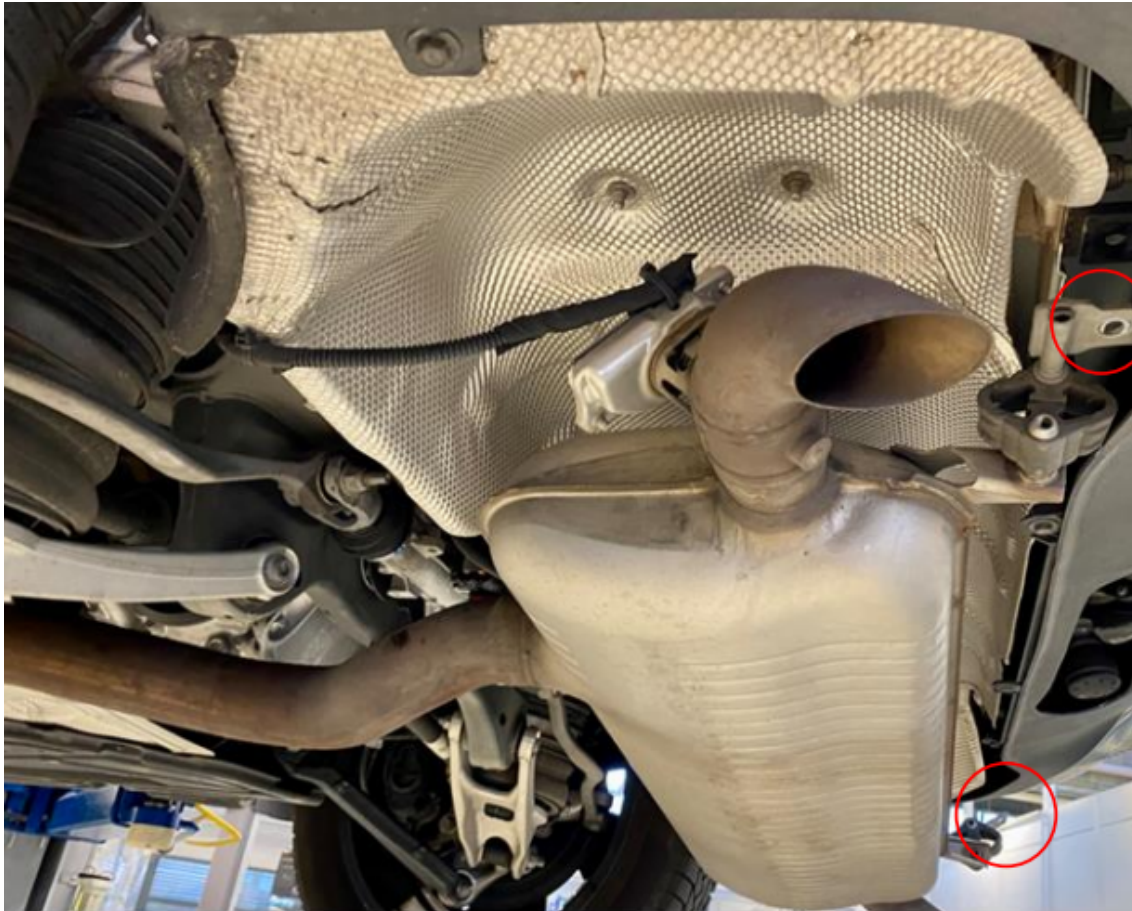
- 1. Detach underfloor paneling under rear axle steering.
- 2. Unscrew both holders of the rear muffler on the exhaust system and lower the rear muffler

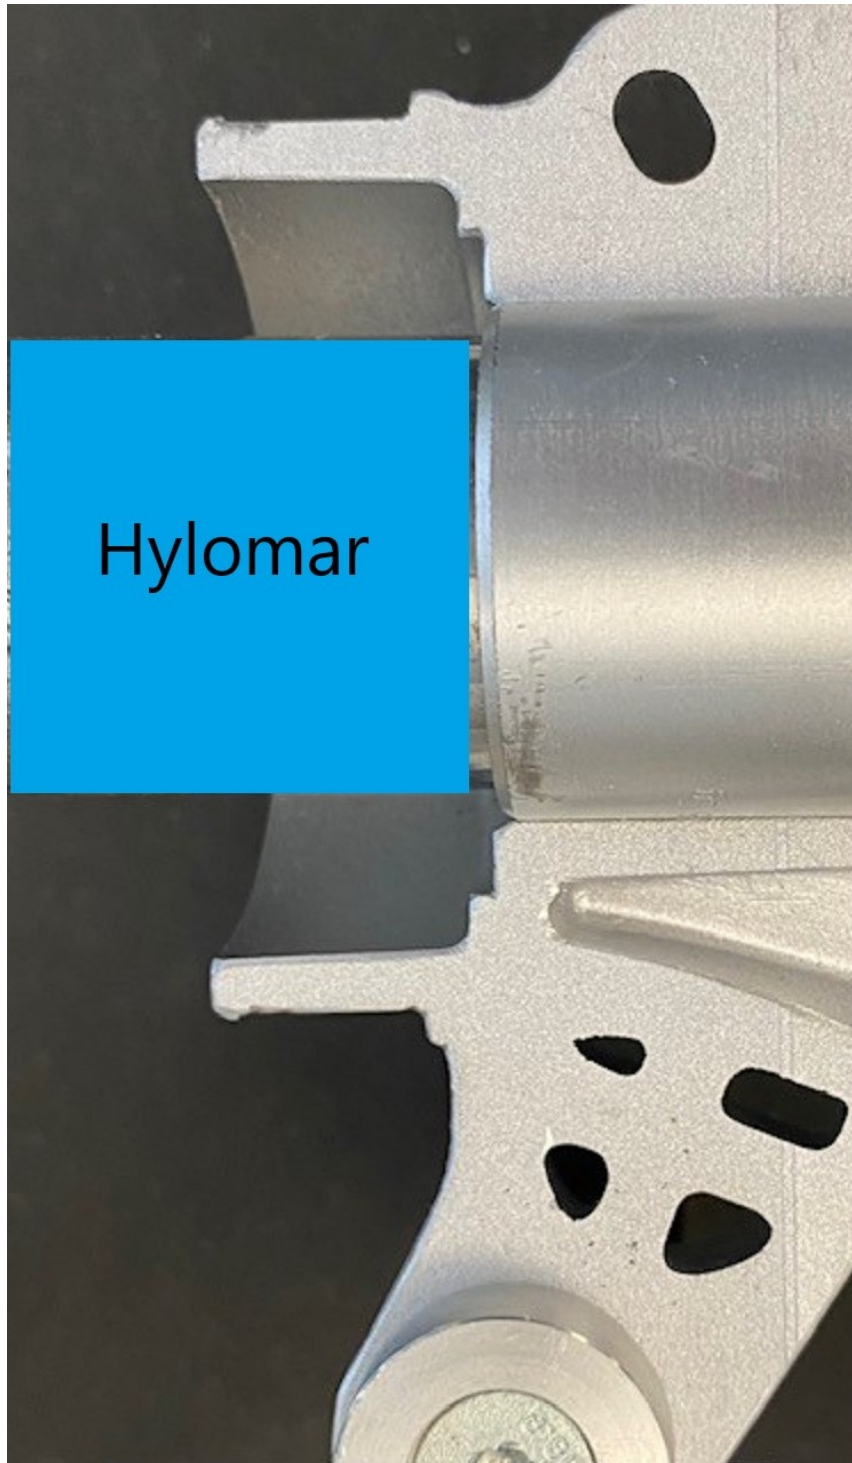
8. Then apply Hylomar (A 001 989 25 20 09) all around to the degreased screw-on stud using a new brush.

=> Up to the area where the stud enters the bearing!

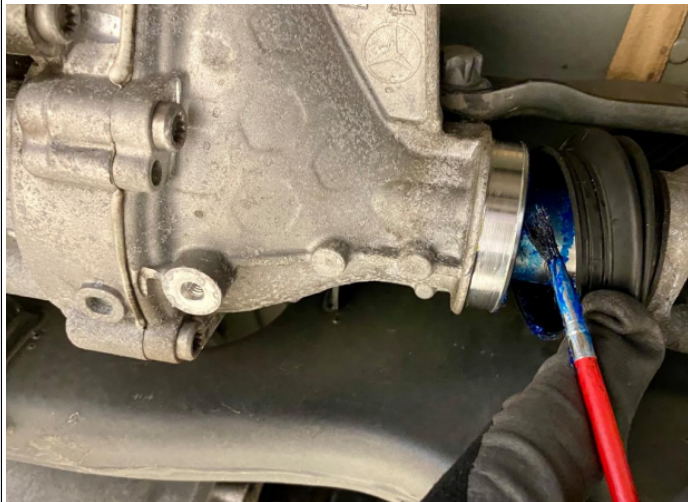
[Hylomar.png](#)

Apply Hylomar

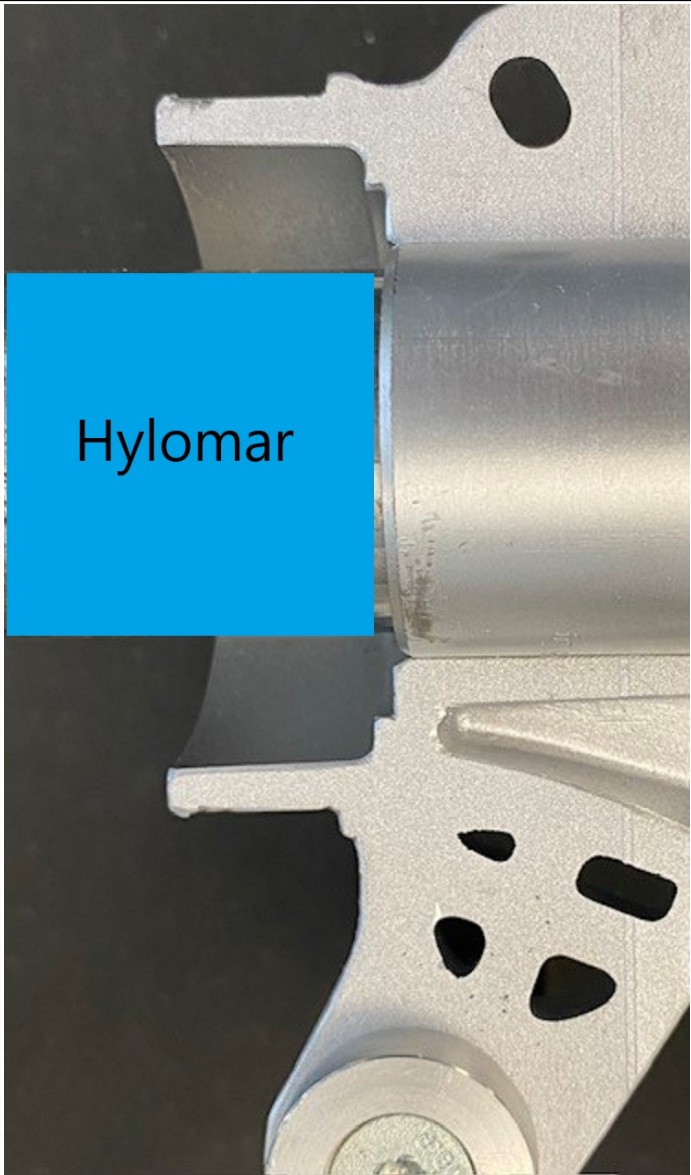
[HAL+Schnittbild+Auftragfläche.jpg](#)

Application surface for Hylomar on screw-on pin
