**Service Campaign Notification**  
May 15, 2026

| Campaign # | Description | Retrofit Spacer on Low-Temperature Coolant Line |

| SUBJECT | Retrofit Spacer to Low-Temp Coolant Line |
| MODEL(S) | G-Class (465 platform) |

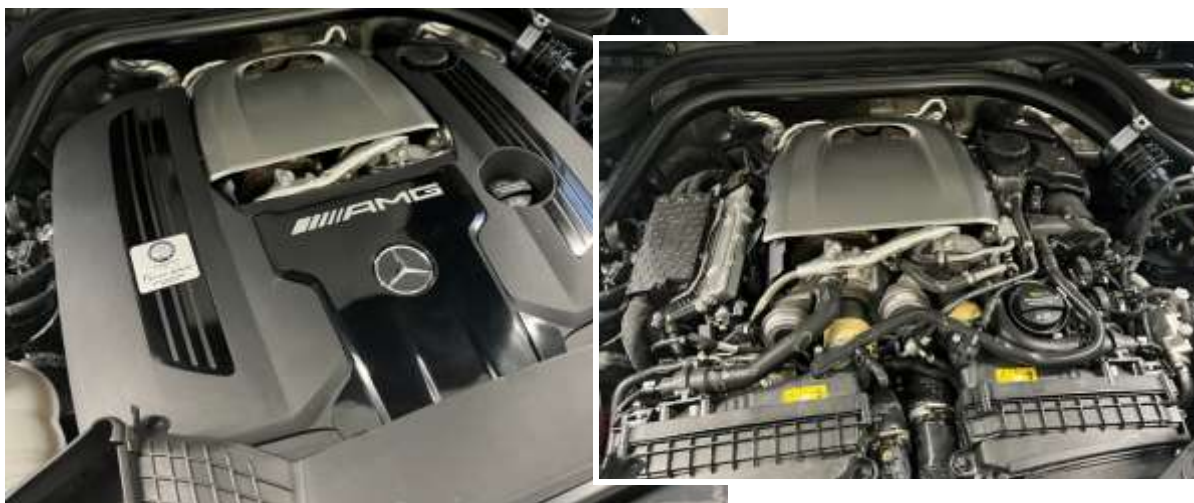
**Figure 1**

1. Remove engine cover.

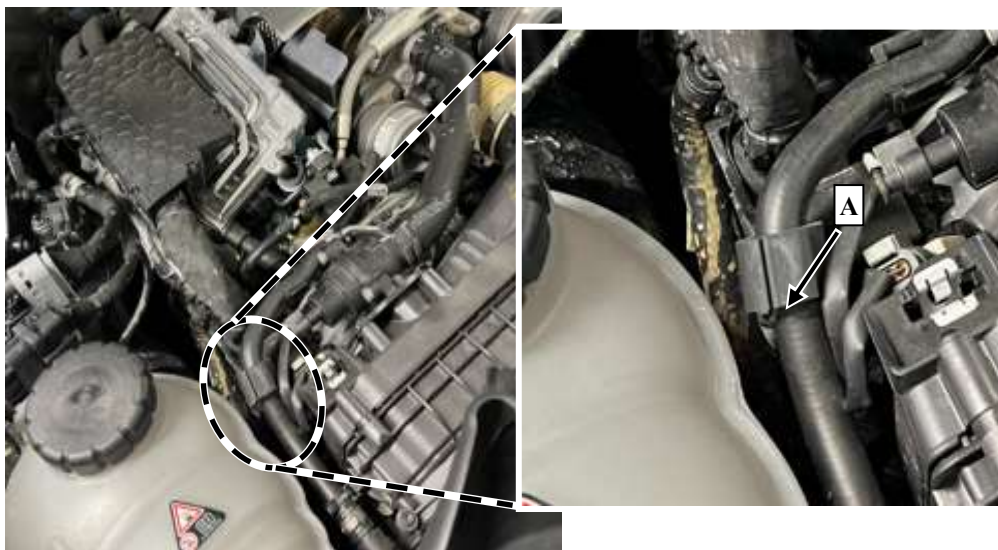
**Figure 2**

2. Install the spacer ring at position (A, Fig. 2) with the opening facing upward toward the coolant reservoir and clip it into place.

| Issue | Mercedes-Benz AG (“MBAG”), the manufacturer of Mercedes-Benz vehicles, has determined that on certain Model Year (“MY”) 2026 G-Class (465 platform) vehicles, the low temperature coolant bleed line may chafe under certain circumstances. | | |

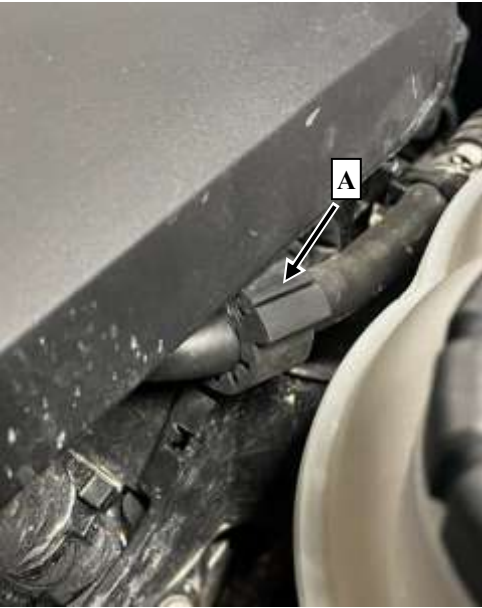
Figure 3

3. Reinstall engine cover.
