## Technical Service Bulletin

GROUP <b>SUSPENSION</b>	NUMBER <b>26-SS-001H</b>
DATE <b>MAY 2026</b>	MODEL(S) <b>PALISADE (LX2)</b>

**SUBJECT:** SELF-LEVELING REAR SHOCK ABSORBER CLUNKING/THUMPING NOISE ON ROUGH ROADS (WARRANTY EXTENSION Z12)

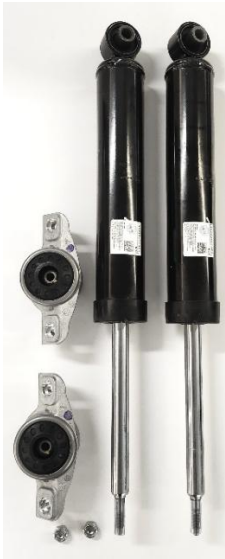
Model	Model Year	Kit Name	Kit Number	Kit Figure	Part Name	Qty	
Palisade (LX2)	2020-2022	<b>First Repair:</b> Shock Absorber w/Insulator Kit	55365-S9300QQH

Self Levelizer Rear Shock-Absorber	2 each	
					Insulator		
	Self-Locking Nut						
	Self Levelizer Rear Shock-Absorber						
	Insulator						
	Self-Locking Nut						
	2023-2024 (FWD)		55365-S8BB1QQH		Self Levelizer Rear Shock-Absorber		
					Insulator		
	Self-Locking Nut						
	Self Levelizer Rear Shock-Absorber						
	Insulator						
	Self-Locking Nut						
2023-2024 (AWD)		55365-S8BD1QQH		Self Levelizer Rear Shock-Absorber			
				Insulator			
Self-Locking Nut							
Self Levelizer Rear Shock-Absorber							
Insulator							
Self-Locking Nut							
2020-2022	<b>Subsequent Repair:</b> Shock Absorber Kit	55364-S9300QQH

**NOTE 1:** Order the correct kit based on if this is the vehicle's first or subsequent repair under this warranty extension.

**NOTE 2:** Lock nut **MUST** be replaced with shock absorber replacement.

**NOTE 3:** Reuse the insulator on subsequent repairs.

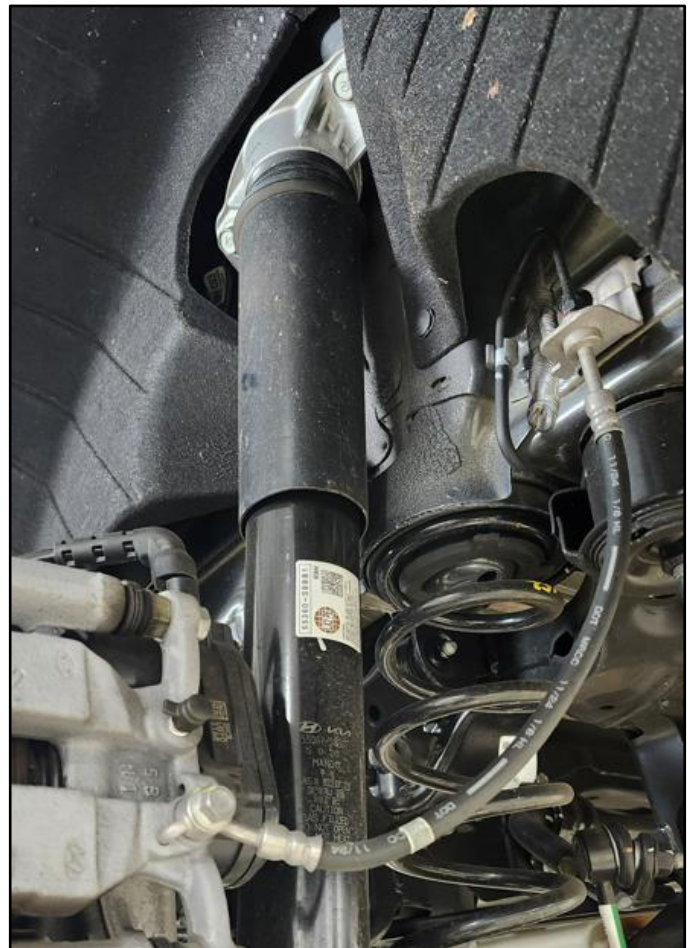
**Shock Absorber Replacement**

1. **First Repair for the vehicle:**  
Install the new rear shock absorbers and insulators on **BOTH** sides of the vehicle.

**Subsequent Repairs for the vehicle:**  
Install the new rear shock absorbers on **ONLY** the affected side(s) exhibiting the noise.  
**Reuse the insulator.**

Be sure to replace the lock nut (B) with a new part. Do **NOT** reuse it.

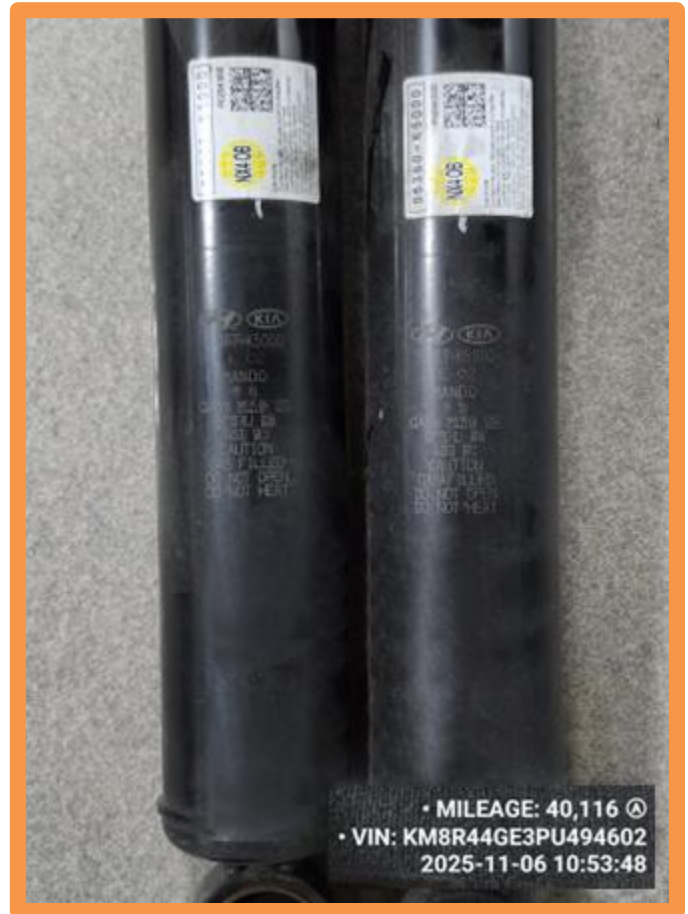
Using the STUI camera function, take a photo of the production stamp on the **original** shock absorbers (side by side if both were replaced).

**NOTE:** If the STUI camera function is **NOT** used, write the last 6 digits of the VIN and date of repair on a piece of paper to include in the photo.
