| <br><b>Technical Service Bulletin</b> | <b>GROUP</b> | <b>NUMBER</b> |
| | <b>CAMPAIGN</b> | <b>26-01-049G</b> |
| | <b>JUNE 2026</b> | <b>G80 (RG3)<br/>G90 (RS4)</b> |
| <b>SUBJECT:</b> THERMOSTATIC EXPANSION VALVE O-RING REPLACEMENT FOR POOR A/C PERFORMANCE (LIMITED COVERAGE CAMPAIGN L09G) | | |

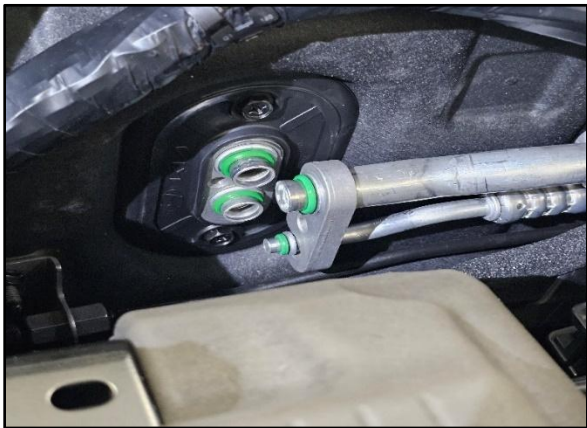
**Description:** Certain G80 (RG3) and G90 (RS4) vehicles equipped with the 2.5T-GDI Theta III or 3.5T-GDI Lambda III engine may experience reduced air-conditioning performance due to a refrigerant leak originating at the Thermostatic Expansion Valve (TXV).This condition may be caused by improper installation of the liquid and suction pipe O-rings at the TXV connection point. This bulletin provides instructions to replace the TXV O-rings at the liquid and suction pipe connections to correct the condition.

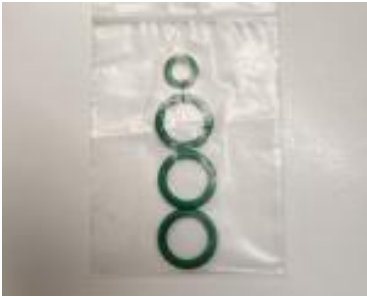
| Model | Part Name | Part Number | Figure | Remarks |
|---|---|---|---|---|
| G80 (RG3) | Set – O Ring | 97690-30000QQH | | Set includes:<br>4 O-rings<br><br>Upper Suction &<br>Liquid Pipe<br>Qty: 1<br><br>Lower Suction &<br>Liquid Pipe<br>Qty: 1<br><br>Evaporator Core<br>Qty:2 |

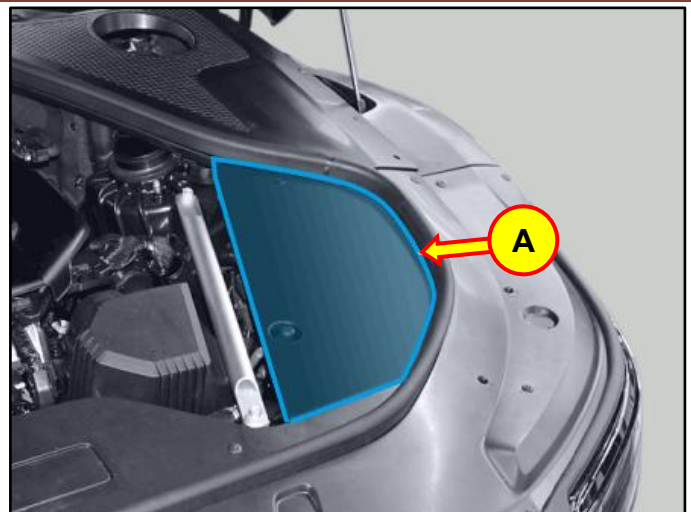
1. For **G90 (RS4)** vehicles equipped with a **3.5T GDI engine ONLY**:

Remove the LH engine room cover (A).

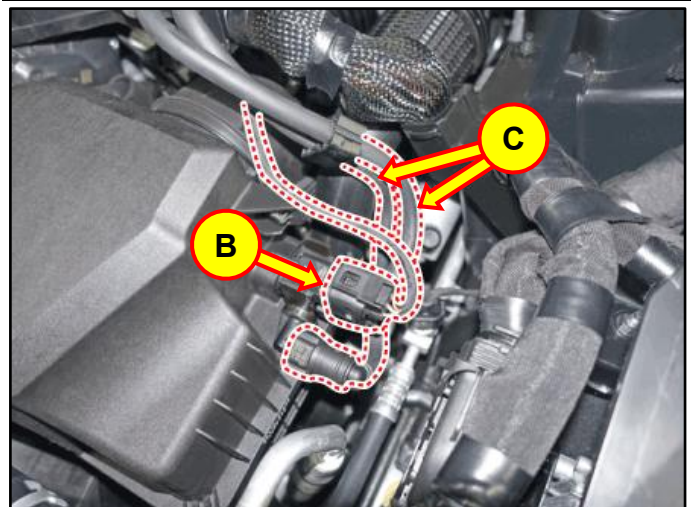
2. Disconnect the dual purge connector (B) and dual purge hose (C).

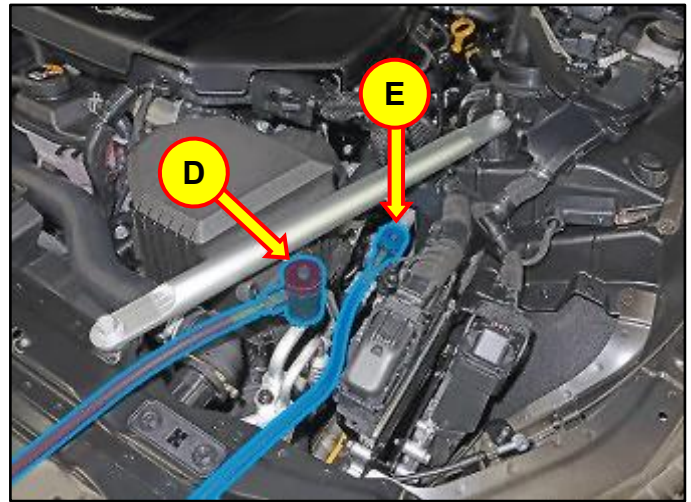
3. Connect the refrigerant recovery/recycling equipment to the high-pressure service port (D) and low-pressure service port (E) and recover the refrigerant by referring to the shop manual:

Drain or measure the amount of PAG oil in the reservoir prior to recovery to accurately determine how much oil is drained.

- Refrigerant Type: **R-1234YF**
- Refrigerant Capacity:
  - **630 ±25 g or 1.38 ±0.05 lbs (RG3)**
  - **700 ±25 g or 1.54 ±0.05 lbs (RS4)**

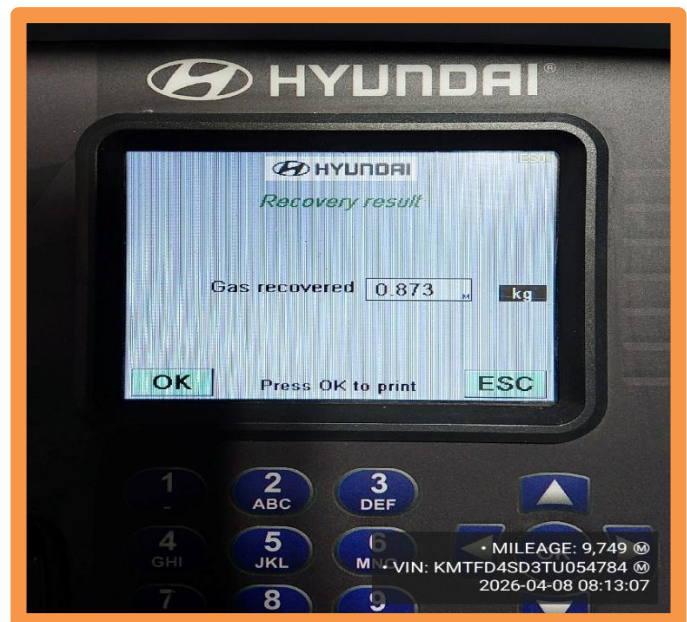
Using the STUI camera function, take a photo of the recovered refrigerant value.

**NOTE:** If the STUI camera function is **NOT** used, write the last 6 digits of the VIN and the date of repair on a piece of paper to include in the photo.

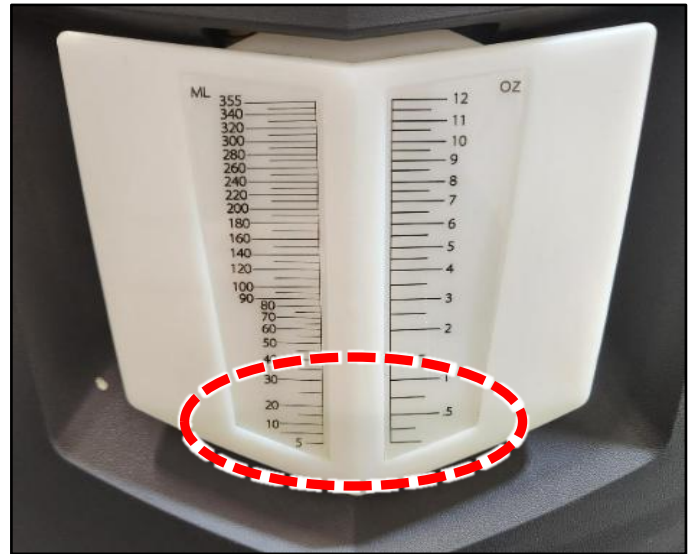
5. Measure and record the amount of PAG oil drained during recovery so the correct amount can be injected during the recharging process.

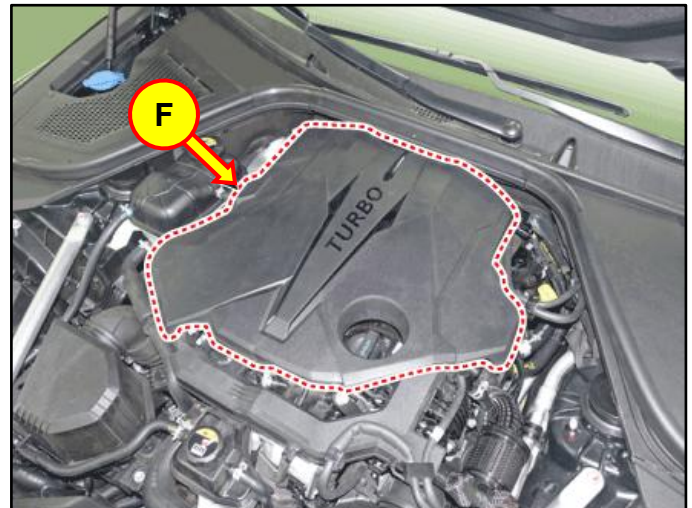
6. Disconnect the negative (–) battery terminal.
7. Remove the engine cover (F).

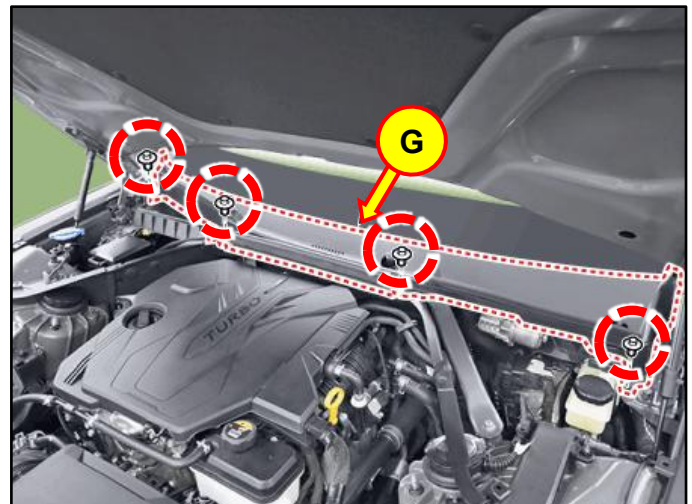
7. Remove the cowl top cover (G) by referring to the shop manual:
- **Body (Interior / Exterior / Electrical) > Exterior Green House > Cowl Top Cover Assembly > Removal and Installation**

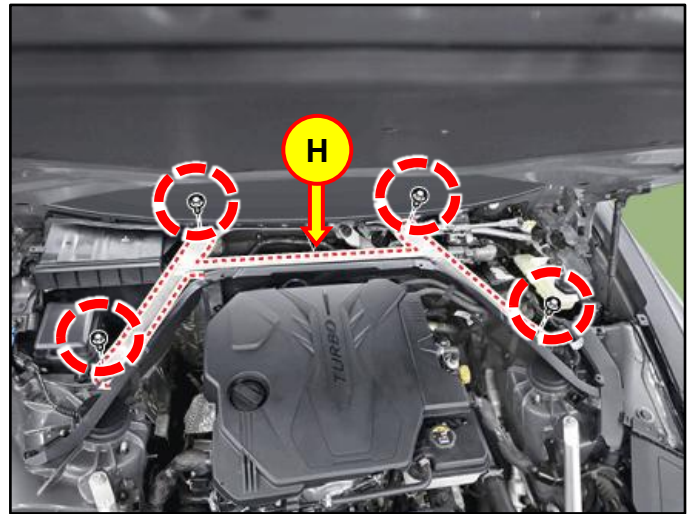
8. Remove **4** bolts, then remove the strut bar (H).

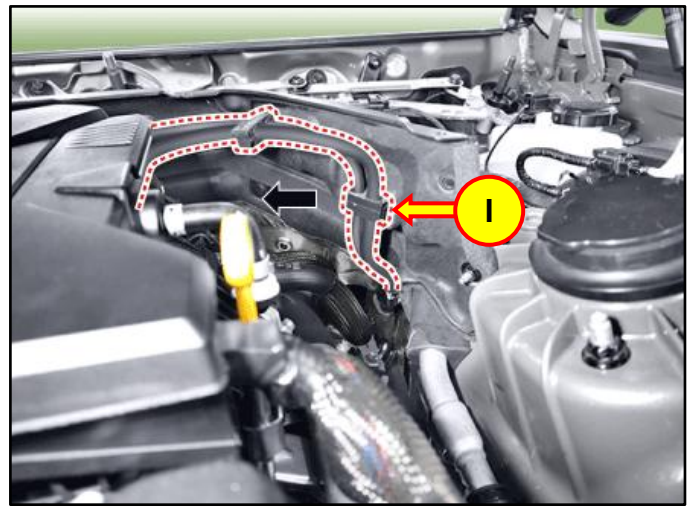
9. Detach the fuel line (I) from the partition wall.

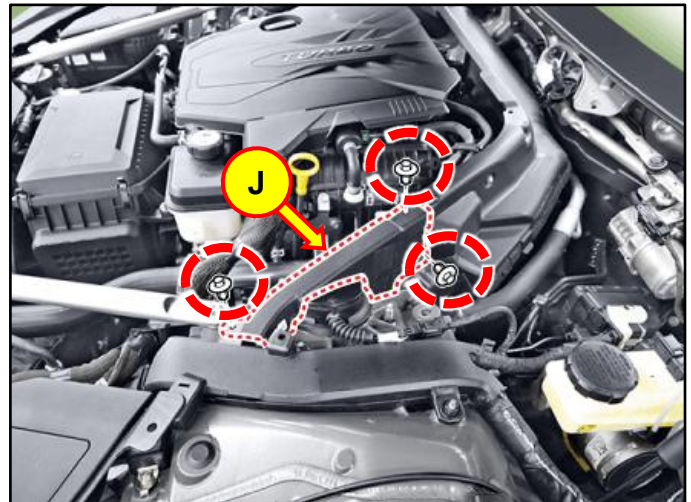
10. Remove **3** clips, then remove the side cover (J).

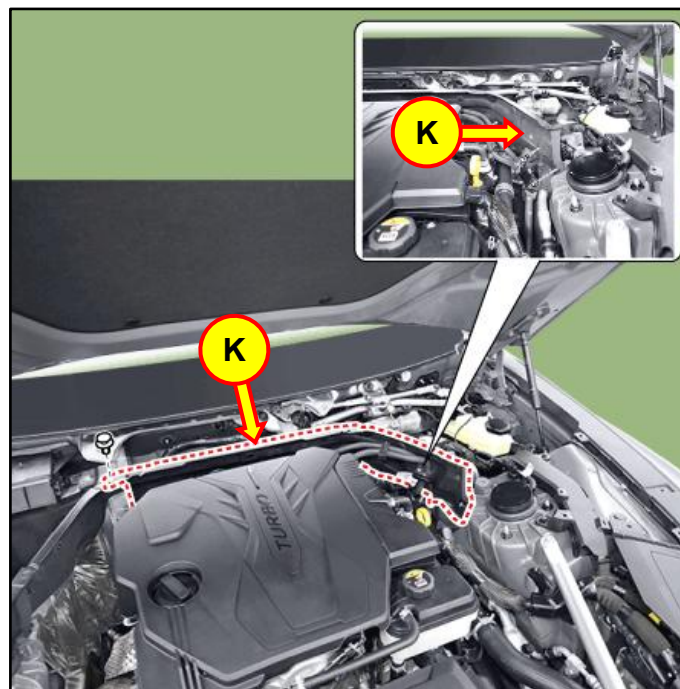
11. Remove the nut and clips, then remove the engine partition wall (K).

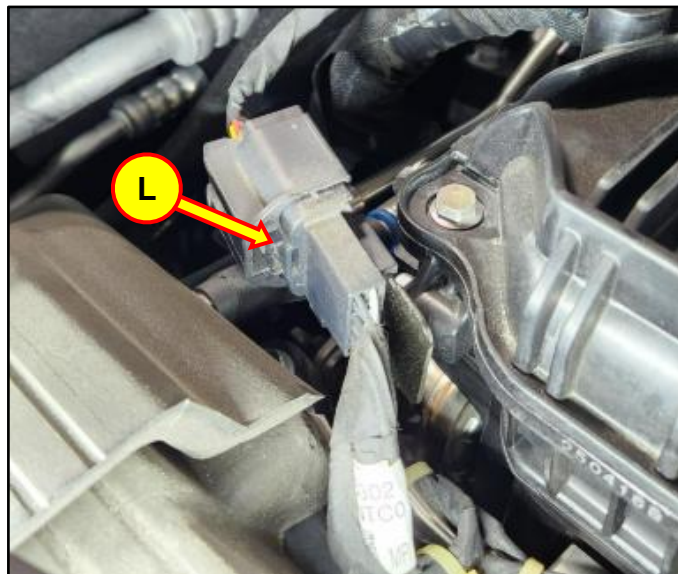
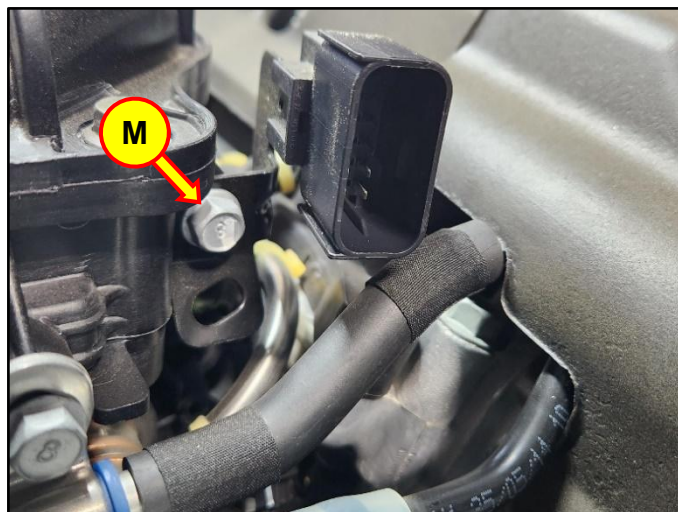
Disconnect the RH MPI injector connector (L), and remove the bracket mounting bolt (M).

**Tightening Torque:**

| lb-ft | 8 |
| lb-in | 96 |
| N.m | 11 |

Removing this component will provide unobstructed access to the TXV side bolt.

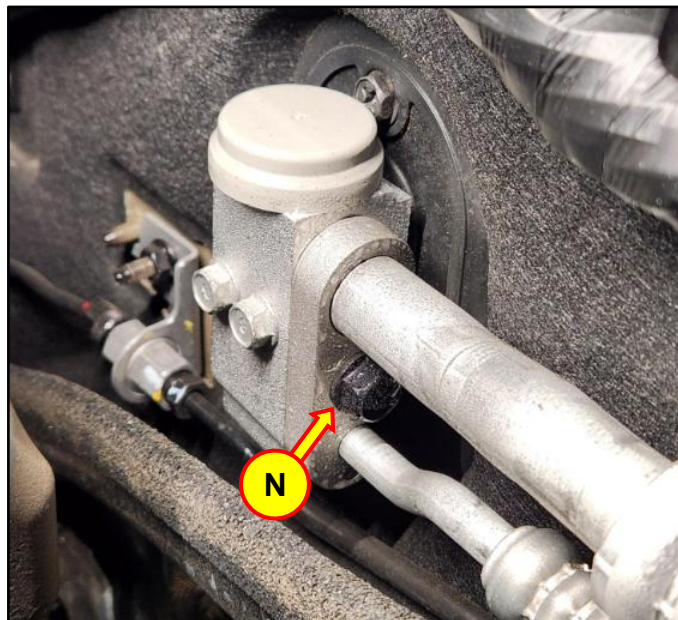
13. Remove the TXV side bolt (N).

**Tightening Torque:**

| lb-ft | 16 |
| N.m | 22 |

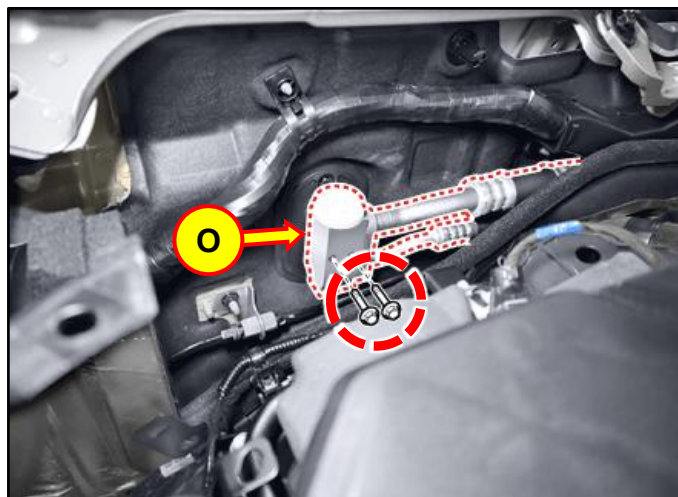
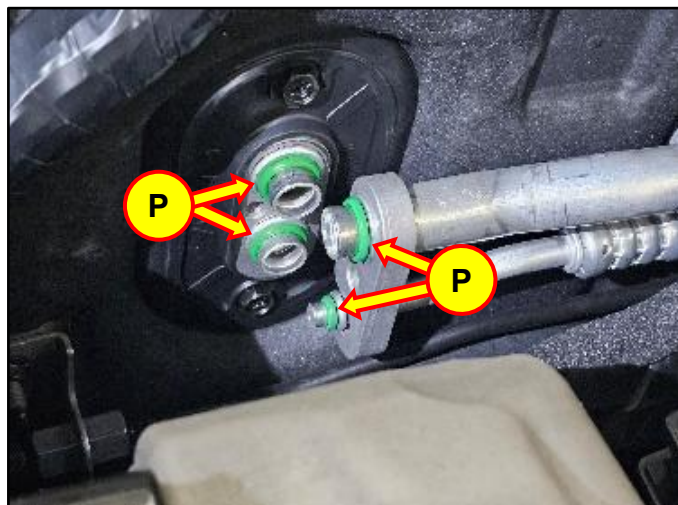
14. Remove 2 bolts, then remove the TXV (O) and O-rings (P).

**Tightening Torque:**

| lb-ft | 7.3 |
| lb-in | 88 |
| N.m | 9.8 |

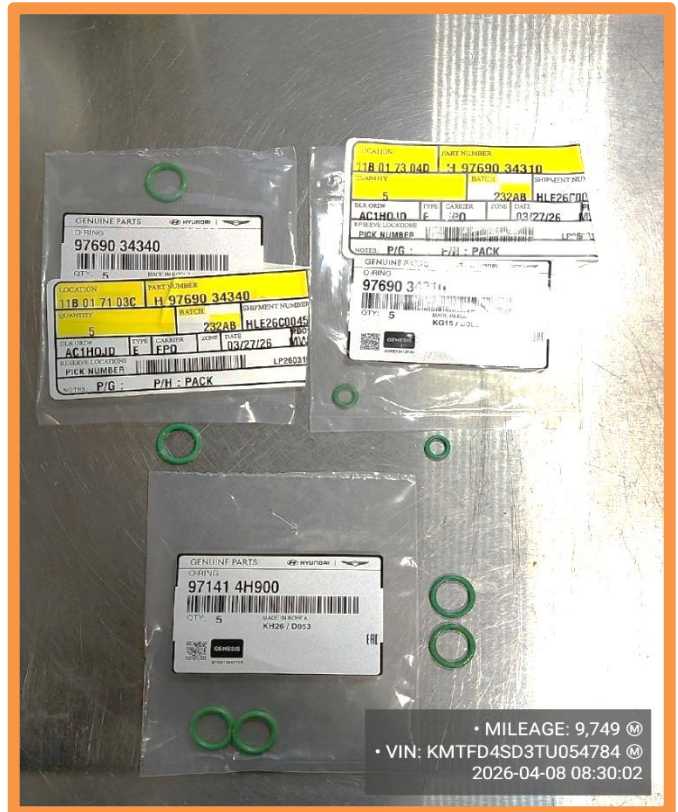
Using the STUI camera function, take a photo of the original O-rings removed next to the new O-Rings in the bags.

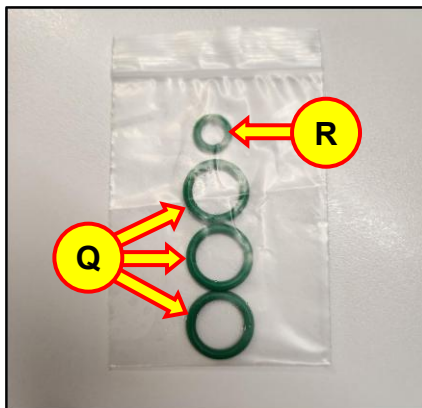
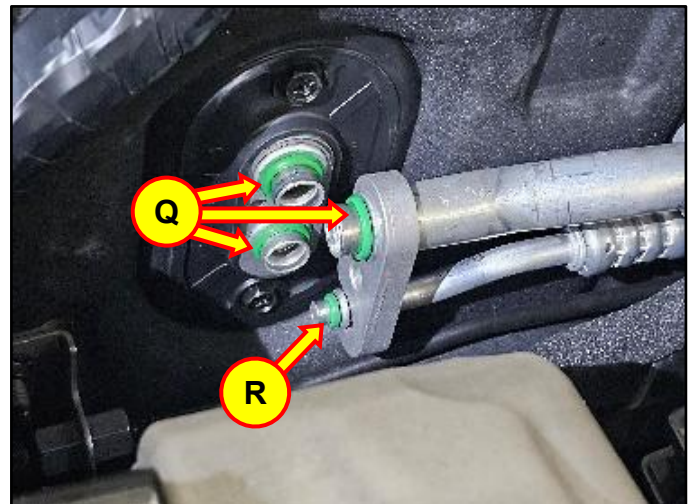
16. Replace the O-Rings with the new ones supplied in the service kit.

- Evaporator Core & Upper Suction & Liquid Pipe (Q)
- Lower Suction & Liquid Pipe (R)

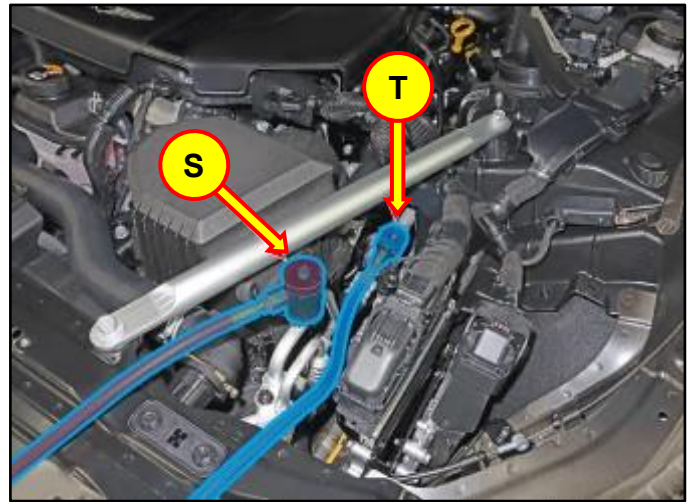
18. Connect the refrigerant recovery/recycling equipment to the high-pressure service port (S) and low-pressure service port (T).

Vacuum and recharge the A/C system by referring to the shop manual:

- **Heating, Ventilation and Air Conditioning > Air Conditioning System > Refrigerant Recovery / Recycling / Charging / Vacuum / Leak Test**
  - **Refrigerant System Vacuum Procedures**
  - **System Charging**
