| <br><b>Technical Service Bulletin</b> | <b>GROUP</b><br><b>HVAC</b> | <b>NUMBER</b><br><b>26-HA-002G</b> |
| <b>SUBJECT:</b> REDUCED HEATER PERFORMANCE – TEMPERATURE CHECK & HEATER CORE REPLACEMENT | | |

**Description:** Some Genesis vehicles (listed below) equipped with Lambda-III 3.5T-GDI engines may exhibit reduced heater performance due to engine coolant deposits clogging the heater core. This bulletin provides instructions to verify the concern and to replace the front and rear heater core (if applicable).

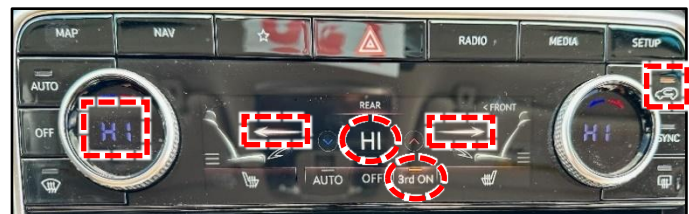
For GV80 (JX1) 7-Passenger models, do the same settings for the 3<sup>rd</sup> row.

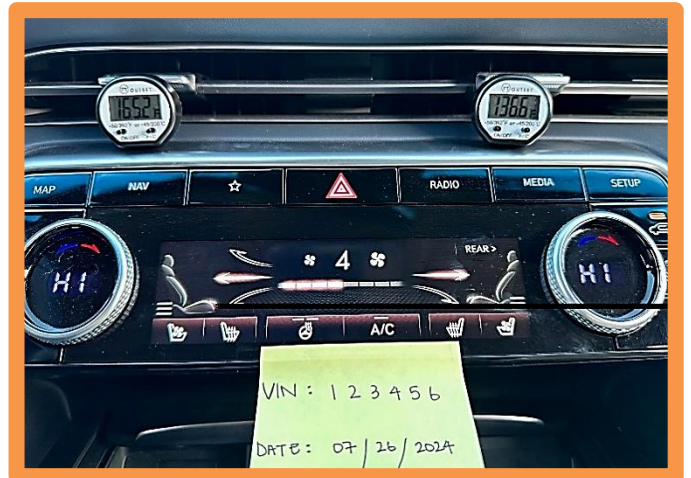
Using the STUI camera function, take a photo clearly showing the temperature readings on **BOTH** thermometers.

3.
  - If the temperature difference between the front center vents is **less than 18°F**, then Use OP Code **40D158R0** to finish this inspection procedure. The service procedure is now complete.
  - If the temperature difference between the front center vents is **18°F or higher**, then **proceed to step 4** for front heater core replacement.

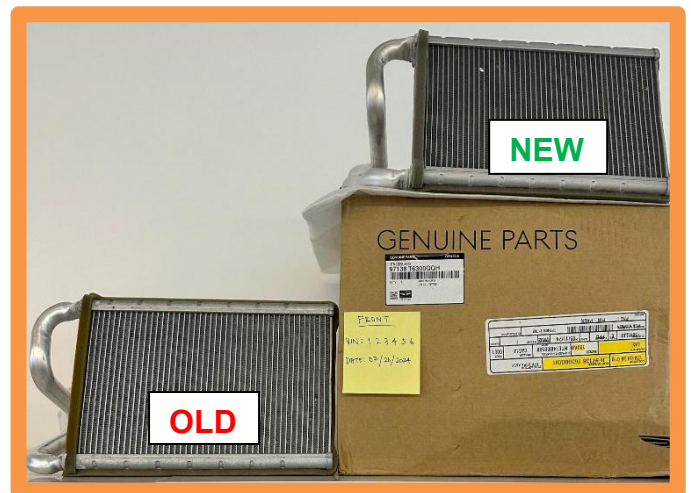
Using the STUI camera function, take a clear photo of the **OLD** heater core removed next to the **NEW** heater core on top of the box with the “QQH” label showing.

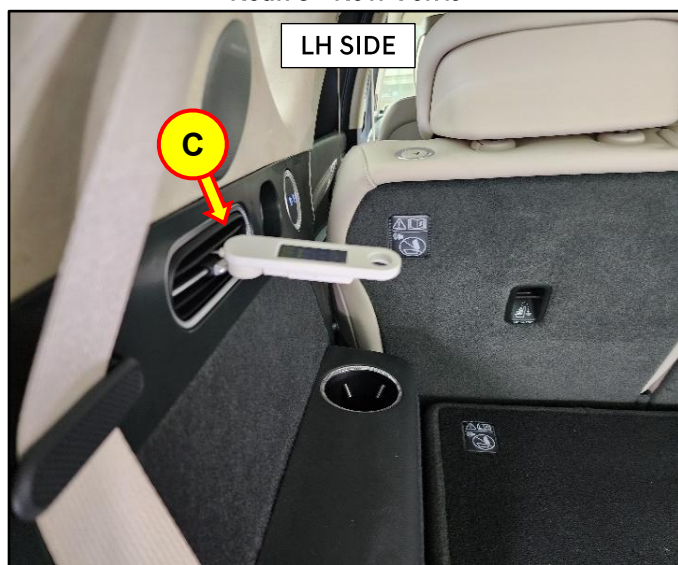
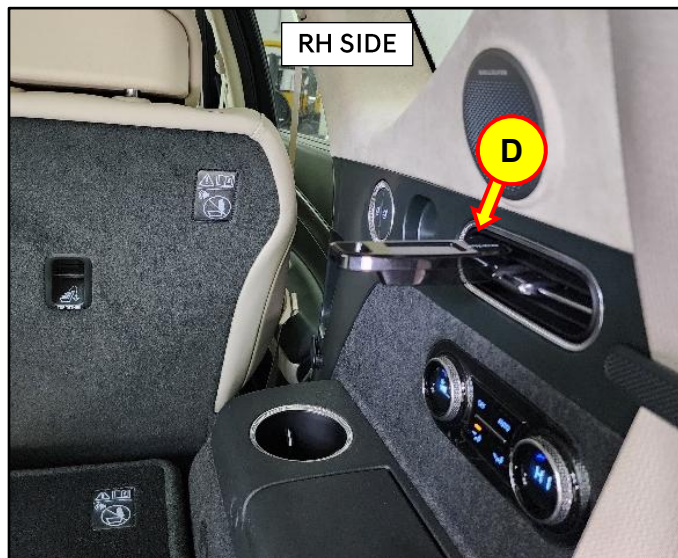
Rear/3<sup>rd</sup> Row Vents

2. Using a thermometer, measure the temperatures at the rear vents in the 3<sup>rd</sup> row on the LH (C) and RH (D) sides.

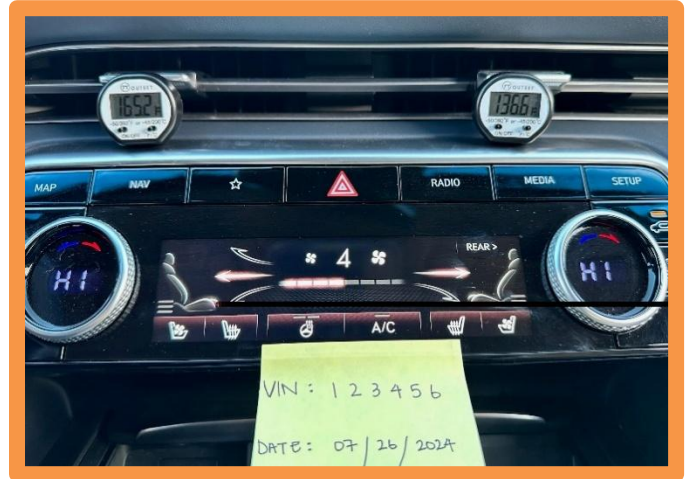
Using the STUI camera function, take a photo clearly showing the temperature readings on **BOTH** thermometers for the front vents.

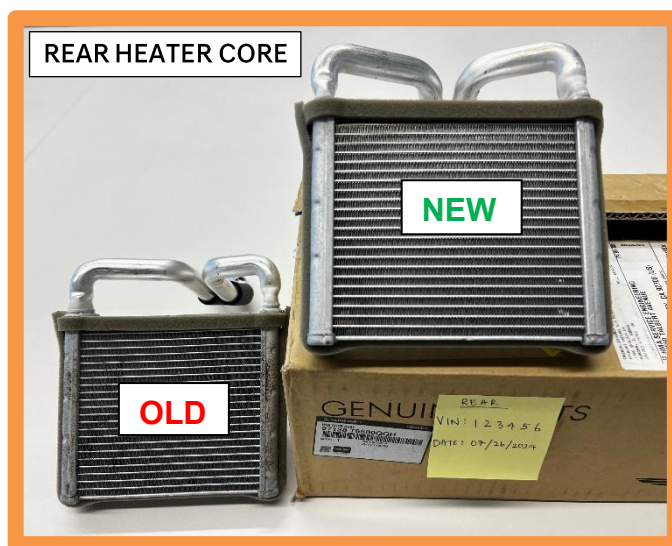
Using the STUI camera function, take a clear photo of the **OLD** rear heater core removed next to the **NEW** heater core on top of the box with the “QQH” label showing and a note designating “Rear”.
