HANDLE - DOOR PULL AND PANEL - FRONT DOOR TRIM : POIGNÉE - TIRE-PORTE ET PANNEAU - GARNITURE DE PORTE AVANT : MANIJA - TIRADOR DE PUERTA  
Y PANEL - EMBELLECEDOR DE LA PUERTA - DELANTERA

Quality Inspection Request

HANDLE - DOOR PULL AND PANEL - FRONT DOOR TRIM

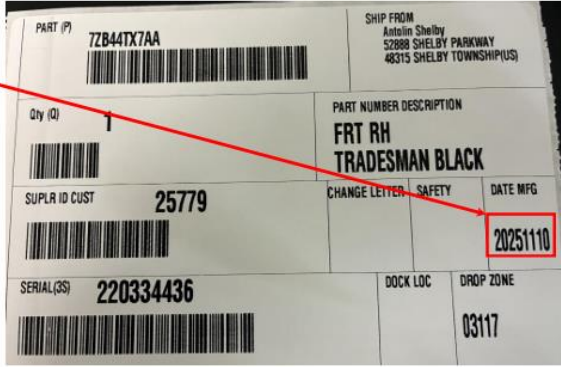
| <p><b>Les Numéro de pièce:</b><br/>6RN86TX7AB et 7ZB44TX7AA</p> <p><b>Emplacement du code de date de construction</b></p> <p>Code de date de construction affiché<br/><b>20251110: AAAAMMJJ</b><br/><b>10 novembre 2025</b></p> <p>La pièce représentée sur l'image n'est pas suspecte.</p> | <p>La pièce représentée sur l'image ci-dessous n'est pas suspecte.</p> |

**Pièces suspectes:** Les pièces construites avant le **20250520** (20 mai 2025) sont des pièces suspectes

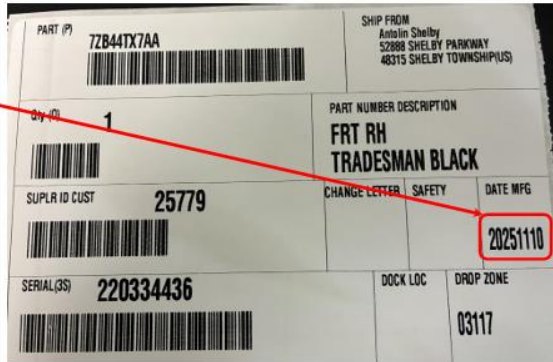
| <p><b>Números de pieza:</b> 6RN86TX7AB y 7ZB44TX7AA.</p> <p><b>Ubicación del código de fecha de construcción:</b></p> <p>Se muestra el código de fecha de construcción<br/><b>20251110: AAAAMMDD</b><br/><b>10 de noviembre de 2025</b></p> <p>La pieza mostrada en la imagen no es la sospechosa.</p> | <p>La pieza que aparece en la imagen de abajo no es sospechosa.</p> |

**Partes sospechosas:** Las piezas construidas antes de **20250520** (20 de mayo de 2025) son piezas sospechosas.
