Job Code:	M920031 – 26-004	Product:	Lineage Series VP
Date:	5/20/2026	Repair Time:	0.2 h

This bulletin describes the procedure to install a Grand Design RV – supplied diode into the water pump control circuit of the Firefly Emprise electrical system on affected ProMaster LVP units. The diode prevents excessive current in the water pump control circuit that can damage the Firefly circuit board.

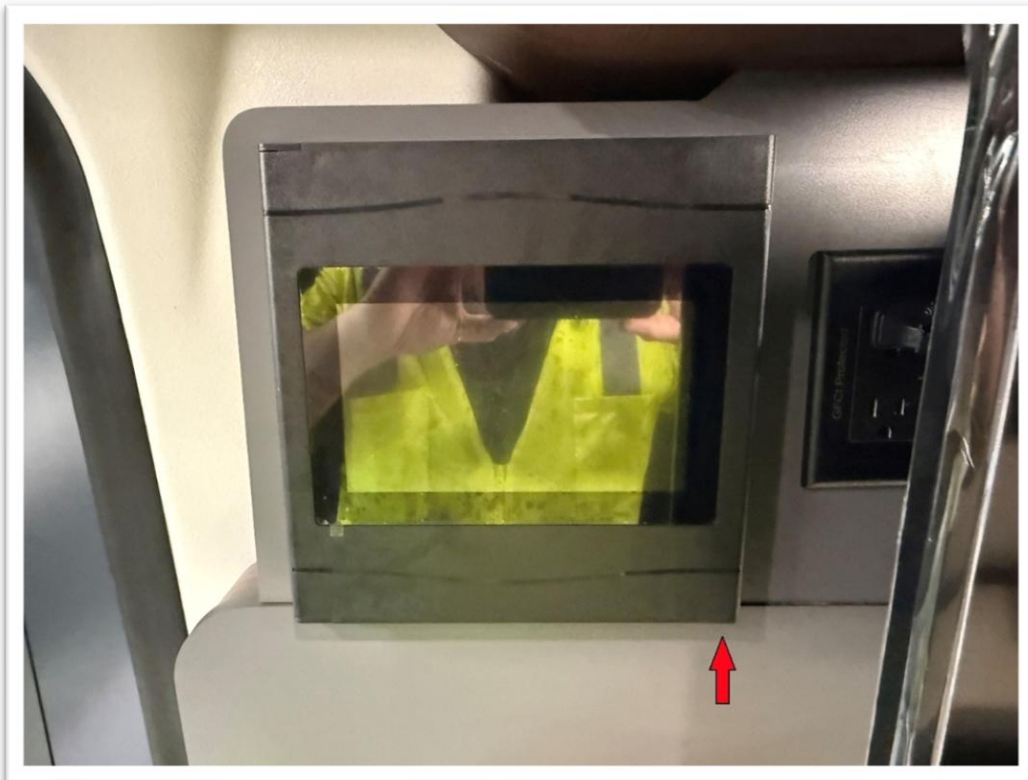
Fig. 1 – Screw location — lower right-hand side of the screen.

Step 1 – Using a Phillips screwdriver, remove the screw located on the lower right-hand side of the screen.

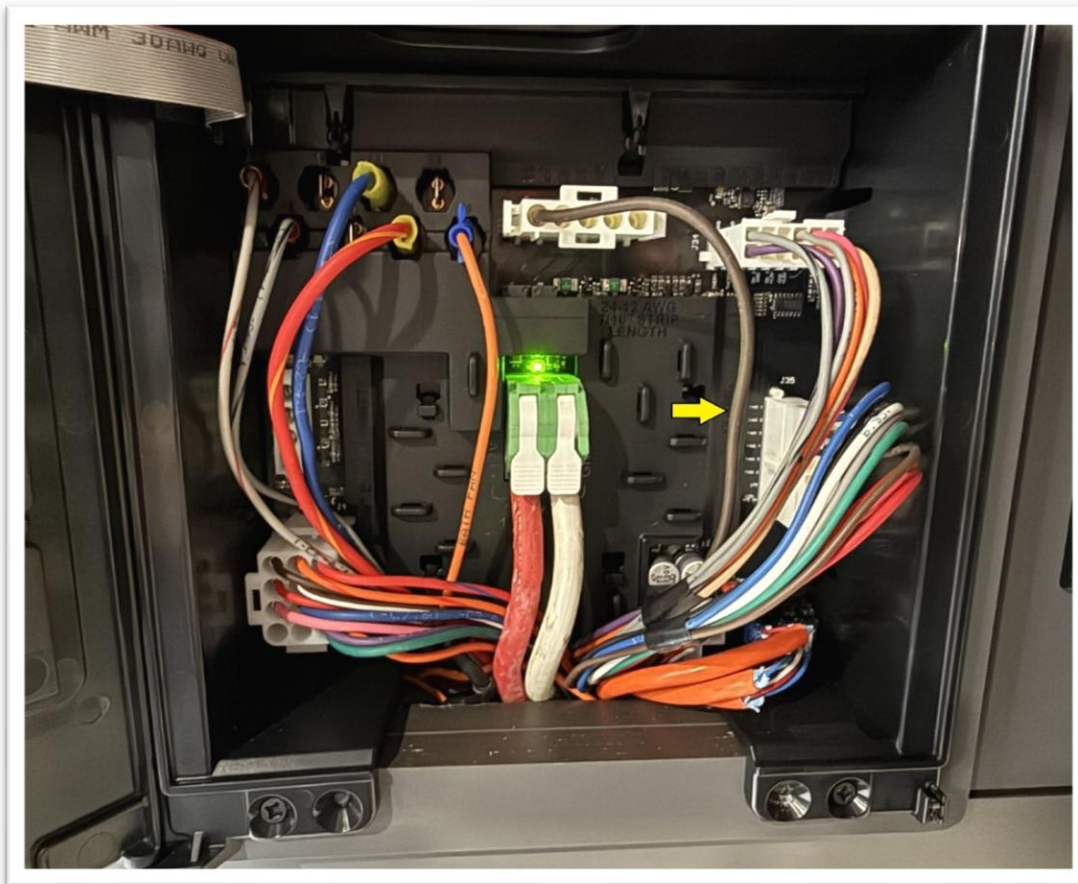
Fig. 2 – 14-gauge brown wire at the 5-pin connector — cut location indicated by arrow.

Step 3 – Locate the single 14-gauge brown wire connected to the 5-pin connector at the upper center of the electrical board. Using wire cutters, cut the wire at the location indicated.

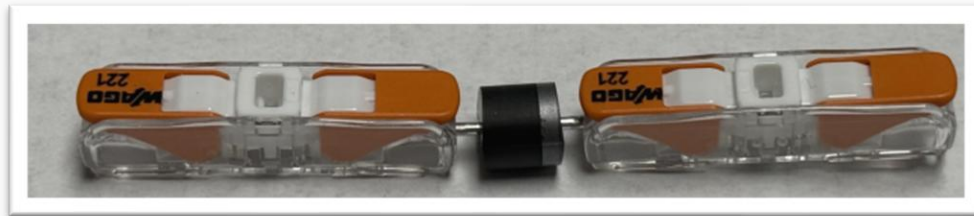
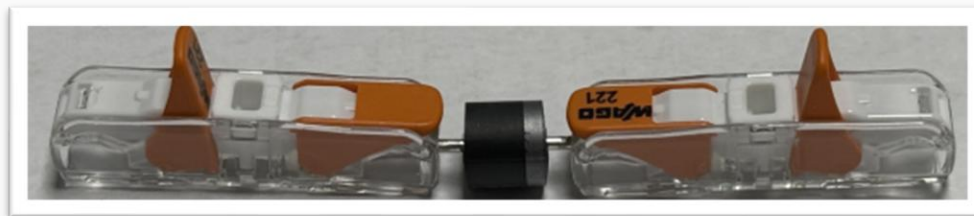
Fig. 3 — Supplied diode with Wago connector — locking levers open.

Step 5 – Take the Grand Design RV-supplied diode with the Wago connector and open the locking levers.
