**TECHNICAL SERVICE BULLETIN**  
**Tailgate Paint Wear**

**26-2298**  
 25 June 2026

Ford 2021-2025 Bronco
--------------------------

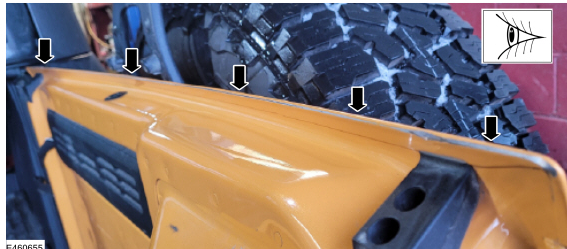
Figure 1

**Issue:** Some of the vehicles listed in the model statement above may exhibit paint wearing along on the top inner edge of the tailgate where the rear window weather strip contacts the tailgate. This may be due to the accumulation of dirt between the rear window seal and tailgate.

1. Does the top inside edge of the tailgate where the rear window weather strip contacts the tailgate show paint wear similar to Figure 1?

**Action:** For vehicles that meet all of the criteria in the Issue and Model statements, follow the Service Procedure to inspect the tailgate inner edge for paint wear, return the tailgate to factory specification, and apply a mylar tape to the edge to prevent future paint wear.

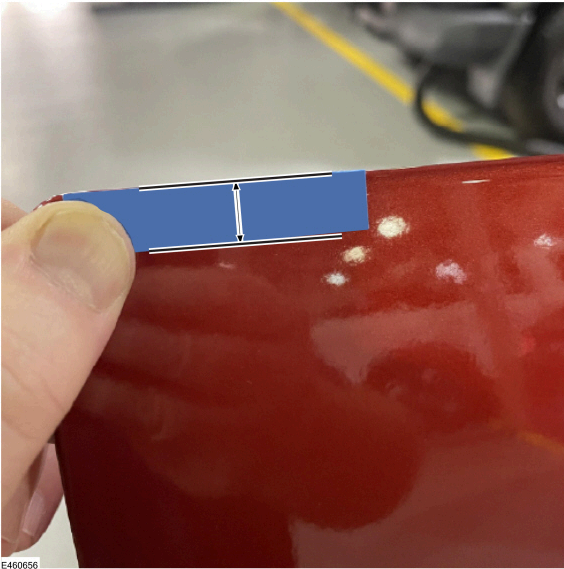
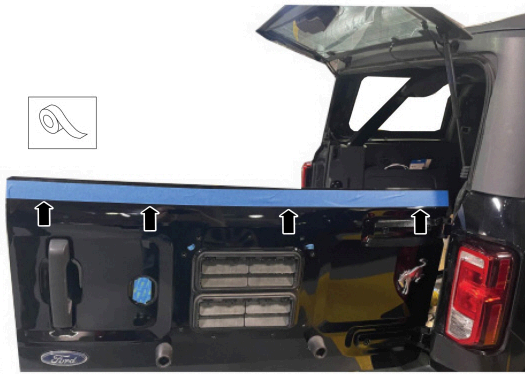
Figure 2

5. Measure 10 mm (0.39 inches) from the top edge of the tailgate and apply a piece of painter's tape down the entire length of the tailgate. This will help with aligning the mylar protective film. (Figures 2-3)

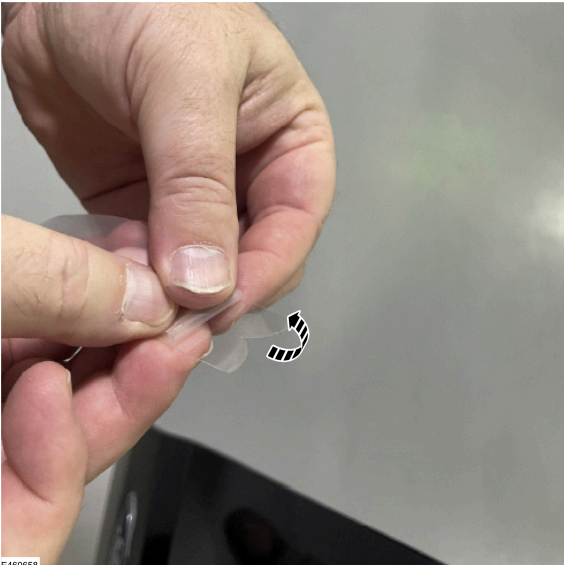
Figure 4

7. Peel away the backing from the edge of the mylar protective film. (Figure 4)

**NOTE: Do not touch the adhesive side of the mylar protective film as it will leave fingerprints.**

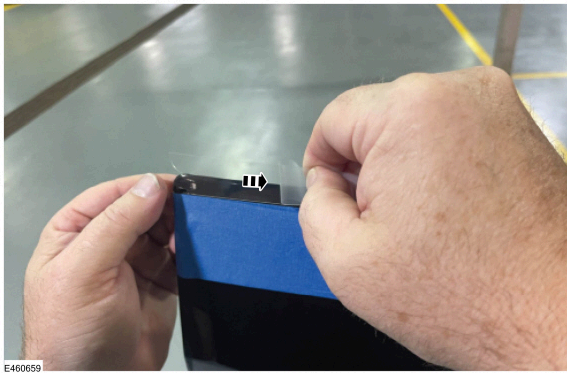
Figure 5

8. Line up the trimmed edge of the mylar protective film to the top left edge of the tailgate and apply the mylar protective film. (Figure 5)

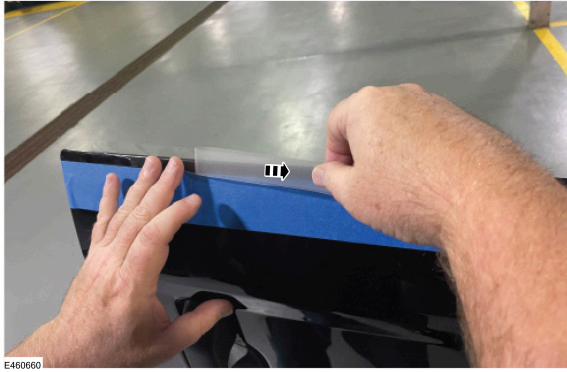
Figure 6

9. Using the painter's tape as a guide, slowly apply the mylar protective film down the tailgate, working from left to right. Remove the backing from the mylar protective film as the tape is applied. This will reduce the chances of the mylar protective film inadvertently sticking to the tailgate. If the mylar protective film is pulled off once it is stuck to the body it will be deformed and it must be discarded. (Figure 6)

**NOTE: Slowly applying the mylar protective film and working from left to right helps make sure there are no air bubbles trapped under the mylar protective film.**

**NOTE: Do not pull or stretch the mylar protective film as it is applied to the tailgate or it will become deformed and will need to be discarded. Extra mylar protective film is provided in case it becomes deformed during initial installation.**

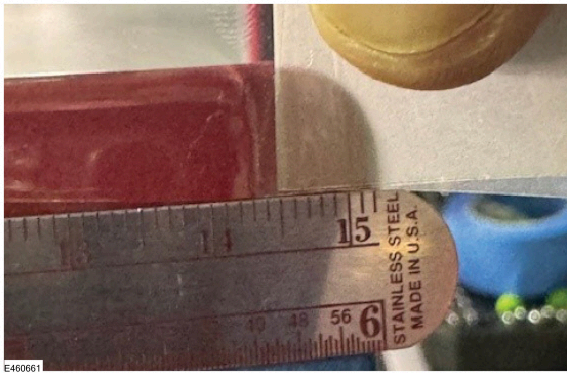
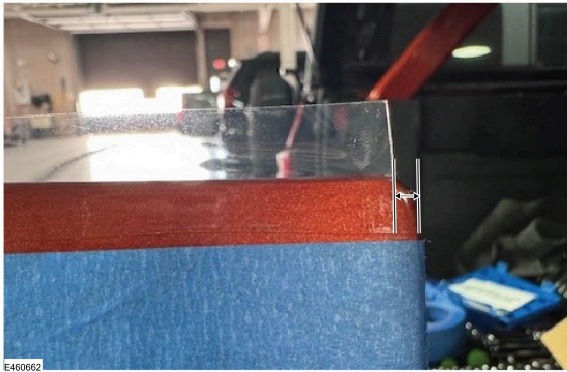
Figure 7

10. Cut the mylar protective film 8 mm (0.31 inches) before the right-side edge of the tailgate. (Figures 7-8)

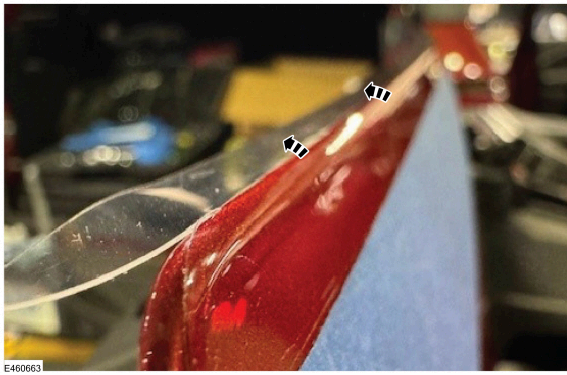
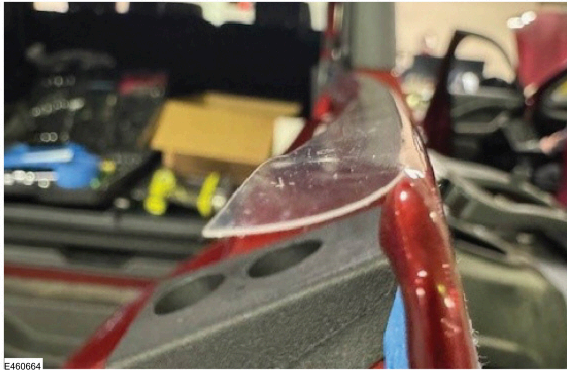
Figure 9

11. Once the mylar protective film is applied to the outside of the tailgate, apply pressure to the bottom edge of the mylar protective film on the outside of the tailgate using only finger pressure. Move fingers slowly from the bottom edge of the mylar protective film over the top edge of the tailgate. Continue to slowly work the mylar protective tape over the top edge of the tailgate from left to right. Once this step is complete, the mylar protective film should be over the top of the tailgate sitting at a 90° angle. (Figures 9-10)

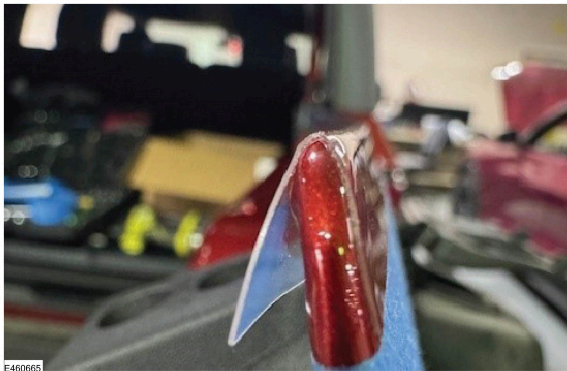
Figure 11

12. Starting on the left outside edge of the tailgate, use finger pressure to apply the top edge of the tailgate and work the mylar protective film over the top edge and down the backside of the tailgate 0.125 inch (3 mm). Continue to slowly work the mylar protective tape over the top edge of the tailgate from left to right. Once this step is complete, the mylar protective film should be over the top edge sitting at a 45° angle. (Figure 11)

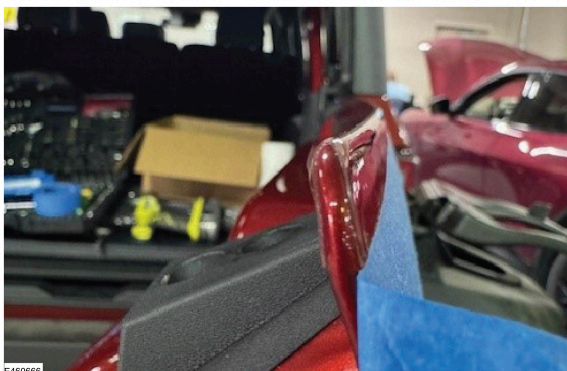
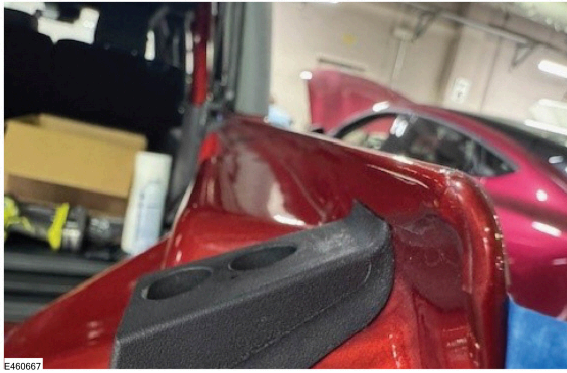
Figure 12

13. Starting at the top right edge of the tailgate, use finger pressure to apply the mylar protective film and work down the inside of the tailgate. Continue to slowly work the mylar protective film down the inside of the tailgate working from right to left until it has been fully applied. (Figures 12-13)
