TECHNICAL SERVICE BULLETIN, VIN: SB-80 GH1 Audio System Remote Wire

Technical Service Bulletin SB-80 Repair Instructions

Models Involved: 2026 GH1 1UP Motorhomes and 2027 GH1 19 AV Motorhomes

Purpose: To add an audio system remote wire to ignition. This will remove a 1 amp draw that drains chassis battery within a week.

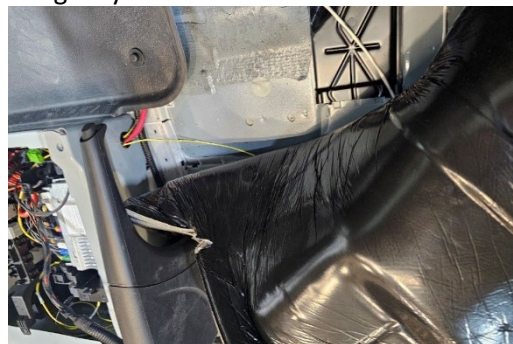
Figure 1

1. Remove drivers' seat using the E12 socket to access modules located beneath the seat.
2. Roll floor mat back to access the seat pass throughs, carefully pulling the center floor mat from under the other mats and avoiding the emergency brake handle.

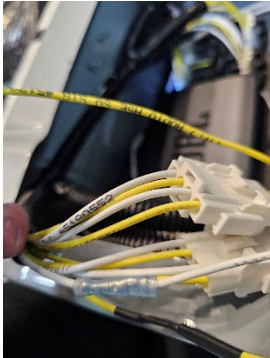
Figure 4A

5. Connect #5191843 Jumper Audio Sub/Amp to house switch signal with #5152028 harness jumper.
 - Cut the wire labeled “AUDIO HSE SW SIG” with the wire strippers or crimpers, see figure 4A.
 - Make connection with the side of the jumper harness containing the diode, shown in figure 4B.

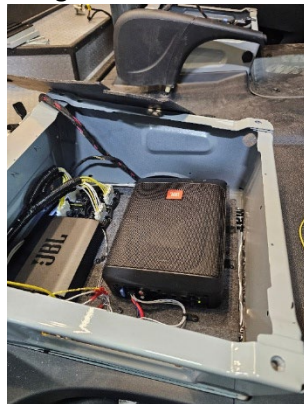
Figure 7

8. Reinstall center floor mat by lifting the mats that are in place and replace the center floor mat ensuring that the mat covers the wire access holes. See figure 7.
