Product Update: 2024 Prologue Rear Chassis Harness Connector Cavity Plugs Inspection

Certain 2024 Prologue vehicles may have improperly installed or missing cavity plugs from the rear chassis harness electrical connector.

Inspect the rear chassis harness connectors, clean off any corrosion, replace any missing cavity plugs, then fully set the remaining cavity plugs as necessary. If corrosion is found on the terminal pins that cannot be cleaned off, replace the associated harness.

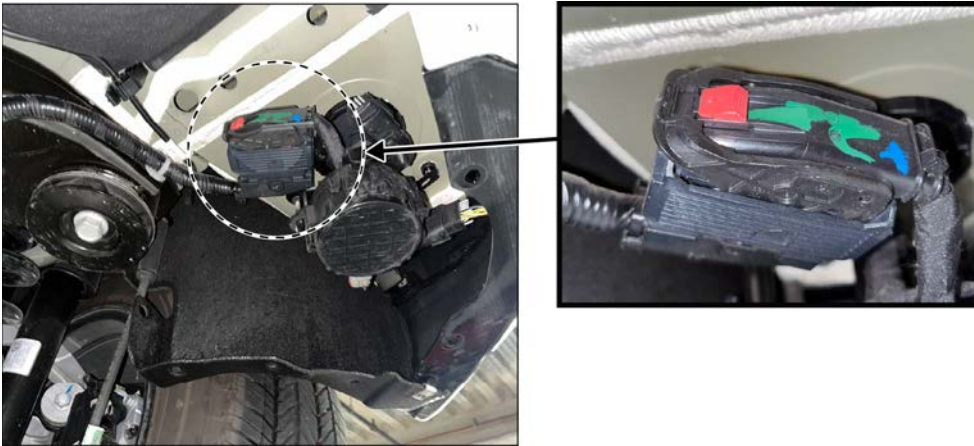
1. Disconnect the 12-volt battery. See [Battery Negative Cable Disconnection and Connection](#).
2. Raise the vehicle. See [Lifting and Jacking the Vehicle](#).
3. Remove the underbody rear air rear deflector. Refer to steps 2–6 of the Removal Procedure in [Underbody Rear Air Rear Deflector – Rear](#).
4. Locate the body wiring harness to chassis harness connector at the right-rear underside of the vehicle.

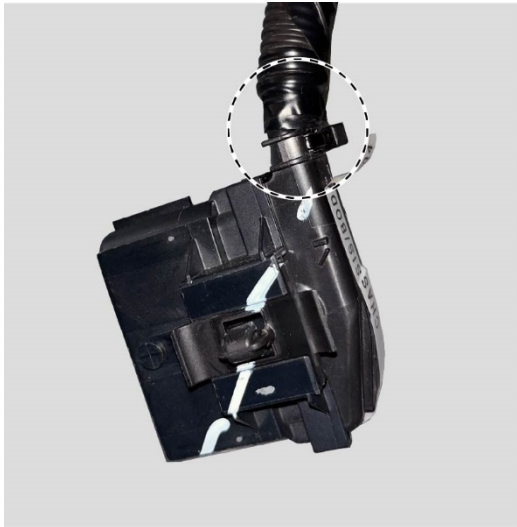
8.1 Cut off the wire tie securing the cover to the harness.

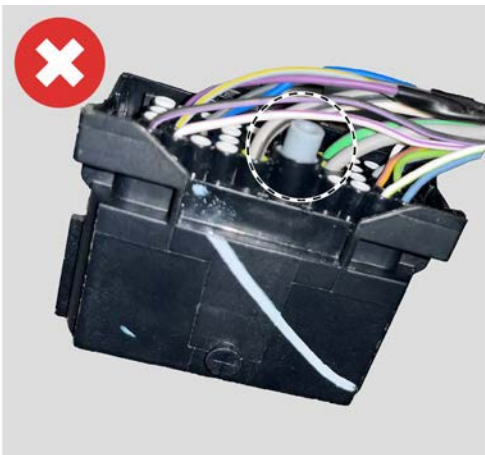
Cavity Plug Not Fully Seated

- 9 If the large cavity plugs are in place but sitting above the connector body (not fully seated), use a flat screwdriver and push the cavity plug in until it is fully seated and sitting below the connector.

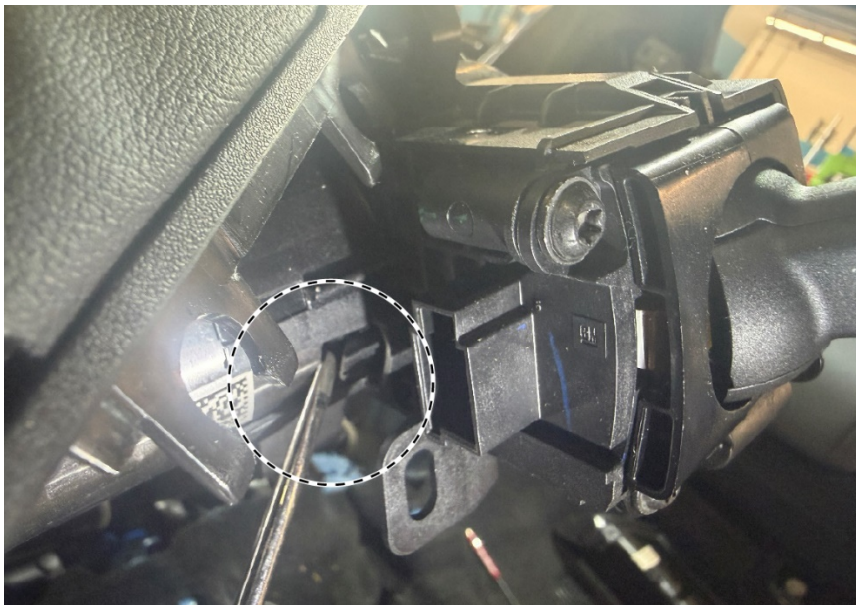
During the removal of the turn signal switch on step 69, there are two spring tabs securing the turn signal switch to the steering column. Gently pry the spring tabs until the turn signal switch releases from the steering column with light pressure. Excessive pressure can break the spring tabs. If the tabs break the turn signal switch must be replaced.

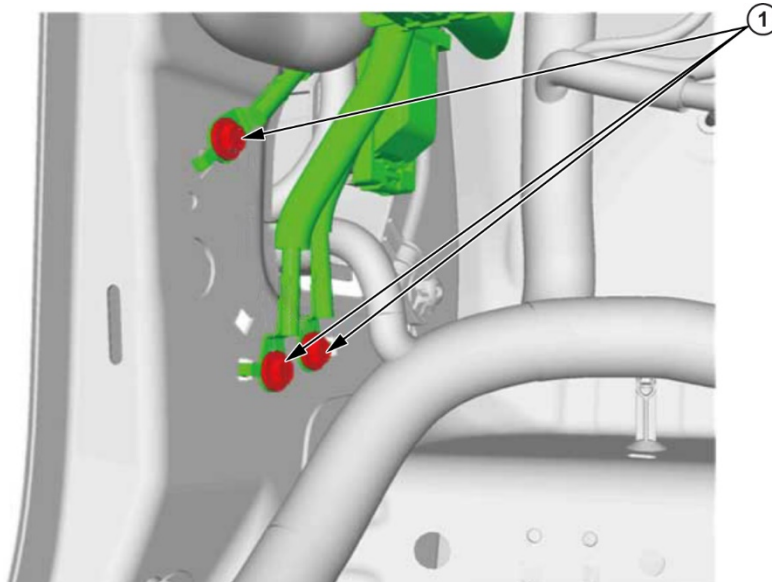
14.2 Disconnect the harness connectors and remove the harness grounds (1) at the kick panels and A-pillars to allow the instrument panel to be removed.

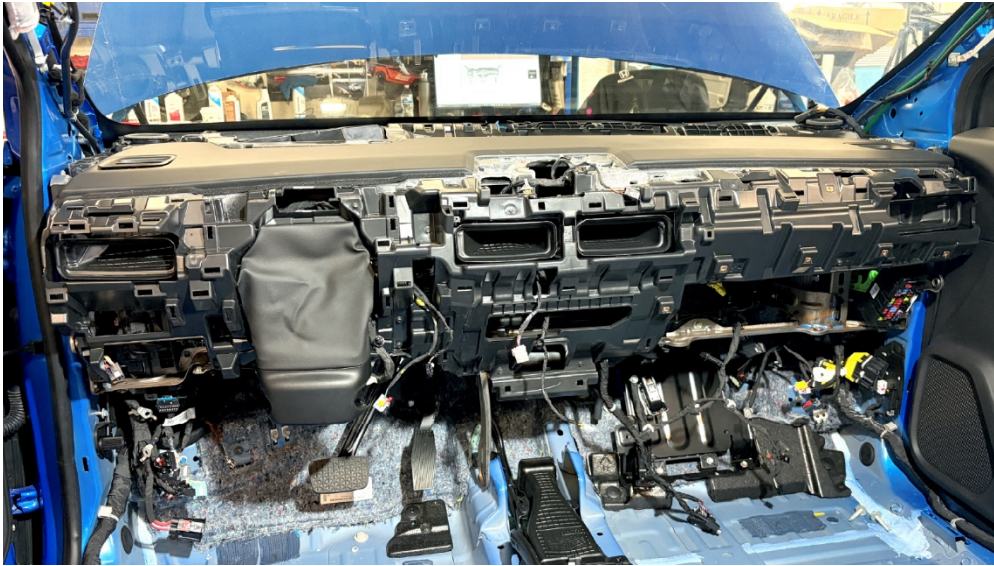
- 14.9 With the aid of an assistant, lift the instrument panel assembly up and rearward to release the assembly off the locating pins, then remove it from the vehicle.
