Product Update: 2024 ZDX Rear Chassis Harness Connector Cavity Plugs Inspection

Certain 2024 ZDX vehicles may have improperly installed or missing cavity plugs from the rear chassis harness electrical connector.

Inspect the rear chassis harness connectors and replace any missing cavity plugs, then fully set the remaining cavity plugs as necessary. In rare cases, if corrosion is found on the terminal pins that cannot be cleaned off with electrical contact cleaner, the associated harness will need to be replaced.

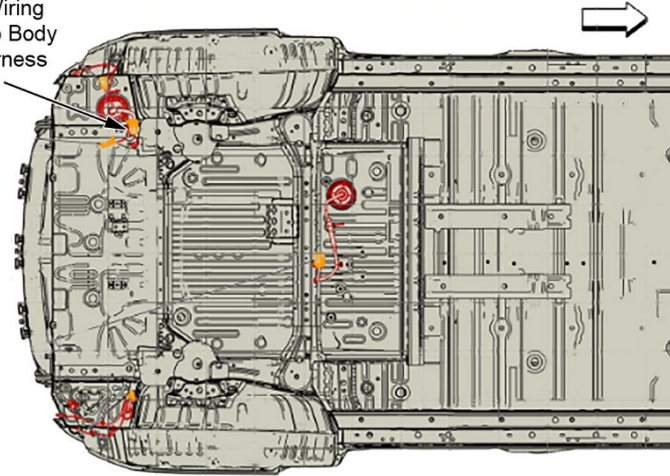
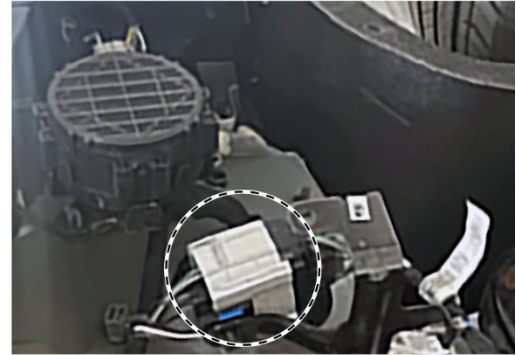
Chassis Wiring
Harness to Body
Wiring Harness

1. Disconnect the 12-volt battery. See [Battery Negative Cable Disconnection and Connection](#).
2. Raise the vehicle. See [Lifting and Jacking the Vehicle](#).
3. Remove the underbody rear air rear deflector. Do steps 2–6 of the Removal Procedure in [Underbody Rear Air Rear Deflector – Rear](#).
4. Locate the body wiring harness to chassis harness connector at the right-rear underside of the vehicle and remove it from the bracket for access.

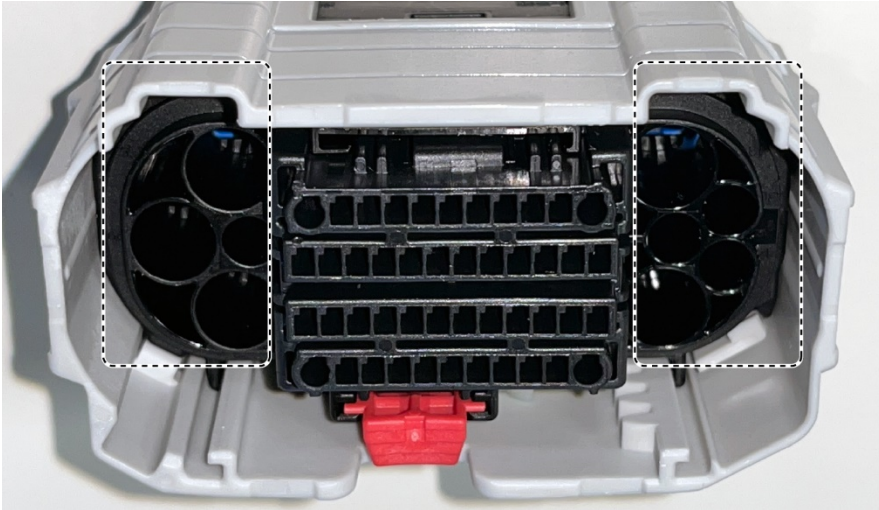
5. Inspect the back side of the chassis harness connector. The following cavity locations should have either a wire or cavity plug inserted (depending on the vehicle trim).

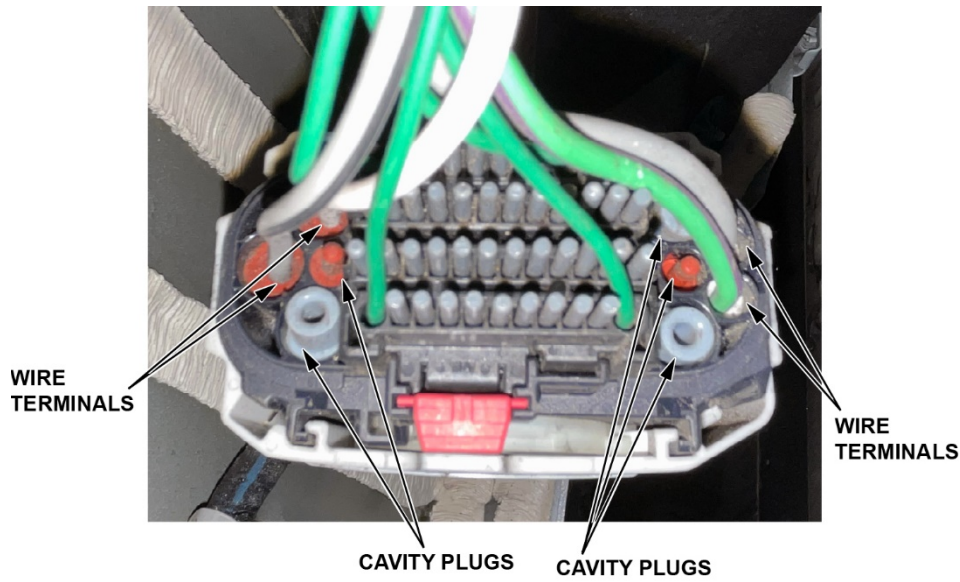
- 5.1 For the large and medium sized cavities that do not have wire terminals inserted, check that the gray or red cavity plugs are in place and fully seated. A fully seated cavity plug will sit below the body of the connector.

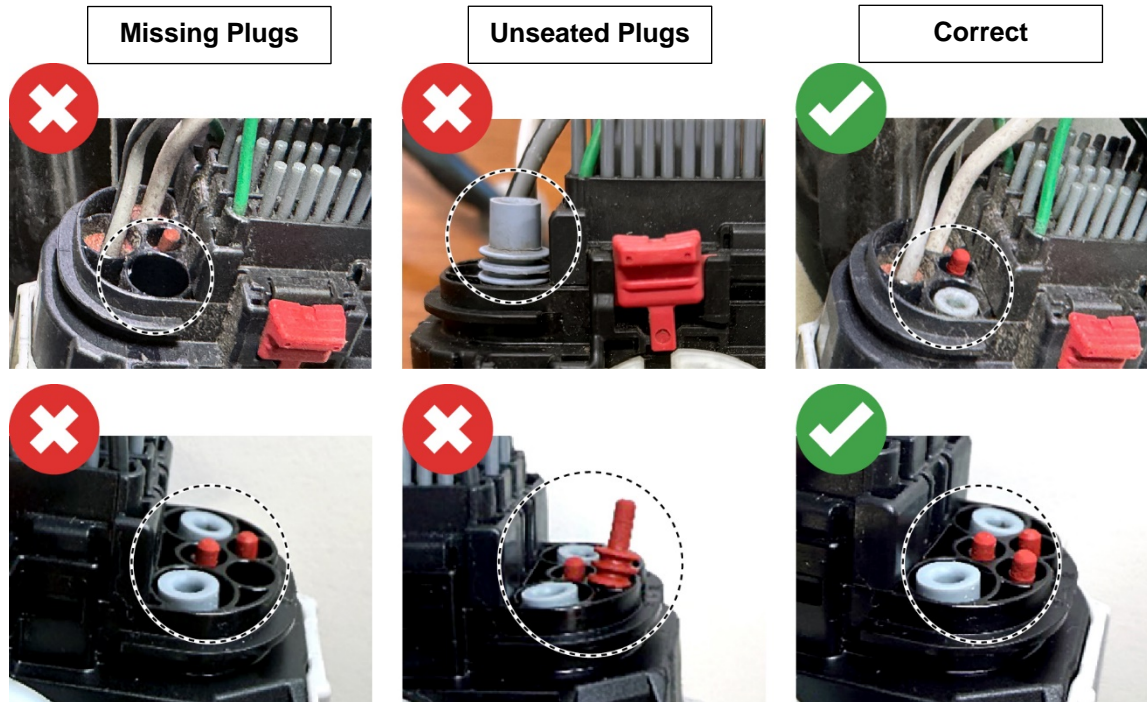
Examples of missing or fully unseated cavity plugs:

5.2 Inspect the large and medium cavity plugs for missing or fully unseated (all 3 ribs are visible) plugs.

YES – Proceed to step 6.

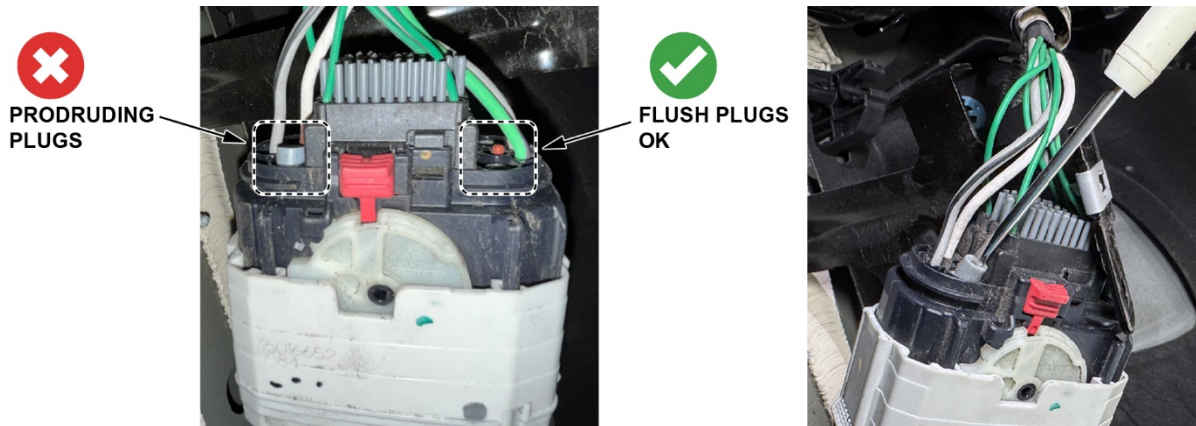
NOTE: If the cavity plugs are in place but sitting above the connector (not fully seated), use a flat screwdriver and push the cavity plug in until it is fully seated and sitting below the connector.

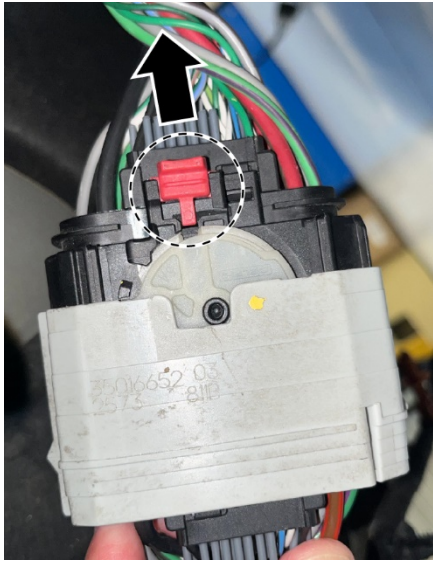
6.1 Slide the release lock to unlock the connector.

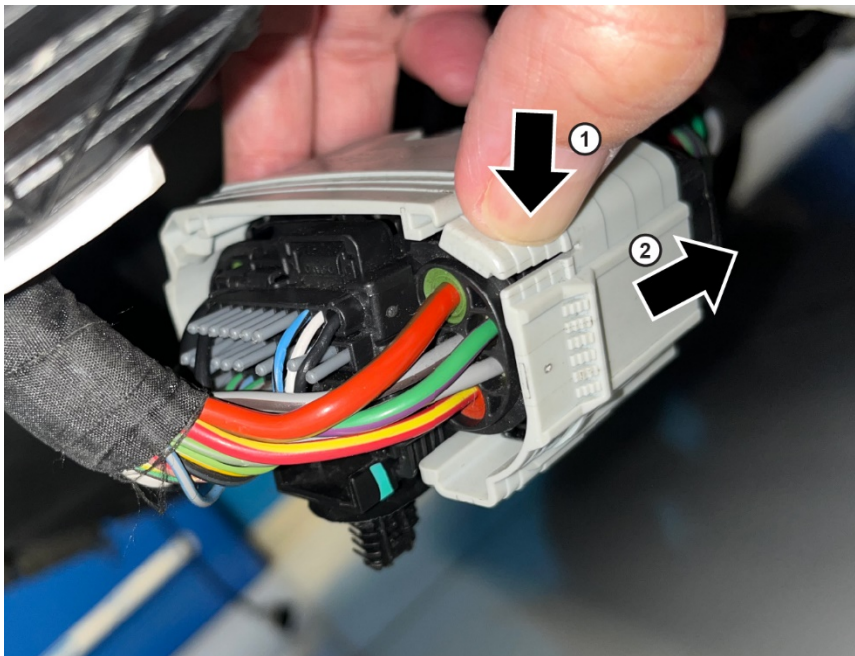
6.2 Press the release tab on the corner of the connector (1) to release the lock, then slide the outer case in the direction shown (2) to release the connector.

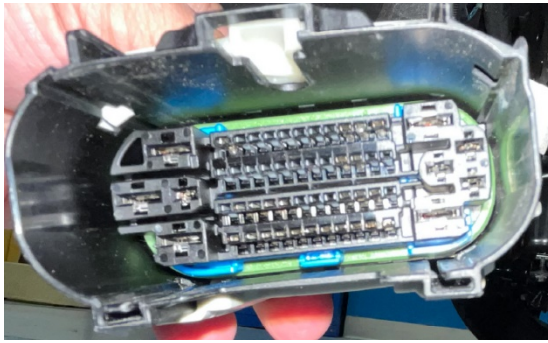
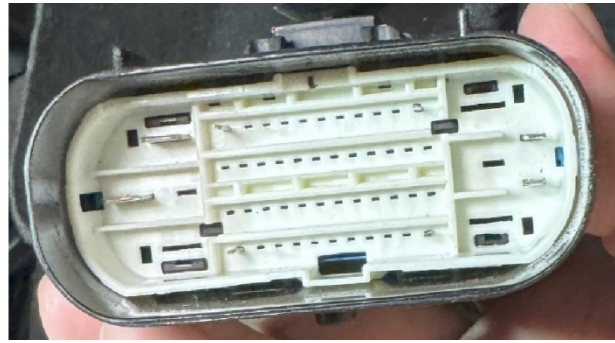
6.3 Inspect both connectors for corrosion on the connector terminals.

Is corrosion present on the connector terminals?

YES – Use electrical contact cleaner to remove the surface corrosion, then go to step 6.4.

Do not use brake or fuel system cleaners as they can damage the connectors.

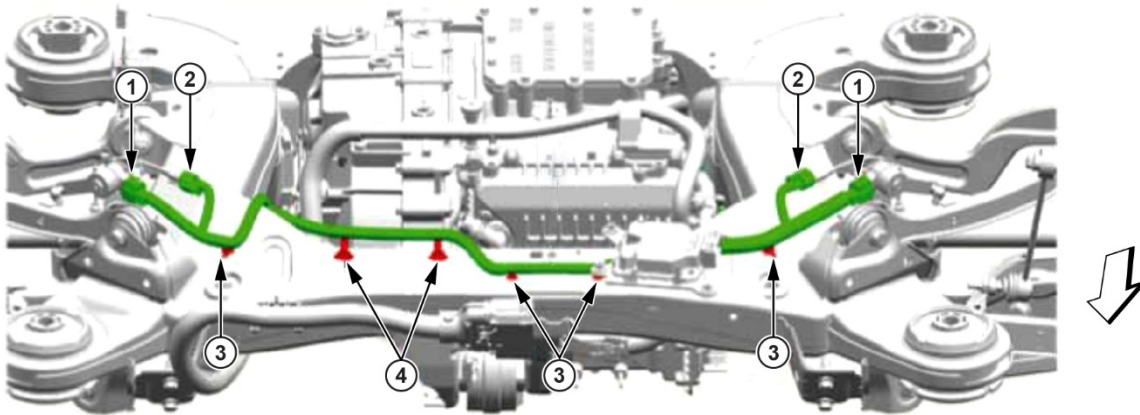
1. Before replacing the chassis harness, take clear photos of the corrosion on the chassis harness connector. These photos must be submitted with the warranty claim.
2. Remove the automatic forward lighting leveling position sensor connectors (1), then remove the rear wheel speed sensor connectors (2). Unclip the harness retainers (3, 4).

3. Install the new chassis harness in the reverse order of removal. Make sure the mounting clips are properly secured, and the connectors have all been reattached.
4. Reinstall the underbody rear air rear deflector - rear. Do steps 1–5 of the Installation Procedure in [Underbody Rear Air Rear Deflector – Rear](#).
5. Lower the vehicle.
6. Connect the 12-volt battery. See [Battery Negative Cable Disconnection and Connection](#).
7. Clear all DTCs.

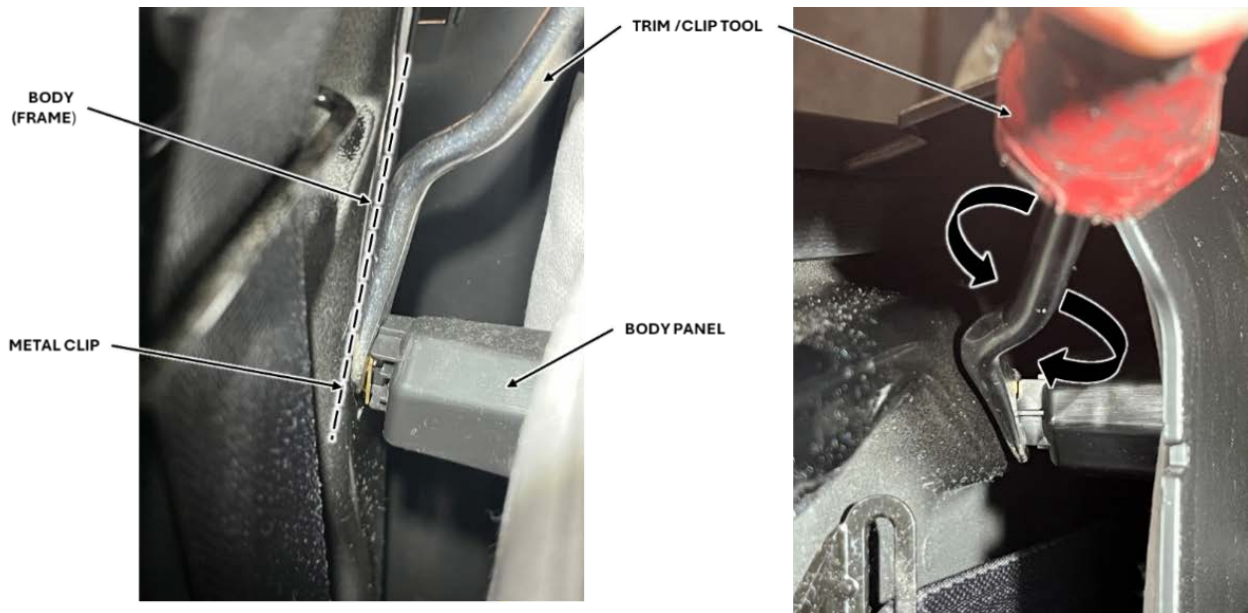
Panel Removal Tip:

1. Slide the trim/clip tool between where the trim panel is secured to the body structure.
2. Gently twist the trim/clip tool to release the metal clip from the body structure.

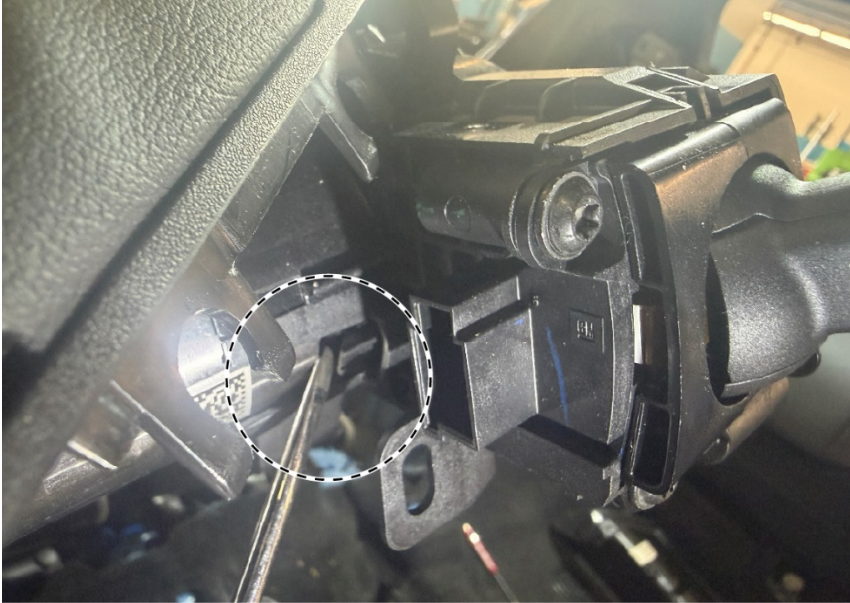
During the removal of the turn signal switch, there are two spring tabs securing the turn signal switch to the steering column. Gently pry the spring tabs until the turn signal switch releases from the steering column with light pressure. Excessive pressure can break the spring tabs. If the tabs break the turn signal switch must be replaced.

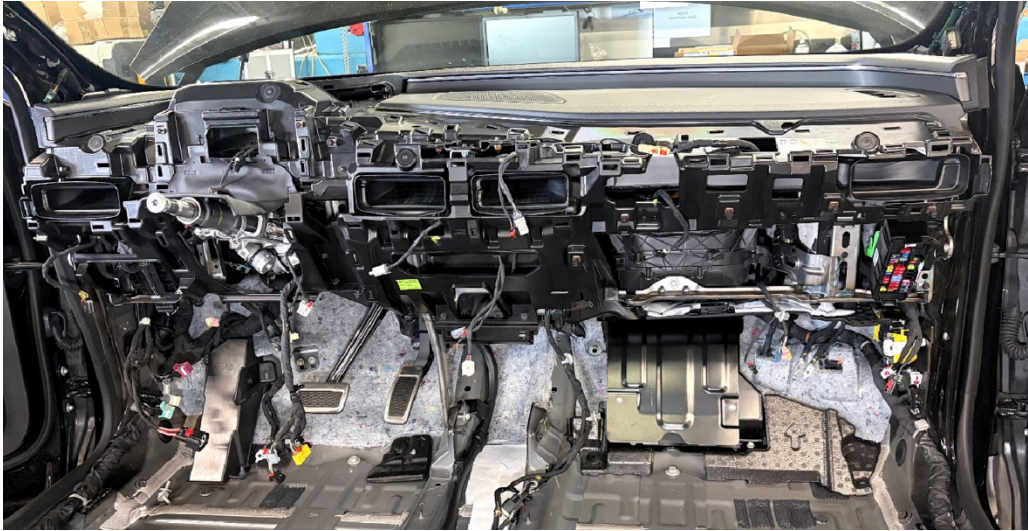
- 17.5 With the aid of an assistant, lift the instrument panel assembly up and rearward to release the assembly off the locating pins, then remove it from the vehicle.

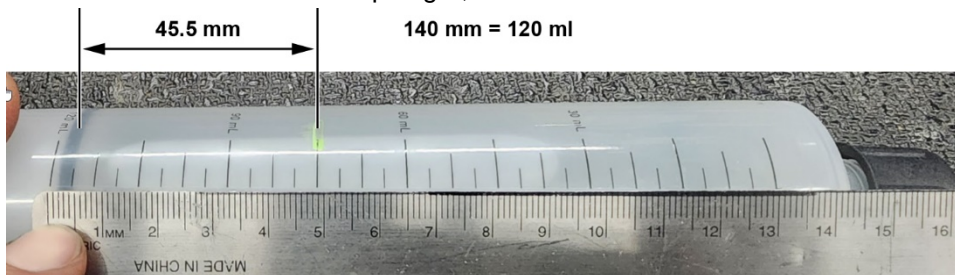
30.2 Current POE bottles do not have level markings to measure fluid. Use an oil injector and calculate how much oil to install.

Example: If the system needs **39 mL (1.32 oz)**, (if your oil measurement is in ounces (oz) convert oz to mL).

- **39 mL x 140 mm = 5460**
- **5460 / 120 mL = 45.5 mm**
- Measure **45.5 mm** from the plunger, which is **39 mL**
