## OM654 Extended engine crank or starting concerns and/or poor running characteristics

Topic number	LI05.30-N-080518
Version	1
Function group	05.30 - Valves
Date	6/3/26
Validity	Model 907 with OM654
Reason for change

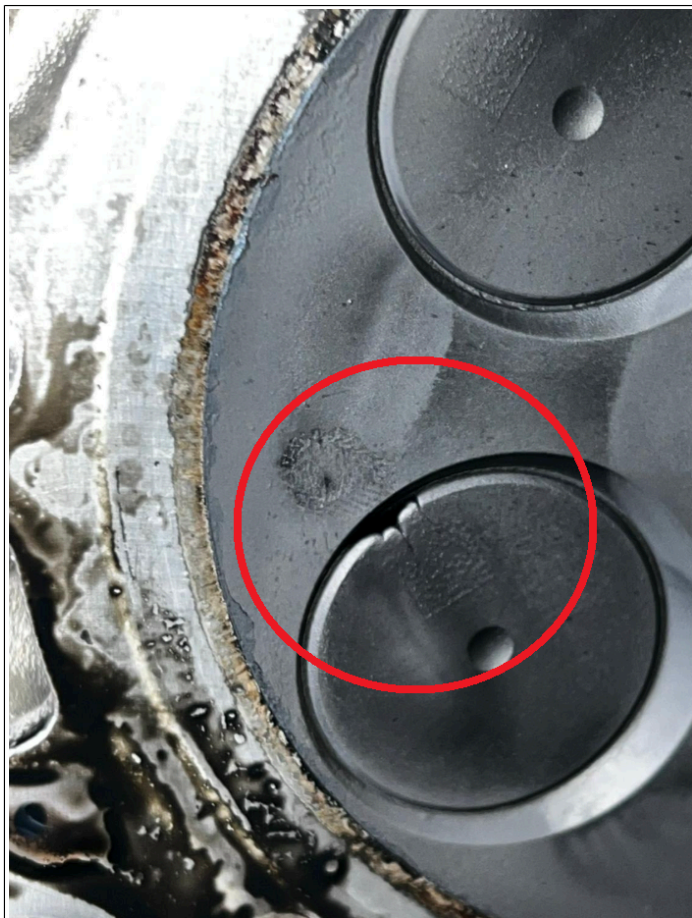
Attachments	
File	Description
<a href="#">Auslassventil undicht.png</a>	Exhaust valve leaking

In some cases, one or more exhaust valves may be leaking due to:

This can result in loss of compression in the affected cylinder(s). Please review the photos in the attachments.

- Replace the complete cylinder head assembly with valves pre-installed

Do not attempt partial repair of affected valves or seats.

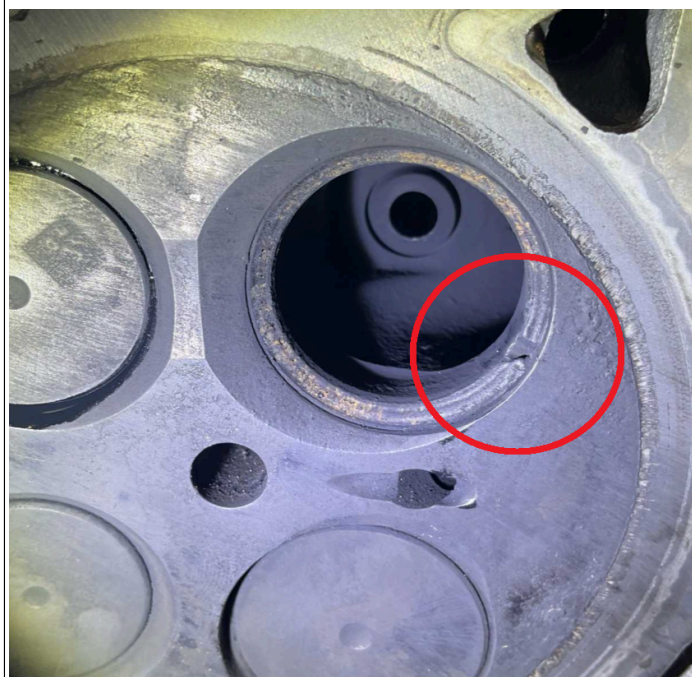
Ventilsitz defekt.png

Valve seat defective

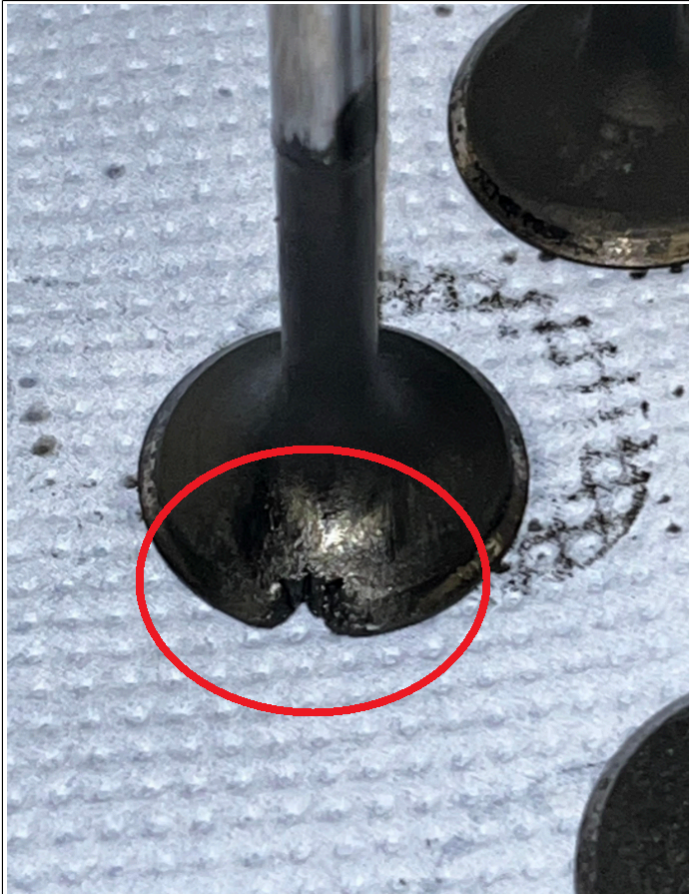
Ventilteller durchgebrannt.png

Burnt valve face

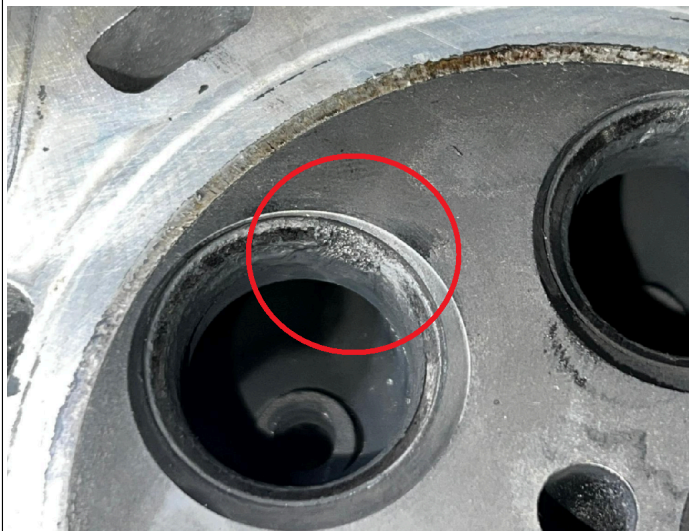
Ventilsitzring durchgebrannt.png

Burnt valve seat ring

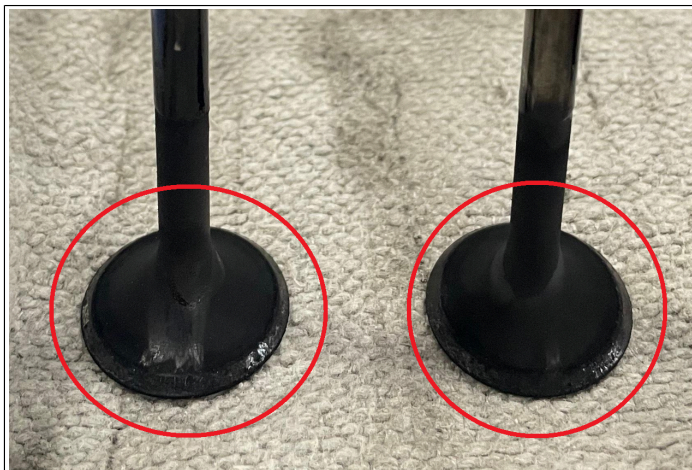
Auslassventile undicht.png

Exhaust valves leaking

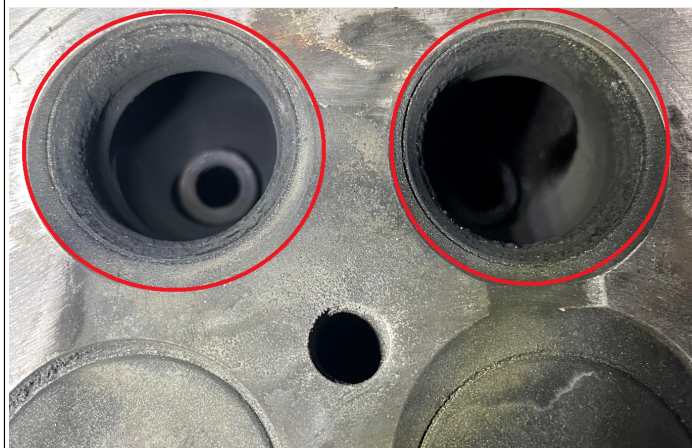
Auslassventilsitz stark verkohlt.png

- Burnt exhaust valve seat rings
- Burnt valve faces
- Heavy carbon buildup on the exhaust valve seat leading to poor sealing

Exhaust valve seat heavily carboned

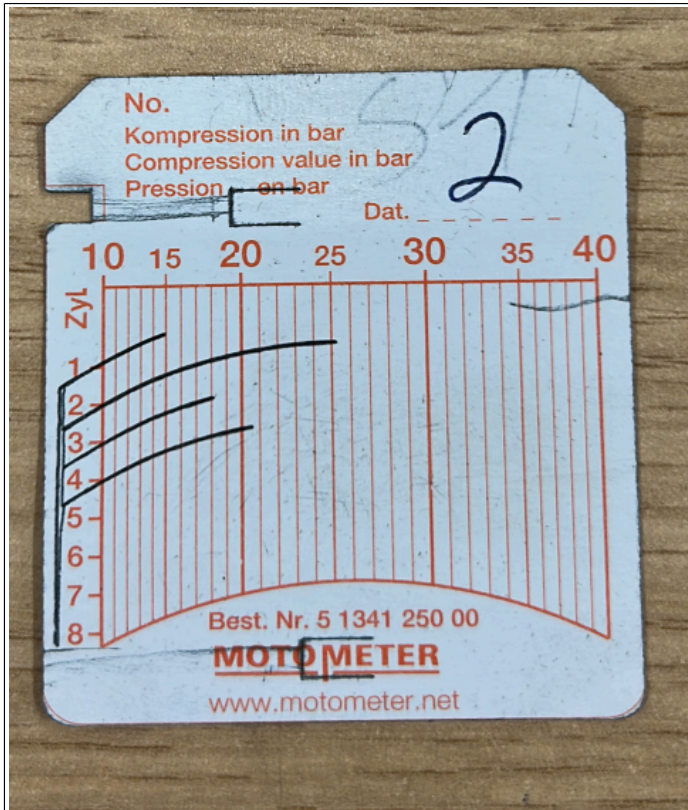
Kompressionsdruckprüfung.png

Compression test

Perform compression test per WIS (engine at operating temperature if possible):

- Manual compression test per WIS doc AR01.00-D-1201TSM
- If compression is out of specification, continue to leak down testing

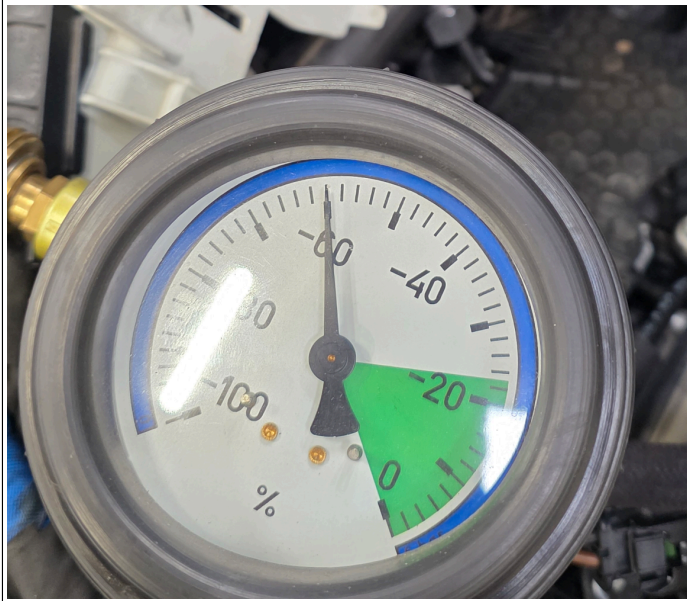
[Druckverlustprüfung.png](#)

Cylinder leak down test

- Perform cylinder leakage test on all cylinders per WIS doc AR01.00-D-1300TSM
- Ensure test equipment is calibrated before testing

- Leakage confirmed through exhaust path → suspect exhaust valve sealing
- Leakage into crankcase → do not proceed; submit TIPS case for further direction
