## Acoustic Warning or message occurring when a closed sliding door is not recognized

Topic number	LI80.20-N-079697
Version	1
Function group	80.20 - Central locking system, interior central locking
Date	6/8/26
Validity	Model series 447, 907  without SA code T55/T50/EL9 electric operation for right sliding door  without SA code T56/T51/EL9 electric operation for left sliding door
Reason for change

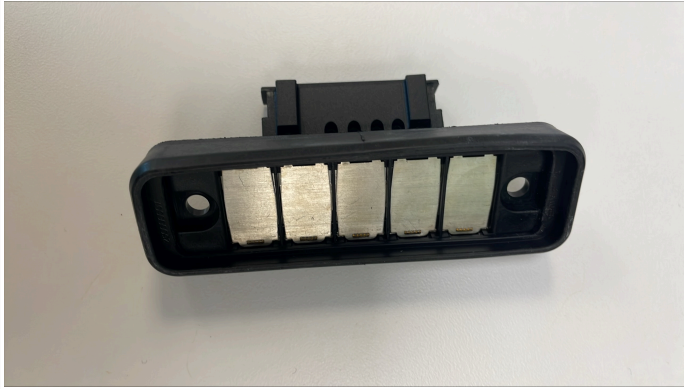
Previous A907 821 31 00.jpg

Attachments	
File	Description
447_907_910_Bilder_Türkontakt.png  	Damaged door contacts caused by corrosion/vibration

- Mechanical damage through bending when loading and unloading
- Worn contact plates --> After detachment of silver plating, the copper plate is corroded
- Movement of sliding door/body when driving --> Contact pins do not always make contact with contact plate --> Central locking system fault message in instrument cluster

In a problem case, replace contact switch for vehicles with +T50/+T55/+EL9 or contact plate with A4478201903.

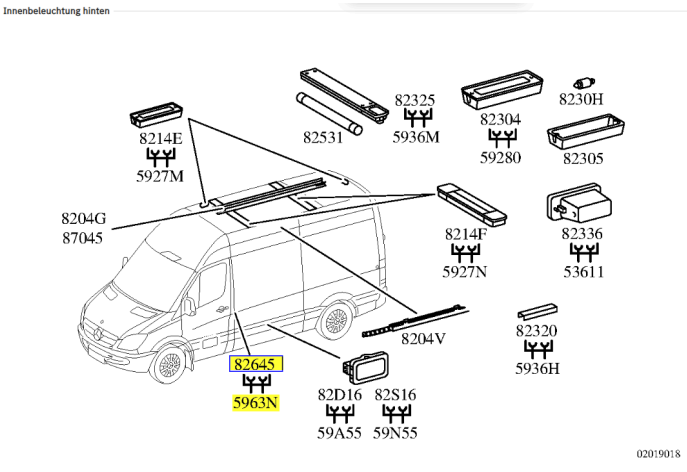
Attachments	
File	Description
<a href="#">907_910_Bilder_SSL.png</a>

Pictures of parts for model series 907/910

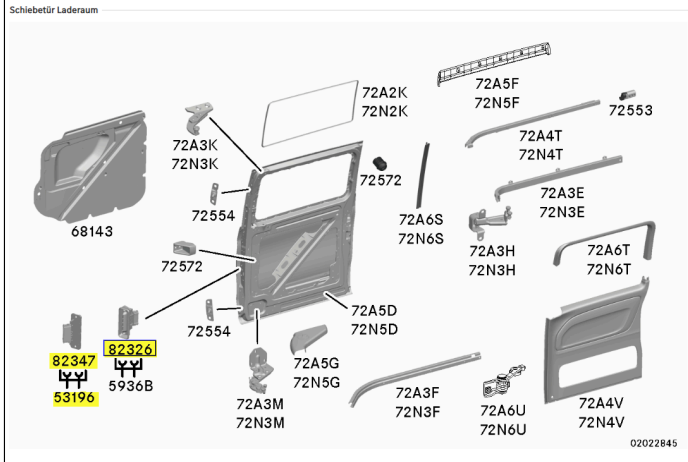
447\_907\_910\_Bilder\_SSL.png

Pictures of parts for model series 447/ 907/910
