SIB 52 03 26

FRONT SEAT BACKREST REAR PANEL DISCOLORATION / HAZE

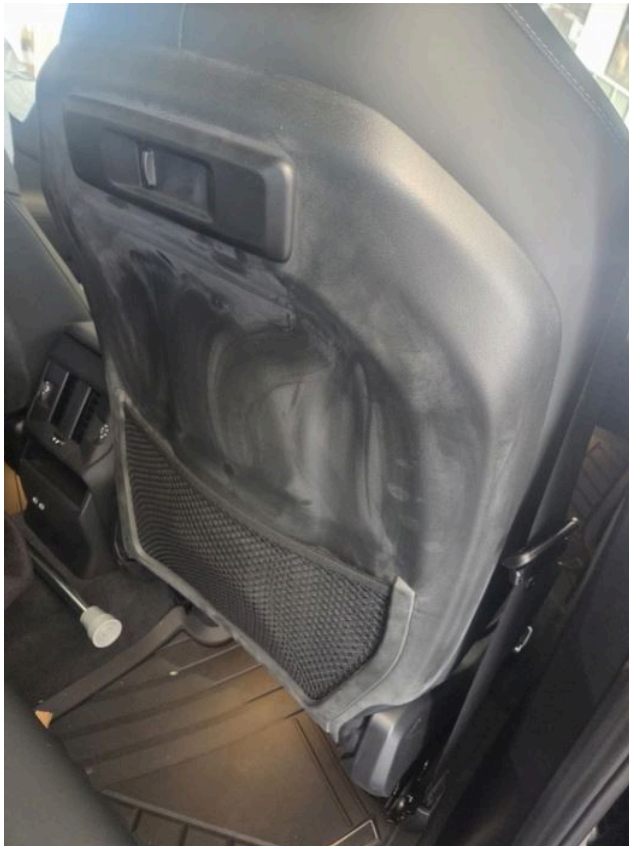
The front seat backrest has a blotchy discolored haze.

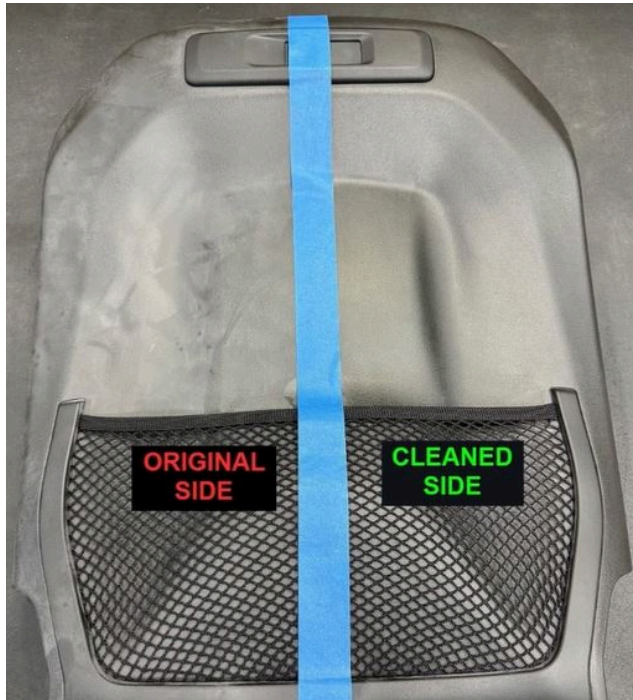
Use a leather cleaner to remove the discoloration on the rear panel(s).

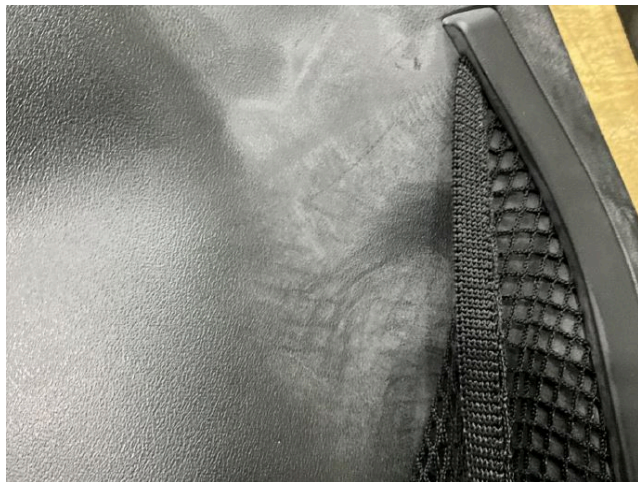
Also clean behind the cargo netting.
