# TECHNICAL UPDATE – TIGER SPORT 660 & TIGER SPORT 800 SCREEN MOUNT ARMS

This notice outlines a potential fitment issue with the screen adjustment arm on all model year Tiger Sport 660 and Tiger Sport 800 models and provides updated installation guidance.

**Models affected:** Tiger Sport 660 (all model years), Tiger Sport 800 (all model years)

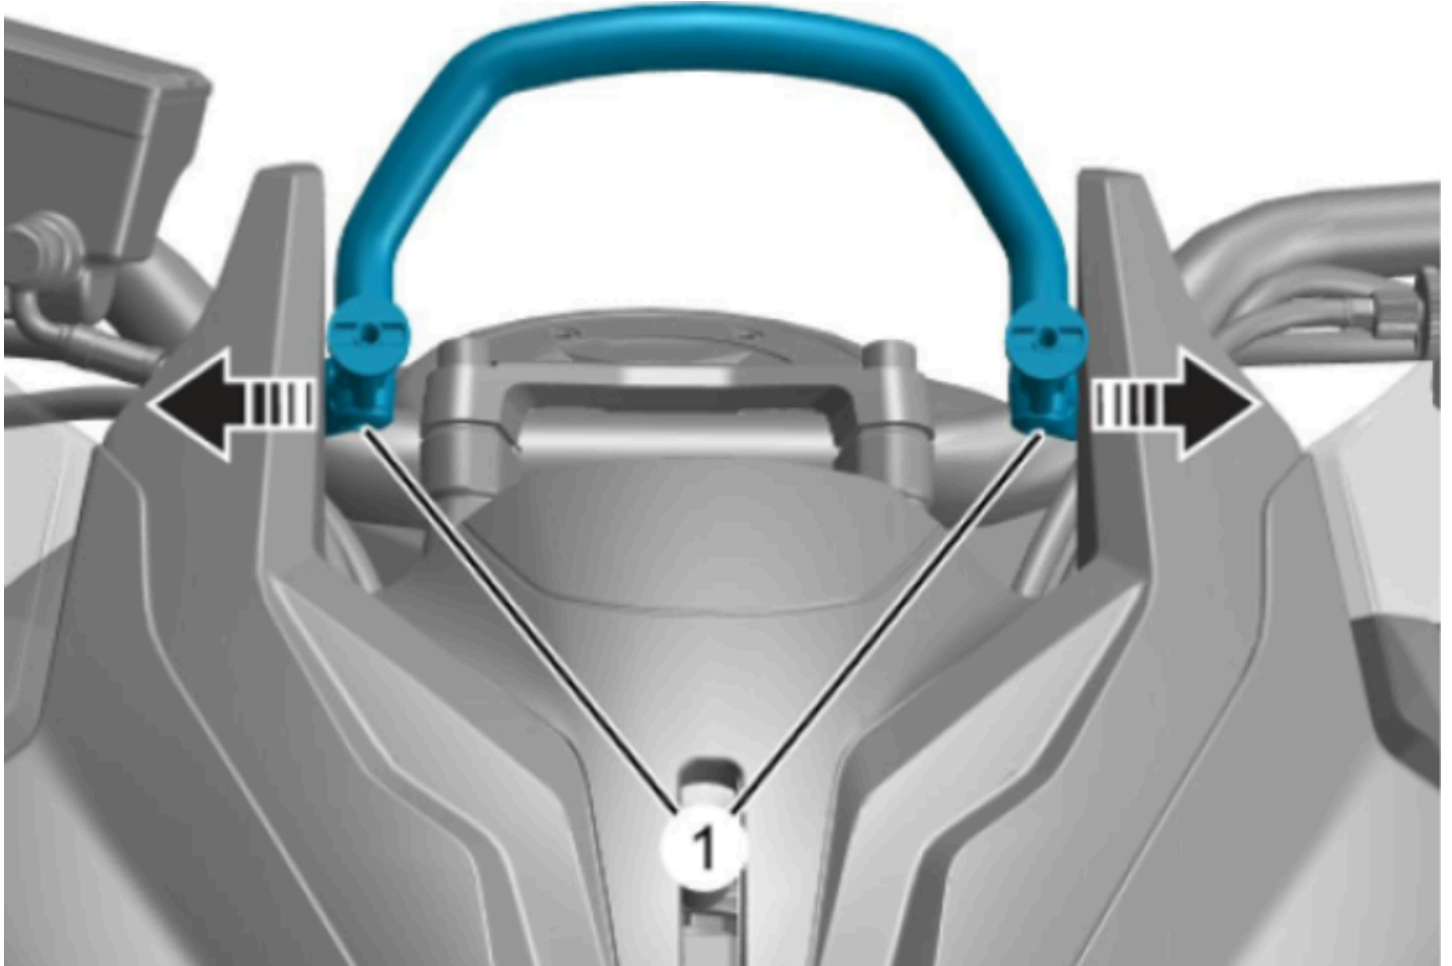
The mounting arm may become damaged during fitment.

The mechanism may immediately become loose or become loose soon after.

Triumph has carried out an investigation into this concern and has found that the method of initial fitment of the assembled screen adjustment arm is the cause.

Dealers are requested to ensure that they apply continuous outwards pressure in the areas indicated below while the mount arms, or complete assembly, are rotated into the final position.
