## Thor Motor Coach Technical Service Bulletin

| TSB # | <b>TSB 26-04</b> | | |
| Description/Title: | Radio fuse | | |
| Affected Product Line(s): | <b>Certain model year</b><br>2025 Eddie Bauer<br>2025-27 Axis<br>2025-27 Vegas | | |

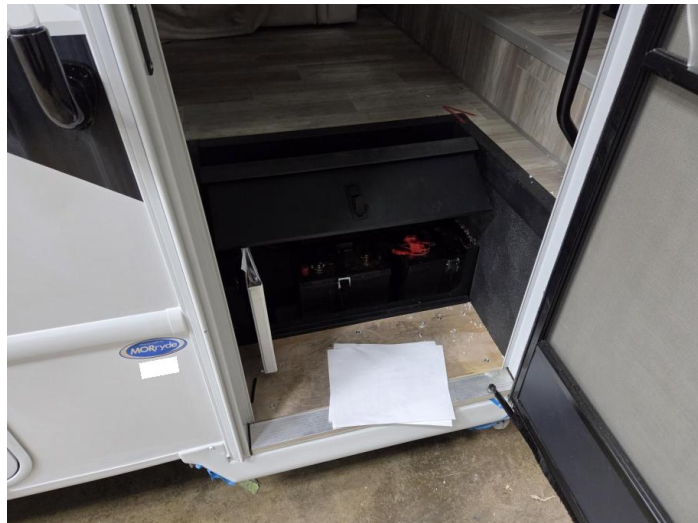
1. Gain access to the house batteries located under the inside stepwell of the entry door.

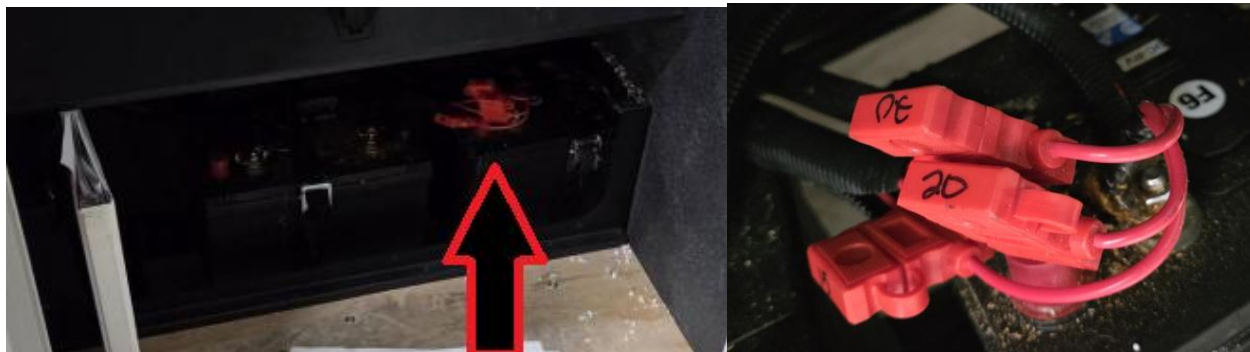
2. Locate the in-line fuses connected to the positive (+) side of the battery.

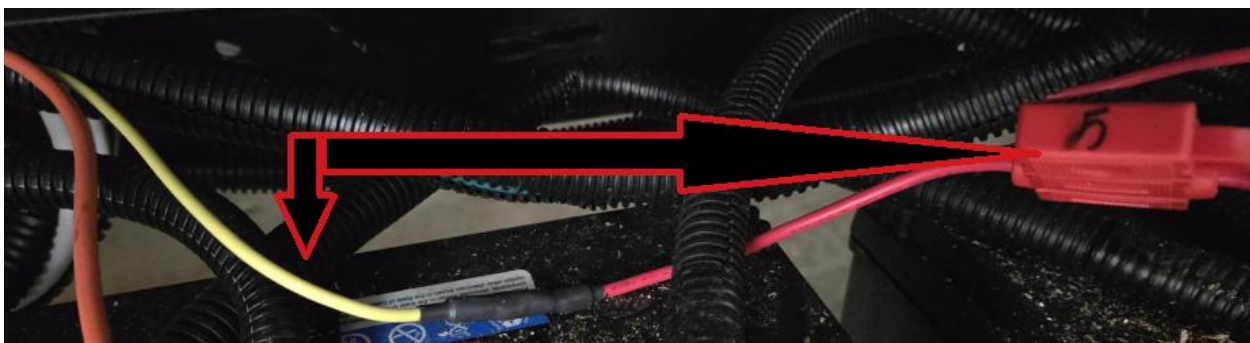
3. The fuse holder labeled '5' will need the 5A fuse changed to a 15A fuse. Verify the wire inside the loom is yellow, which represents the dash radio.

It has been discovered the dash radio in-line fuse was installed with the incorrect fuse size. Production installed a 5A fuse when it should be a 15A fuse. The undersized fuse greatly reduces the surge allowance during normal operation. The wire for the dash radio is 14 gauge and is compatible with a 15A fuse.

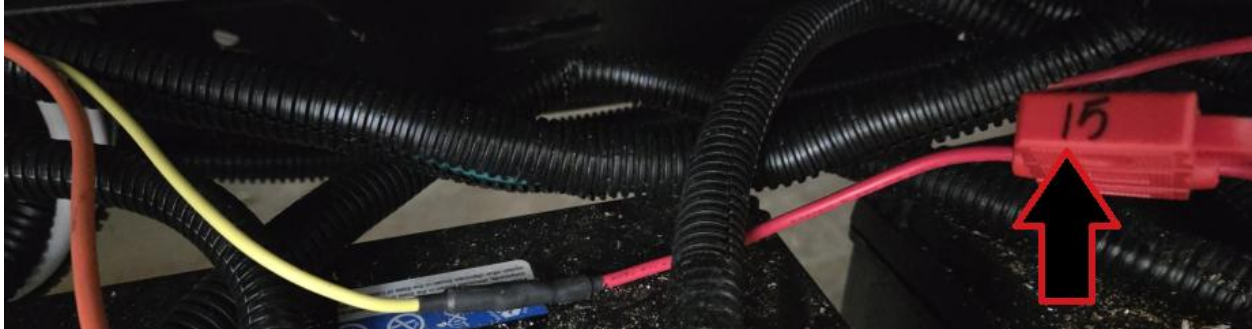
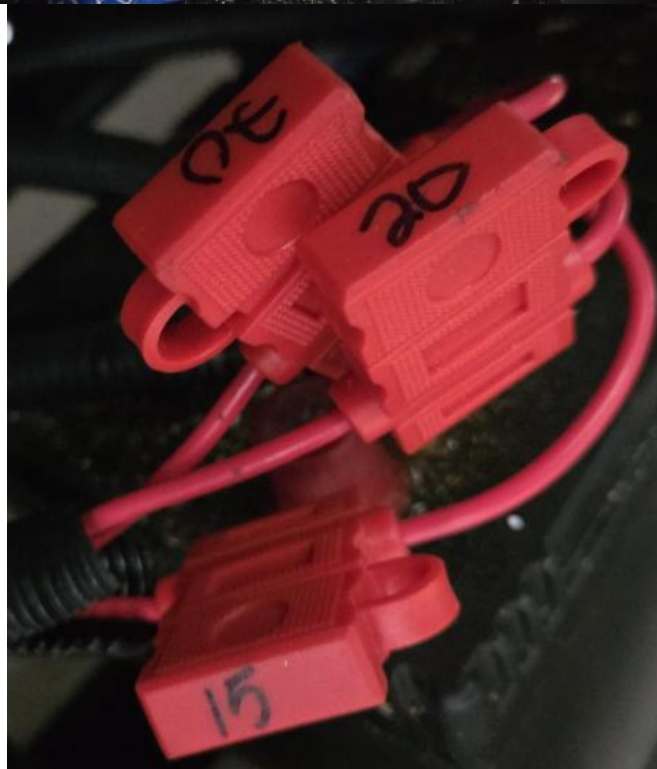
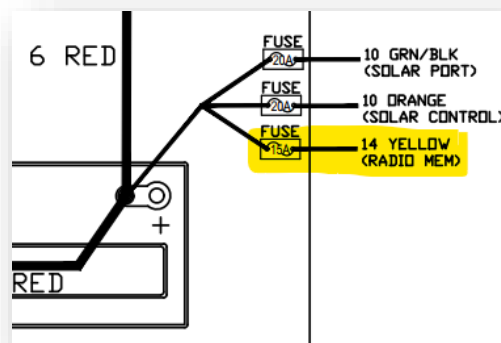
4. Once the fuse has been changed to 15A, add a '1' before the '5'.
