Technical Service Bulletin: TSB250167

TRP #5819 C1000D6RE Cooling Package Assembly Replacement

- C1000D6RE

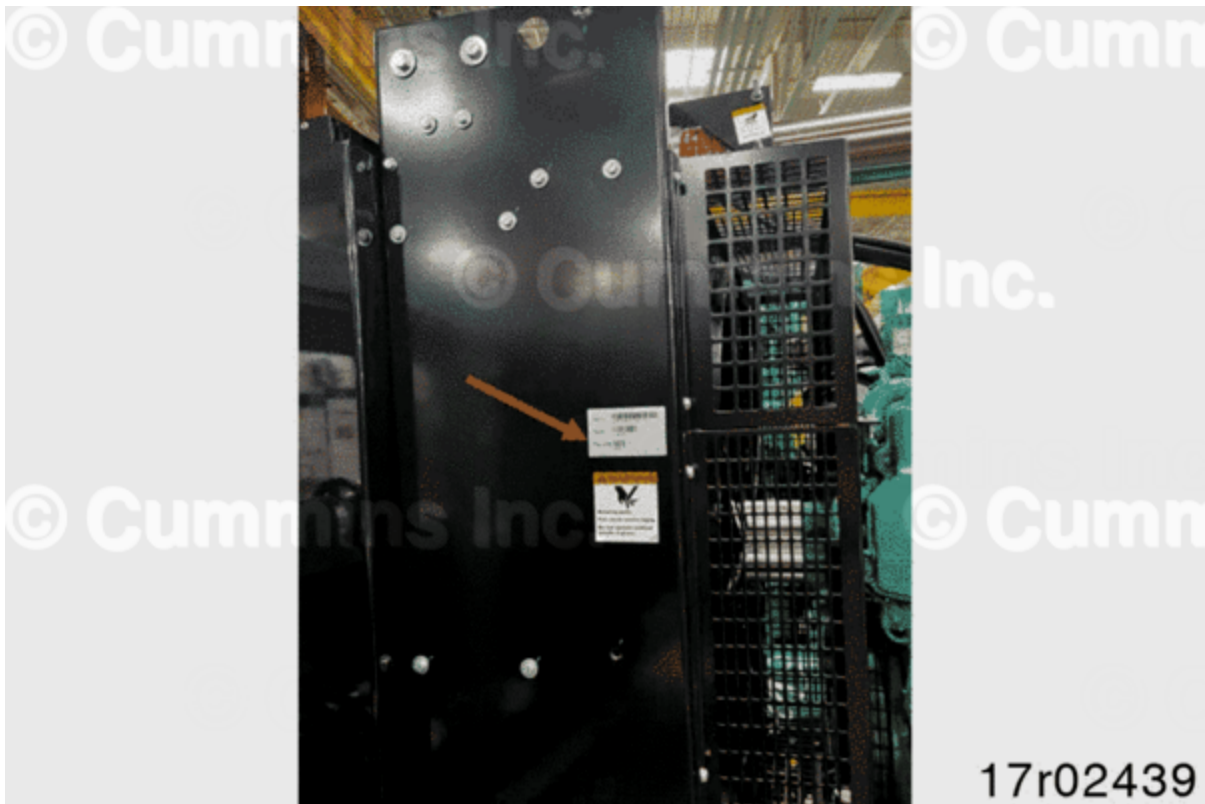
Figure 1, A068H458, A076T598, A077Y449, A079J255 and A079N739 Part Number Location

**Note:** This TRP **only** covers radiator core failures on cooling package, part numbers A068H458, A079J255 and A079N739. See Figure 1 for part number location on side of cooling package frame.

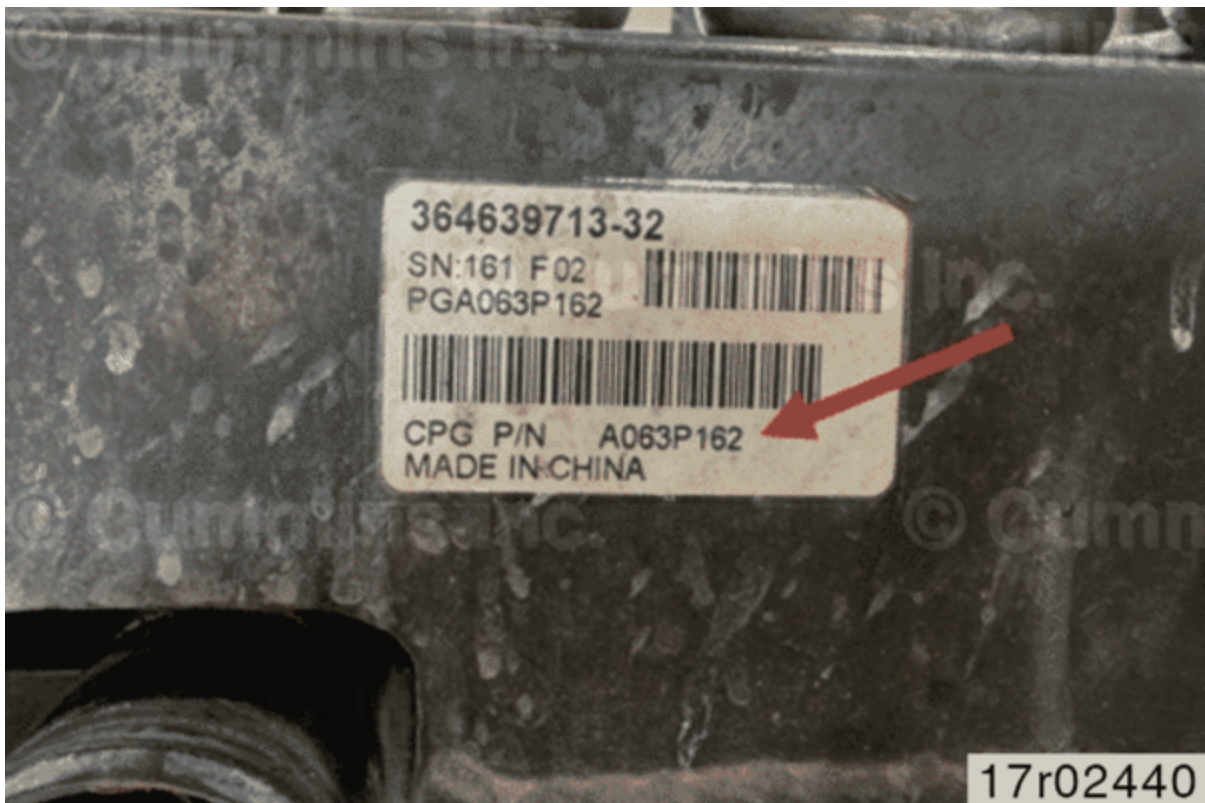
Figure 2, A063P162 Part Number Location, Not Covered in the TRP

Radiator core failures on cooling package part number A063P162 are **not** covered in the TRP. See Figure 2 for part number location on upper tank by upper radiator hose for Part Number A063P162

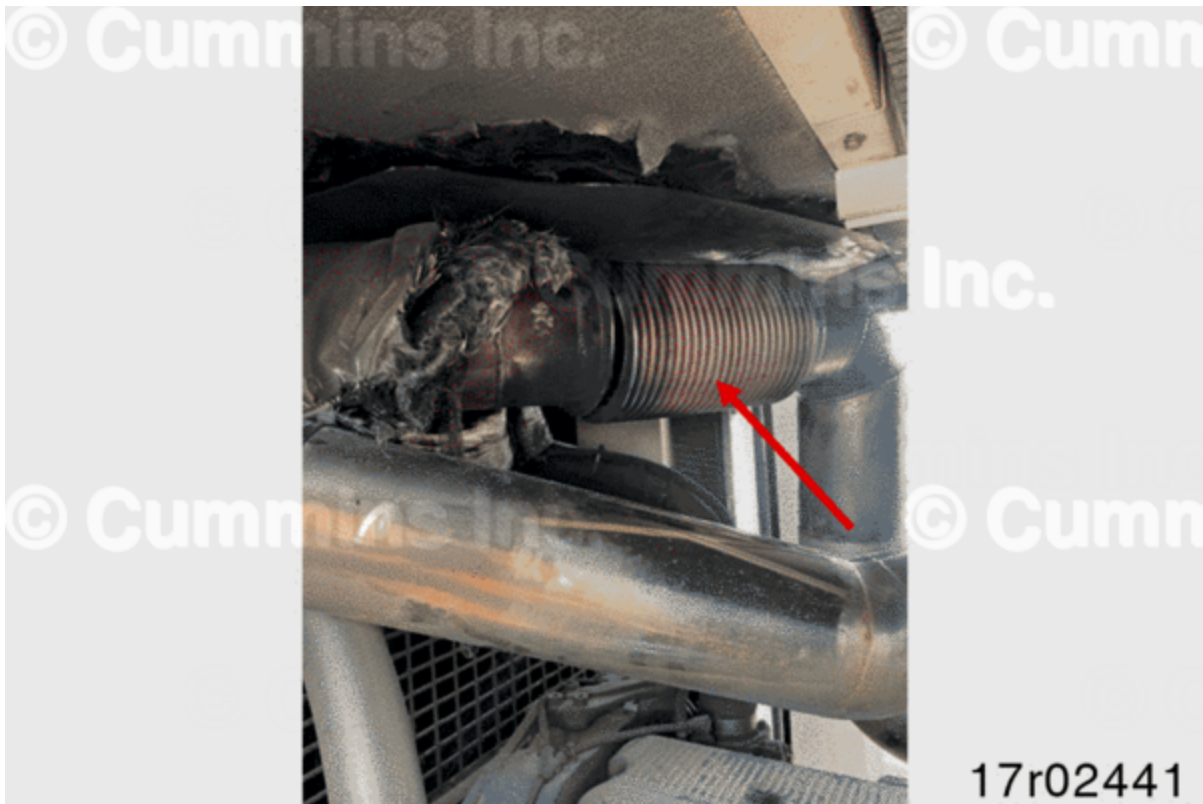
Figure 3, Old-Style Failed Bellow

**Note:** A revised exhaust bellow kit has also been released. If the unit experiencing the radiator failure has the old style bellow pictured below in Figure 3, the revised bellow kit, should also be ordered and replaced at the time of radiator package replacement. See Service Parts Availability section for part ordering information.

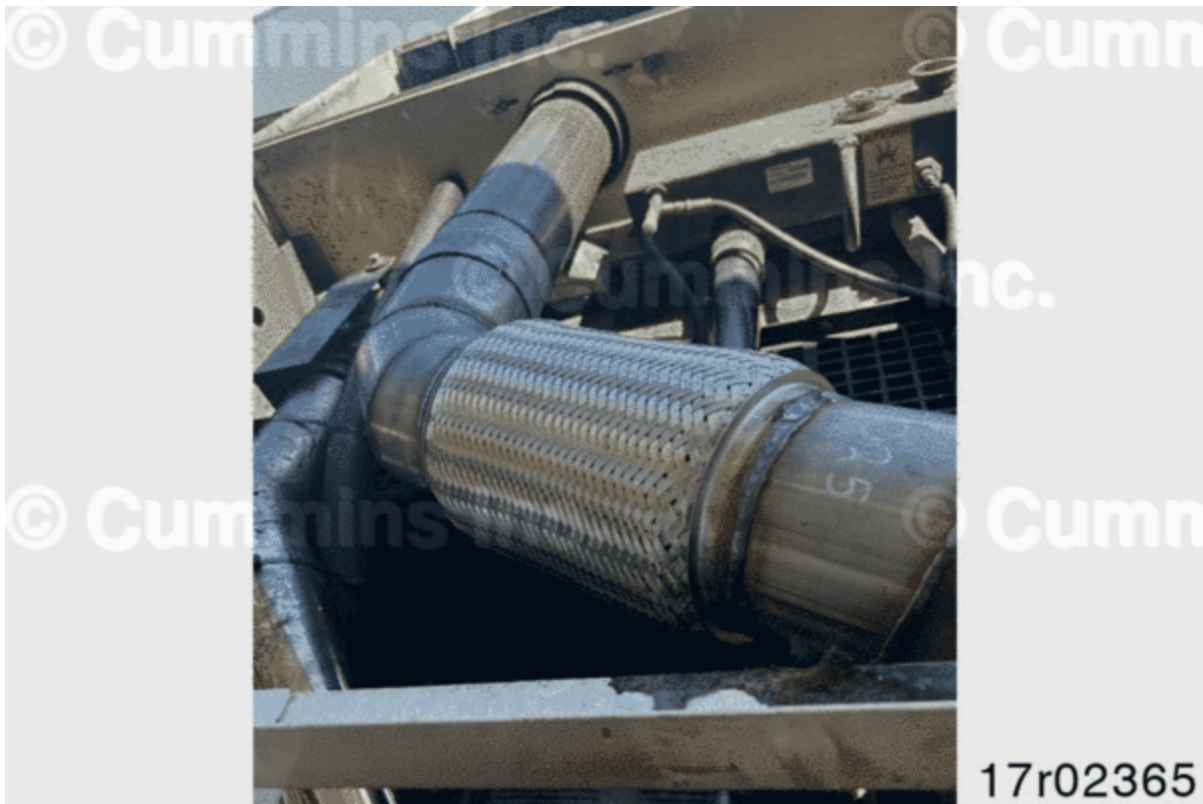
Figure 4, Revised Exhaust Bellow

\*Exhaust bellow kit is to be ordered from Girtz Industries. Refer to TSB220216 for related part numbers and ordering process.
