**Complaint Regarding the Camera View (Real Top View) in the PCM Central Display (03/26)**

Model Line: **Cayenne (9YA / 9YB)**

Equipment: **ParkAssist incl. Surround View (M-no. KA6)**

Concerns: **Signal lines and plug contacts for the Real Top View cameras**

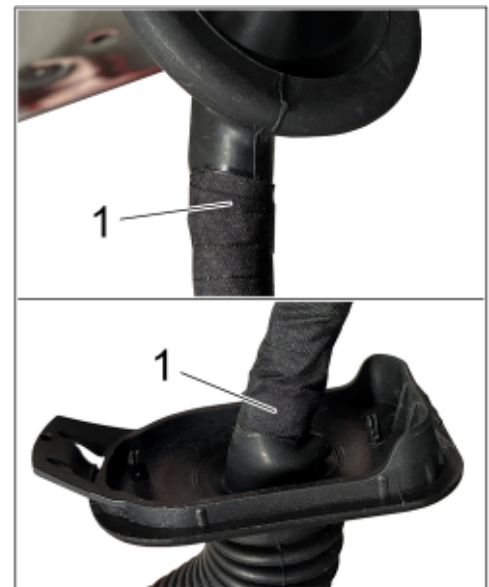
*Electric door wire harness, front*

- 6 Remove fabric tape from the grommets ⇒ *Electric door wire harness, front -1-*.

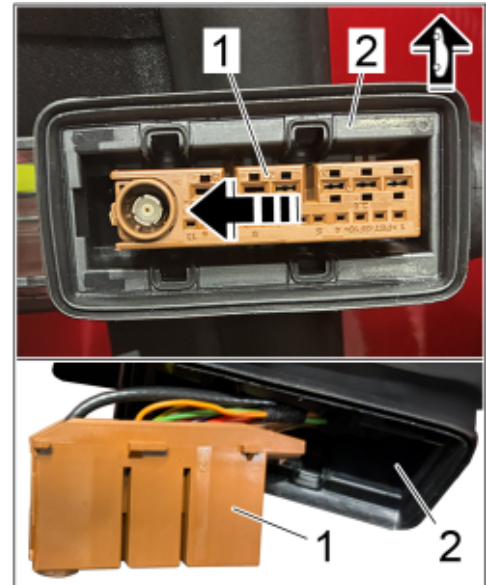
- 9 Release connector housing for door connection point  
 ⇒ Connector housing for door connection point -1- in  
 ⇒ Connector housing for door connection point -**Arrow direction**- and pull it out of the mounting housing ⇒  
 Connector housing for door connection point -2-.

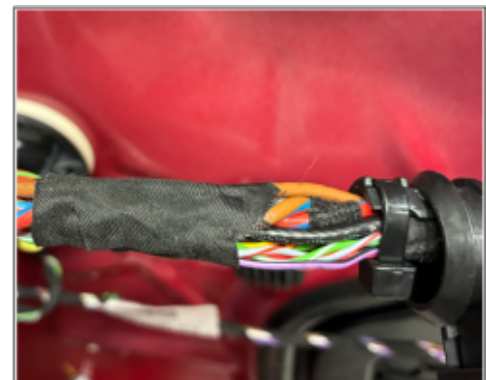
If fabric tape has been opened or removed from the electric wire harness in the area below the grommet, re-attach it.  
⇒ *Fabric tape*

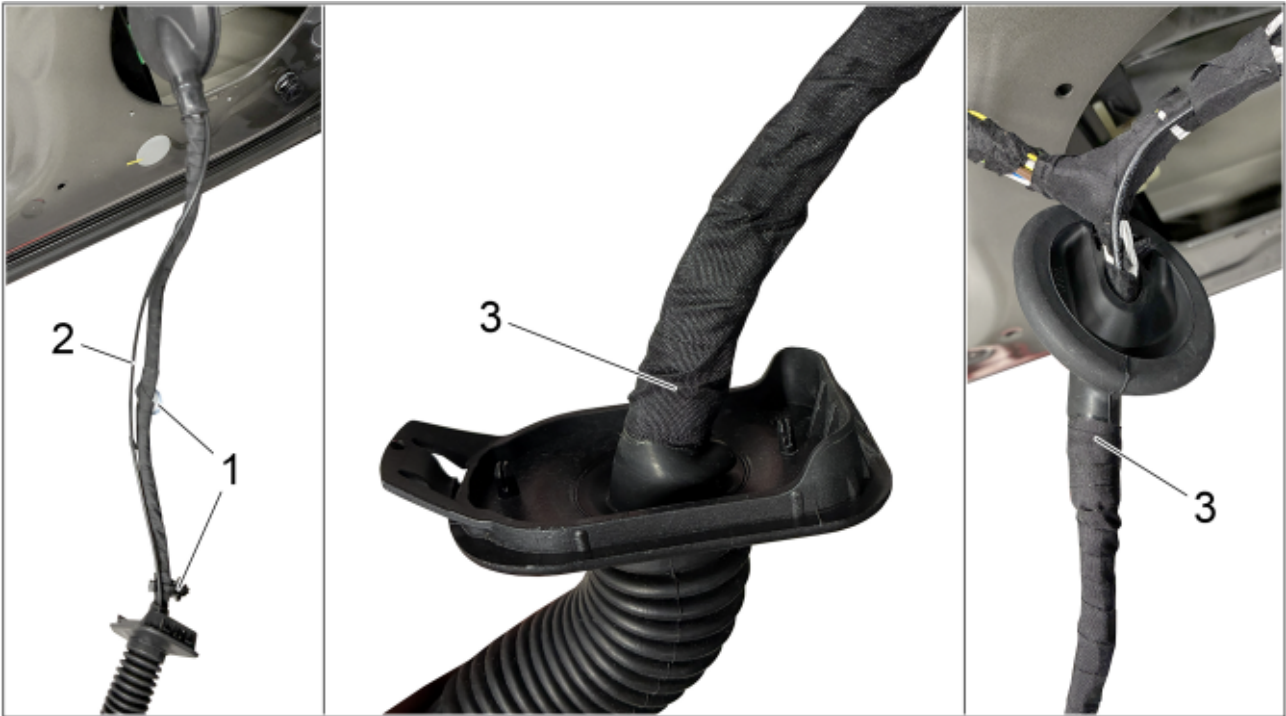
Electric door wire harness, front

- 14 Open cable holder ⇒ *Electric door wire harness, front -1-* and wrap the signal line tightly around the wire harness ⇒ *Electric door wire harness, front -2-* using fabric tape. Then wrap the grommets tightly with ⇒ *Electric door wire harness, front -3-* fabric tape again to the wire harness and ⇒ *Electric door wire harness, front -1-* fit the cable holders. Ensure that no moisture can penetrate into the wire harness.

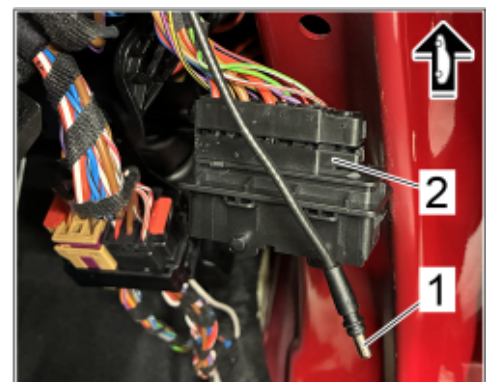
*Signal line for door connection point*

- 4 Release plug contact of the signal line ⇒ *Signal line for door connection point -1-*, pull ⇒ *Signal line for door connection point -2-* it out of the connector housing and replace it with a **new** plug contact.  
For work procedure, see: ⇒ *Workshop Manual '912841C8 Repairing antenna cable'*
- 5 Install electric plug connection for vehicle-side door connection point.
