## Technical Service Bulletin

Transaction No.: **2082445/1**

90 Panoramic display: partial failure of display, crack in display

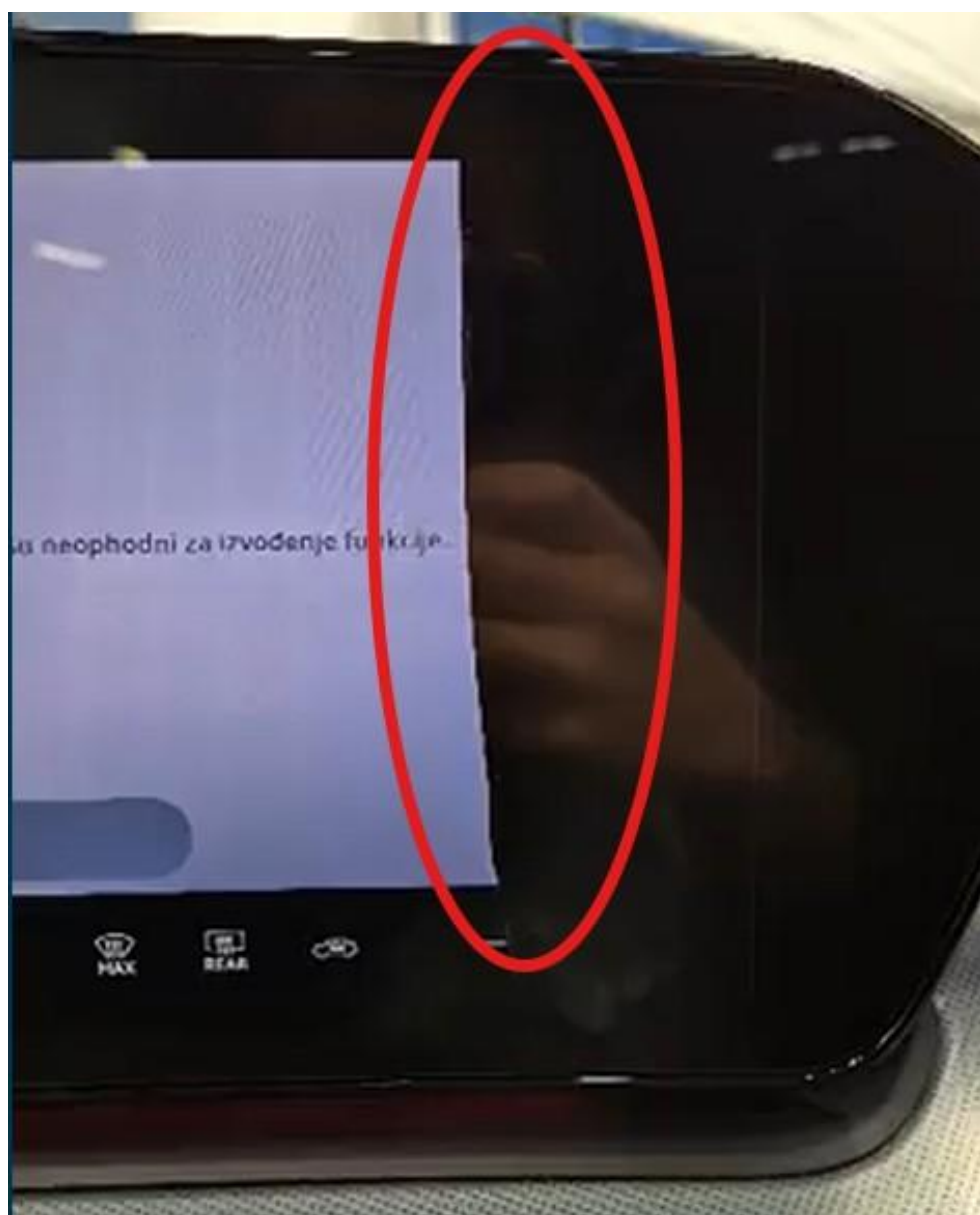
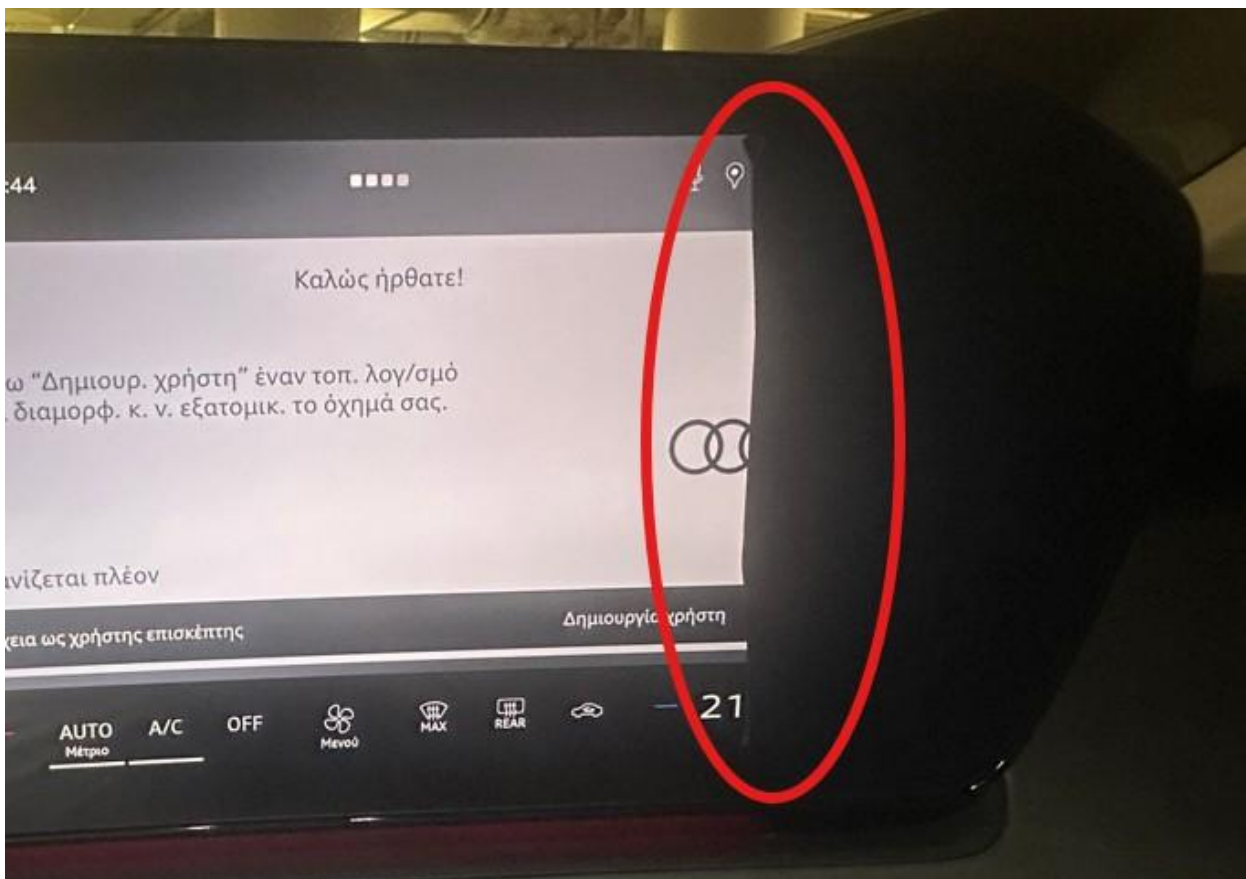
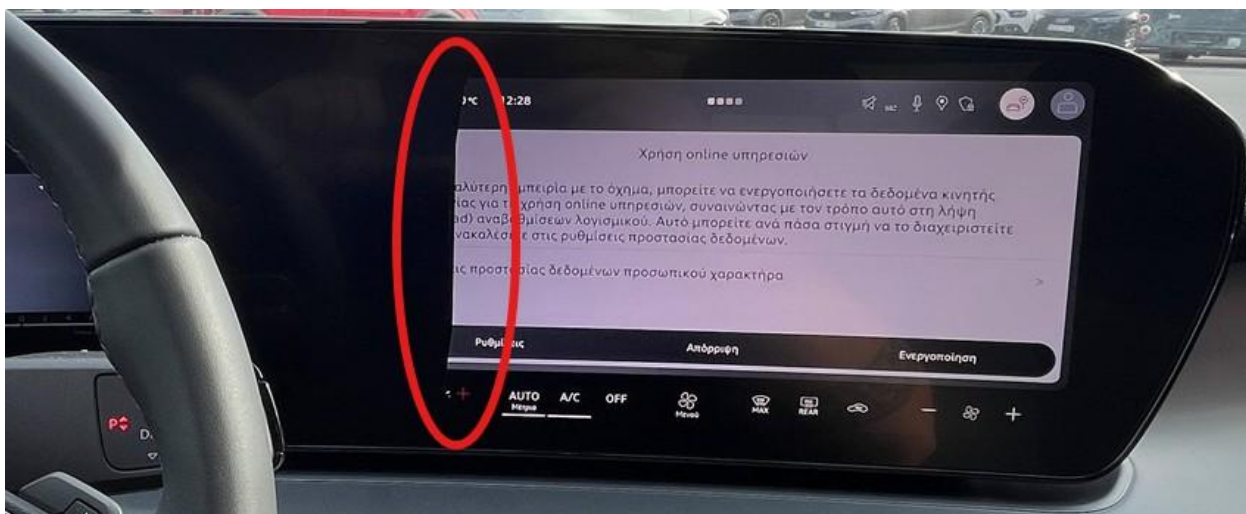
There is an area along a vertical line which is displayed incorrectly or not displayed at all (refer to red ovals in example photos).

Sometimes a crack can be seen in the display.

The following photos show possible examples of complaints.

Please replace the panoramic display.
