# Service Bulletin

Bulletin No.: PIC6654

**Subject:** Blank Head Up Display (HUD) Screen

| Brand: | Model: | Model Year: | | VIN: | | Engine: | Transmission: |
|---|---|---|---|---|---|---|---|
| Chevrolet | Corvette | 2027 | | All | All | All | All |

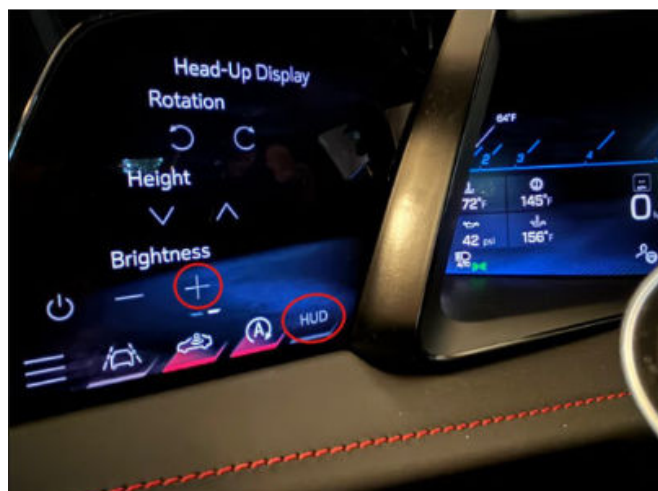
7162922

| <b>Condition</b> | Some customers may notice a blank Head-Up Display (HUD) on the windshield that does not recover. He or she may comment that it is simply inoperative or appears to be broken. |
| <b>Cause</b> | Engineering is currently investigating an anomaly in the radio system that affects how the previously selected HUD brightness level is stored and retained across ignition cycles. |

Using the HUD control panel in the outboard auxiliary display screen, located to the left of the main IPC screen, swipe left to access the HUD controls, then tap the brightness "up" button until the HUD image reappears.

Do not replace the HUD or Radio (Vehicle Control Unit) for this condition, as it will not permanently solve the problem. Engineering is investigating the concern. In the meantime, please advise the customer that they may continue to drive the vehicle. The PI will be updated or replaced with a TSB once a determination has been made.
