Mitsubishi Motors North America, Inc.

## TECHNICAL SERVICE BULLETIN

### **ABNORMAL NOISE/VIBRATION FROM THE REAR DIFFERENTIAL ASSEMBLY**

No: TSB-25-27-001

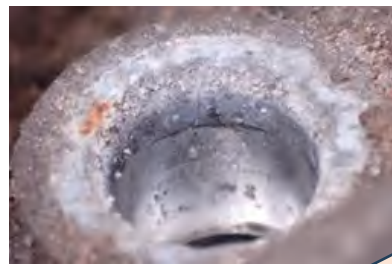
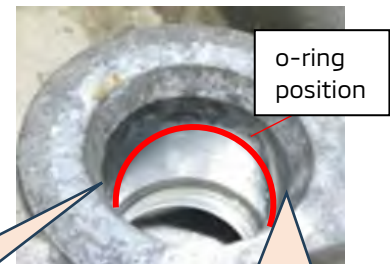
2. Clean around the coupling to prevent contaminants from entering coupling before removing the old breather pipe. To avoid damage from occurring on the insertion hole during cleaning, sand the metal tip down on the nylon brush.
3. Remove the old breather pipe from differential carrier.
4. Clean insertion hole with nylon brush and parts cleaner in a way not to damage the insertion hole of differential carrier breather.

※Clean the area above the red line (o-ring position) so that the o-ring is not damaged when installing the breather pipe.

※Be careful not to damage the o-ring position as this may result in water intrusion.

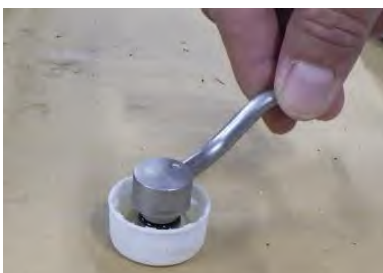
5. Install the new breather pipe:
  - a. Apply coupling oil to the insertion hole of differential carrier breather so that the o-ring can be smoothly inserted.
  - b. Fill the container cap of the bottle with coupling oil, dip the breather pipe with o-ring in the container to apply coupling oil all around the o-ring.
