**Technical Service Bulletin (TSB)**  
**Coolant Leak at Right Rear of Vehicle**

| REFERENCE: | TSB: 07-003-26<br>GROUP: 07 - Cooling | Date: | June 30, 2026 | REVISION: | — |
| VEHICLES AFFECTED: | 2026 (RU) Chrysler Pacifica / Voyager<br>This bulletin applies to vehicles built on or after January 19, 2026 (MDH 0119XX) and on or before March 13, 2026 (MDH 0313XX) equipped with a 3.6L V6 24V VVT Engine UPG 1 W/ESS (Sales Code ERC). | | | MARKET APPLICABILITY:<br><div><input checked="" type="checkbox"/> NA<input type="checkbox"/> MEA</div> <div><input type="checkbox"/> EE<input type="checkbox"/> IAP</div> <div><input type="checkbox"/> SA<input type="checkbox"/> CH</div><br><b>NOTE:</b> This bulletin applies to North America markets. | |

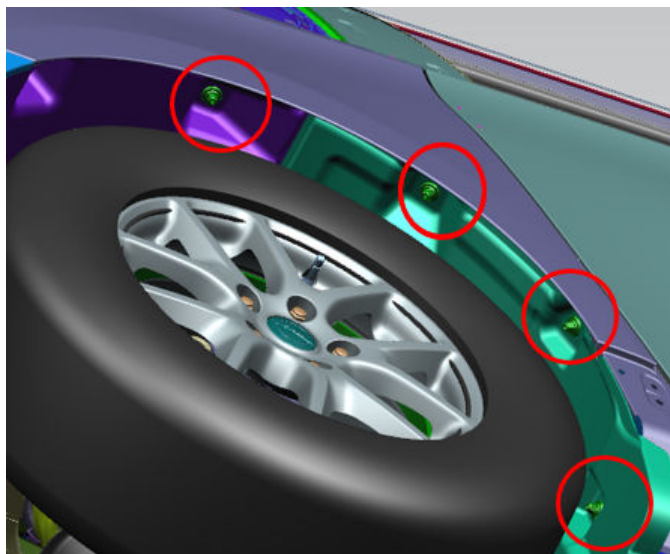
**Fig. 1**  
Wheel Splash Shield Fasteners

1. Raise and properly support the vehicle. Refer to the detailed service procedures available in DealerCONNECT/Service Library under: Service Info> 04 - Vehicle Quick Reference / Hoisting / Standard Procedure.
2. Remove four of the right rear wheel splash shield fasteners outlined in [Fig. 1](#).

8. Start the engine and let the engine warm up to operating temperature.
9. Top off the coolant system as needed.
10. Reposition the right rear wheel liner for installation.
11. Install the four removed right rear wheel splash shield fasteners outlined in [Fig. 1](#) and tighten the fasteners to 2.6 N·m (23 in. lbs.).
12. Lower the vehicle and remove from the hoist.

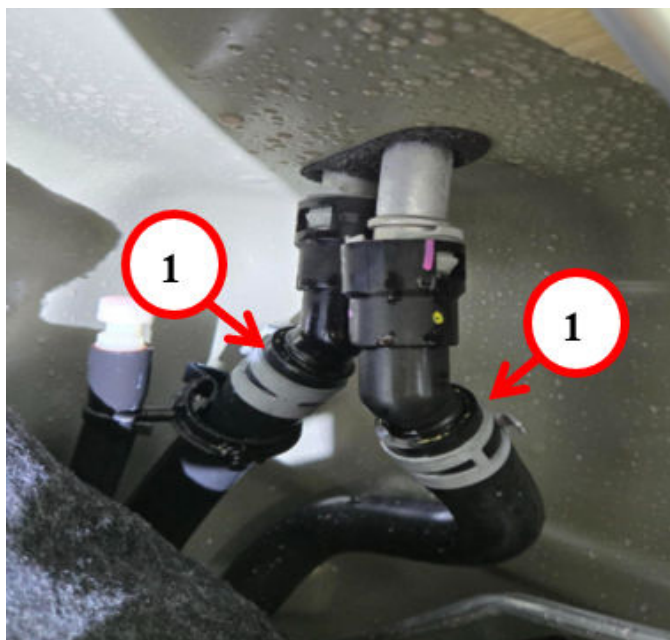
**Fig. 2**  
Rear Coolant Hoses

3. Reposition the right rear wheel splash shield aside to expose the two coolant hoses connecting to the rear heater core [Fig. 2](#).

1 - Rear Coolant Hoses Connecting To Heater Core

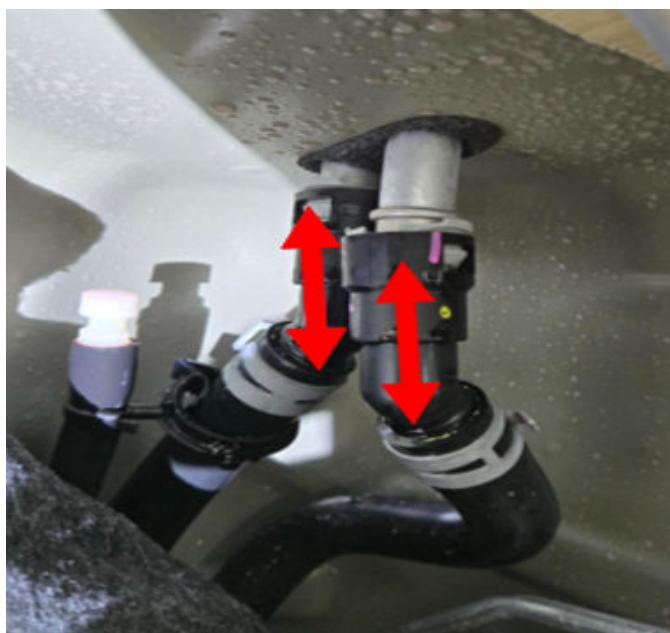
**Fig. 3**  
Rear Coolant Hose Inspection

| CAUSE: | Coolant leak at the rear heater core quick connects | | | | |

4. Perform a push pull push on both rear core coolant hoses while inspecting the coolant hose quick disconnects to the rear heater core [Fig. 3](#).

5. Is each rear coolant hose securely connected to the rear heater core?
  - YES>>> Use Inspection LOP (24-46-18-91) to close the active RSU and proceed to [Step 10](#).
  - NO>>> Proceed to [Step 6](#).
6. Secure the rear coolant hose quick disconnect fitting(s) to the rear heater core.
7. Perform a push pull push on the rear coolant hoses to confirm they are securely attached to the rear heater core.
