# Service Bulletin

Bulletin No.: PIT5855K

**Subject:** Heated and Ventilated Seats Inoperative

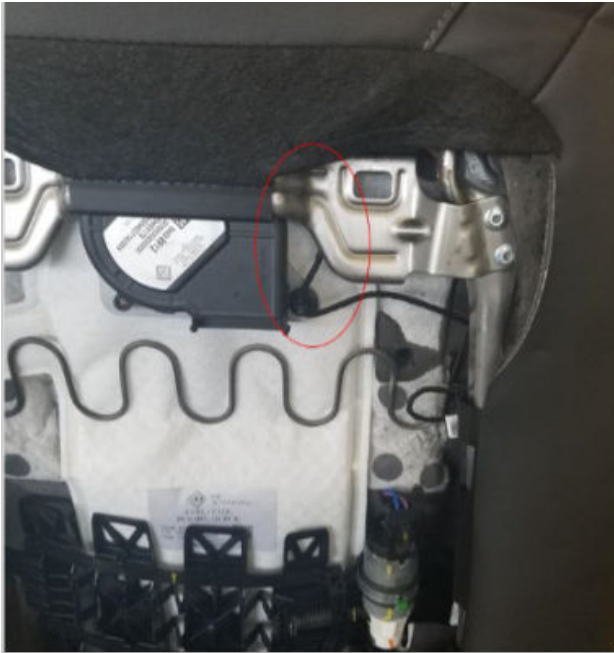
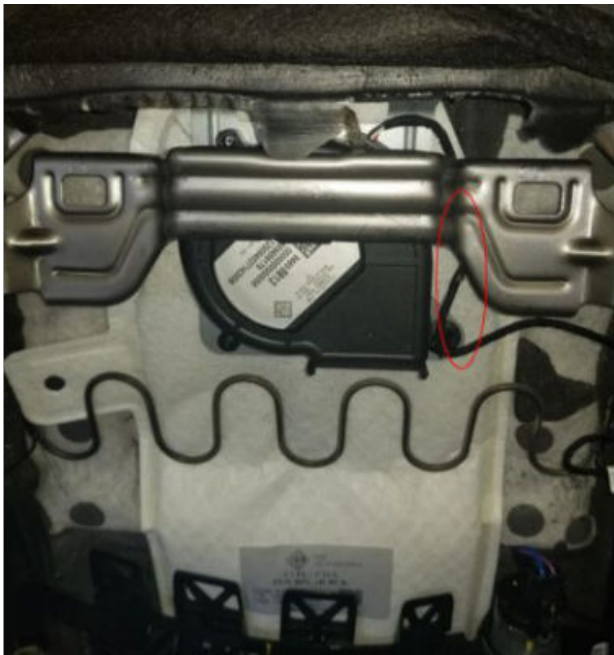
Inspect the harness in the seat back for chaffing.

The most likely areas are shown in the photos below, but there could be contact with the harness causing damage anywhere in the seat back.

Repair the damaged circuits following the correct procedure in SI for wire and connector repair.

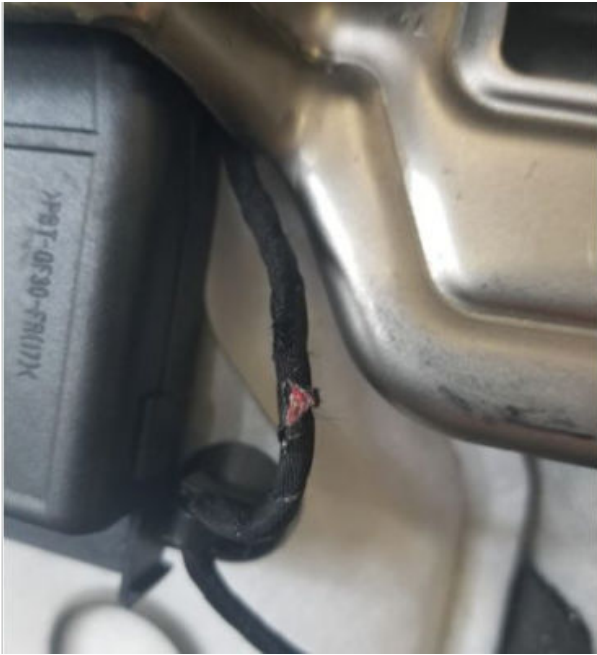
The harness may need to be moved to see the area that is damaged.

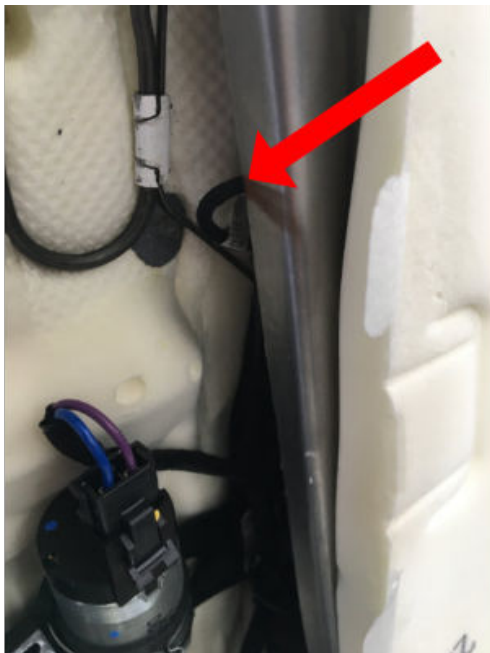
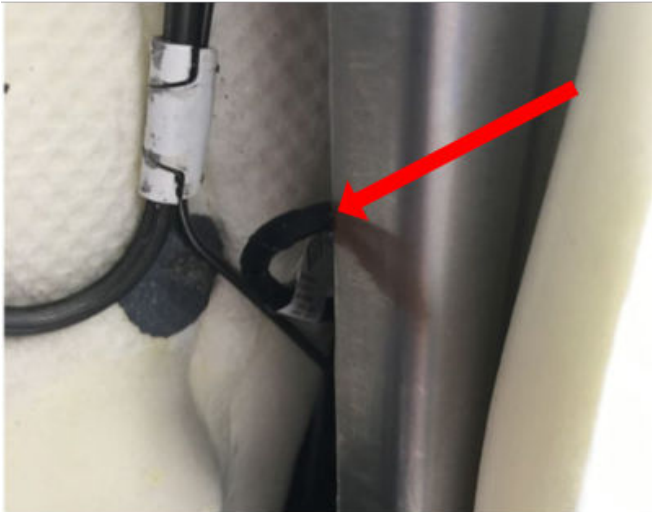
If no damage is found in this area, also inspect the harness along the side of the seat frame as shown in the two photos below.
