Subject: UPDATE: N262546590-01– Special Coverage  
Radiator Inlet Hose Leak  
Additional Vehicles Added

Models: 2025-2026 Buick Enclave  
2024-2026 Chevrolet Traverse  
2023-2026 Chevrolet Colorado  
2023-2026 GMC Canyon  
2024-2026 GMC Acadia

## N262546590 Radiator Inlet Hose Leak

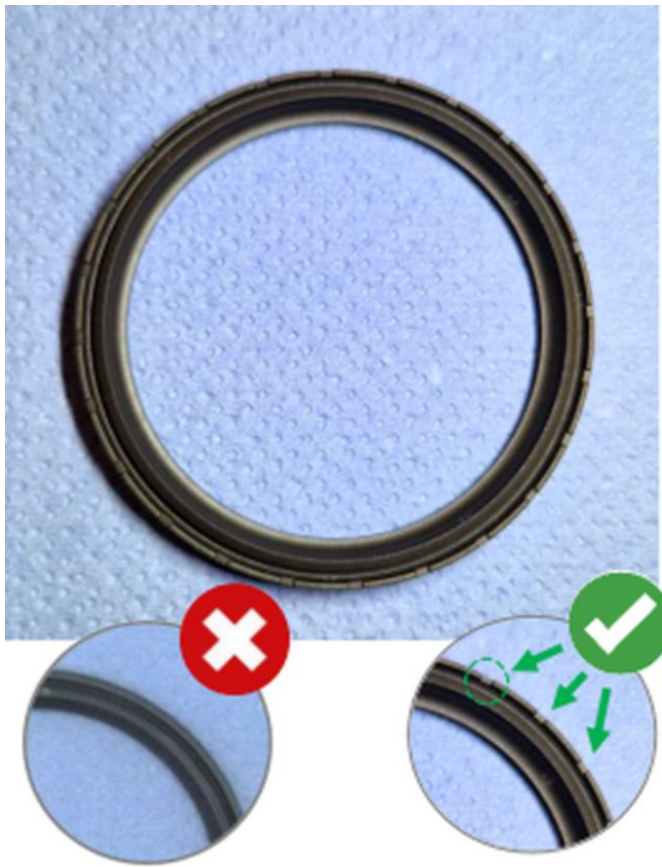
7027342

**Important:** Do not use any sharp or metallic tools to remove the old seal to prevent damage to the sealing groove.

4. Remove and discard the old seal from both ends of the quick connect.

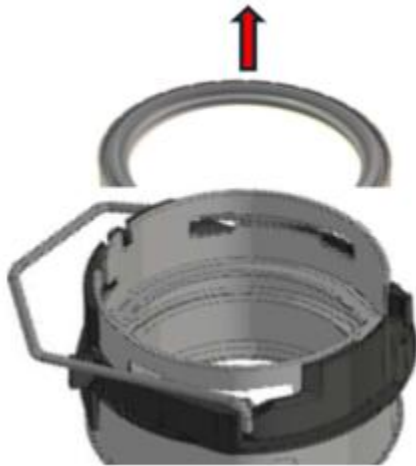
7027326

6. Before installing the new seal, ensure the correct orientation of the seal by locating the notched side of the seal.
  - The notched side should be pointing to the outside open end of the hose.

**Note:** If the seal is installed upside-down, you will not be able to fully seat the hose's quick connect onto the radiator and engine.

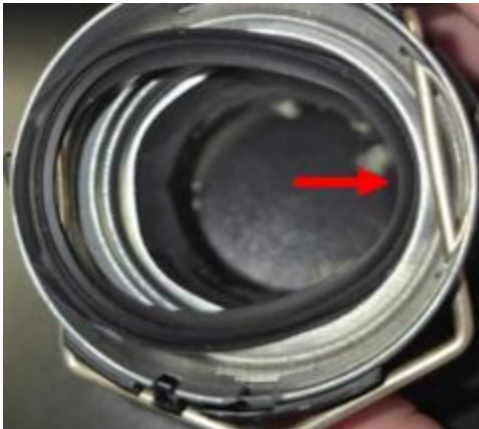
7027327

7. With the seal properly oriented, insert the seal into the groove on one side of the connector and hold it in the groove with your thumb.

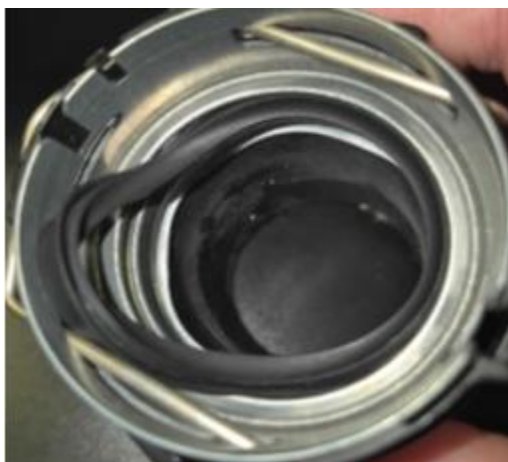
7027238

8. Grab the loop of the seal with your other hand while still holding with your thumb and insert the seal further into the groove to fill at least three-fourths of the groove with the seal.
  - As shown in the graphic above, you should only have a small amount of seal unseated in the groove at this point.

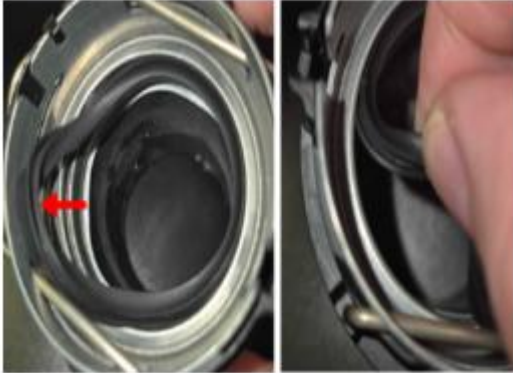
7027335

9. Grab the remaining loop, bringing it down to the groove, releasing the seal fully seating it into the groove.
  - Light pressure may be needed to allow the seal to fully seat.

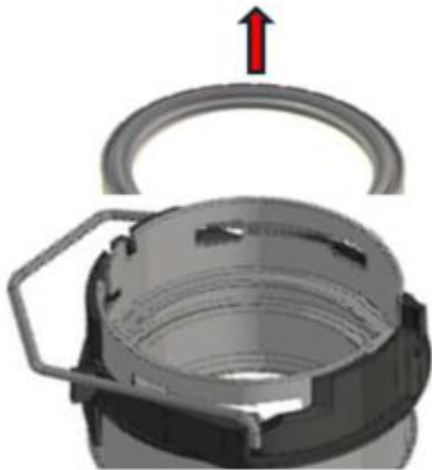
7046680

4. Before installing the new seal, ensure the correct orientation of the seal by locating the notched side of the seal as shown in the picture. The notches should be facing the quick connect side of the hose (facing the direction of the arrow).
