Subject: N252534680 - Customer Satisfaction Program  
Windshield Foam Seal Delamination

Models: 2025-2026 Cadillac OPTIQ

# Customer Satisfaction Program

## N252534680 Windshield Foam Seal Delamination

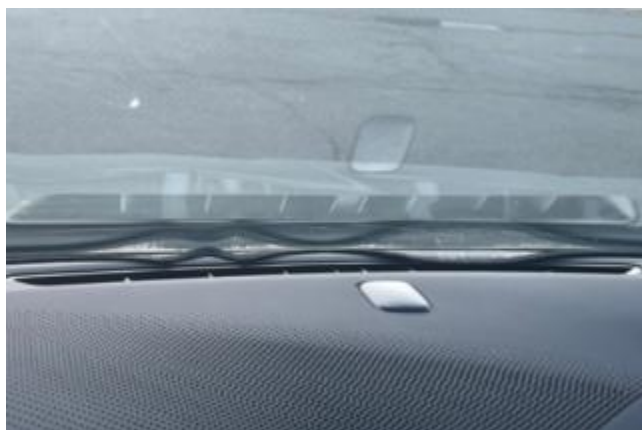
7012512

1. Inspect the windshield foam seal for delamination as shown above. If the foam seal is intact, no further action is required.
2. Remove the Instrument Panel Extension. Refer to *Instrument Panel Extension Replacement* in SI.

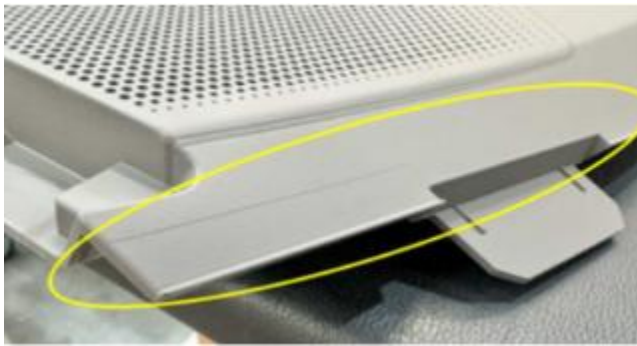
7012505

3. Remove the foam seal and clean adhesive from the surface using isopropyl alcohol (90% or better).
4. Use a cloth to scrub the surface until no adhesive residue is observed.
5. Use air to remove any dust/debris from the foam seal installation location.

**IMPORTANT: Abrasives or harsh chemicals will damage the finish of the Instrument Panel Extension.**

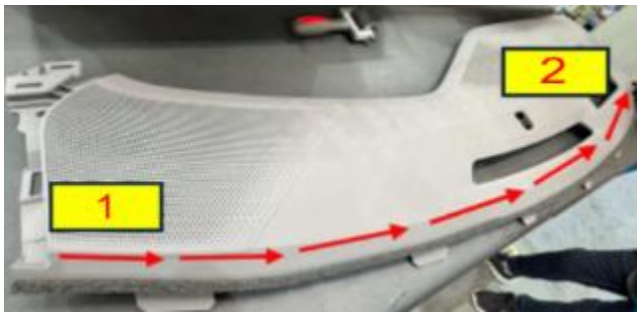
7012507

6. Install the NEW foam seal from right to left, between the rib and rail located on the edge of the Instrument Panel Extension as indicated above.
7. Use light pressure by hand to ensure correct placement.

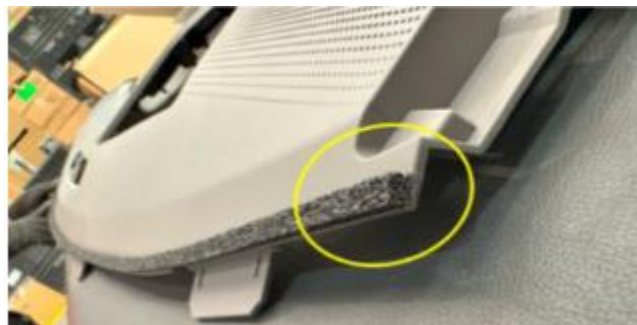
7012508

8. The foam should line up evenly on both sides when installed.

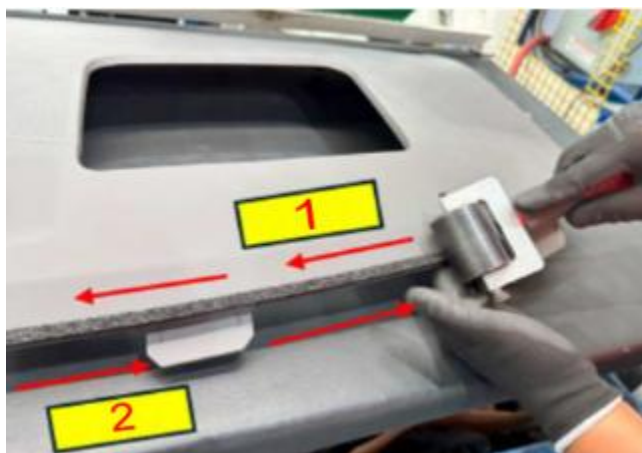
7012510

9. Slowly apply pressure with a roller from right to left (1) and then again left to right (2) to activate the pressure activated adhesive. If a roller is not available, any hard cylindrical object will work.
10. When finished, perform a visual inspection to ensure the ends of the windshield do not protrude from the substrate and that it is properly adhered.
11. Reinstall the instrument panel extension. Refer to *Instrument Panel Extension Replacement* in SI.
