## SERVICE BULLETIN

**APPLICABILITY:** 2019-23MY Crosstrek PHEV  
2026MY Crosstrek SHEV  
2025-26MY Forester SHEV

**NUMBER:** 09-140-26

**SUBJECT:** Fuel Cap / Design Change

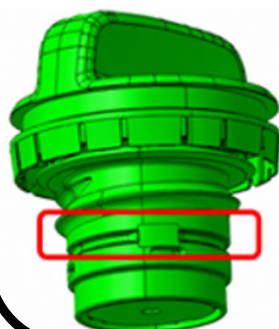
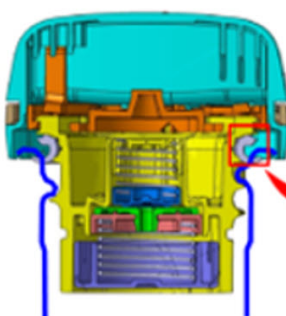
### New Part Number: 42031SL020

This part number incorporated recess interruption and the gasket/O-ring combination to improve system sealing.  
(● mark and ■ mark as identification)

Gasket

O-ring is added.

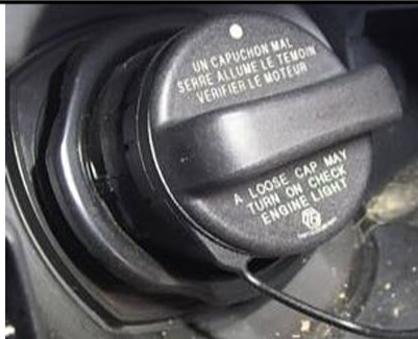
Properly tightened.

If DTC P04EC or fuel leak is detected inspect the fuel cap to ensure it is properly tightened. See images below:

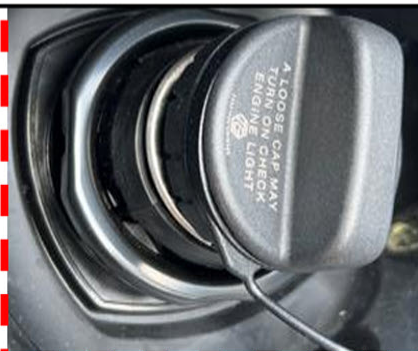
Improperly tightened.

If the cap is improperly tightened, determine whether it is the updated design by checking for a black circle at the 5:00 position on SHEV vehicles and at the 8:00 position on PHEV vehicles.

If the cap is identified as part number 42031SL000, 42031FL020, or 42031FL021, replace it with the updated version. If the cap is identified as part number 42031FL070 or 42031SL020, properly secure the cap.
