**Subject:** TriPac 3 MAC and RIO Fuse Replacement

**Units:** TriPac 3 units built before August 2026

**Description:** TriPac 3 units built before August 2026 may experience corrosion or failure at the MAC (40A) and RIO (50A) input power fuses. Thermo King has introduced a new harness with sealed fuses. Follow the procedure below to install the new harness with sealed fuses.

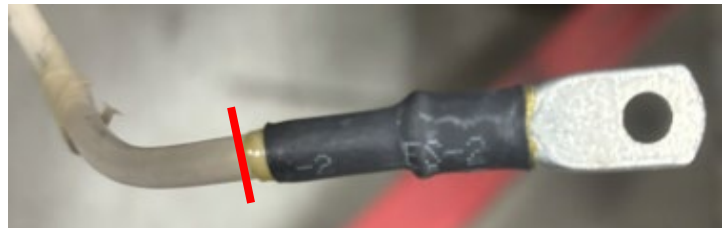
5. Cut the three lugs from the harnesses in the location shown below. Remove ½ inch of insulation on the three harnesses.

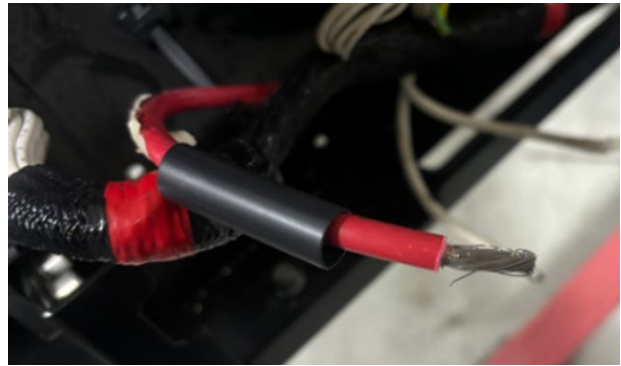
6. Insert the three heat shrinks (two inches long each) prior to adding splice to each of the three wires.

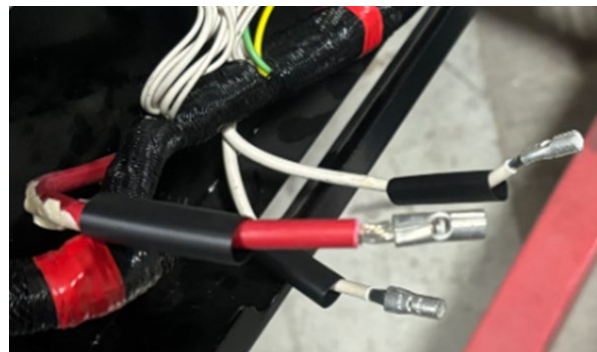
8. Crimp the splice. Repeat on the remaining two wires.

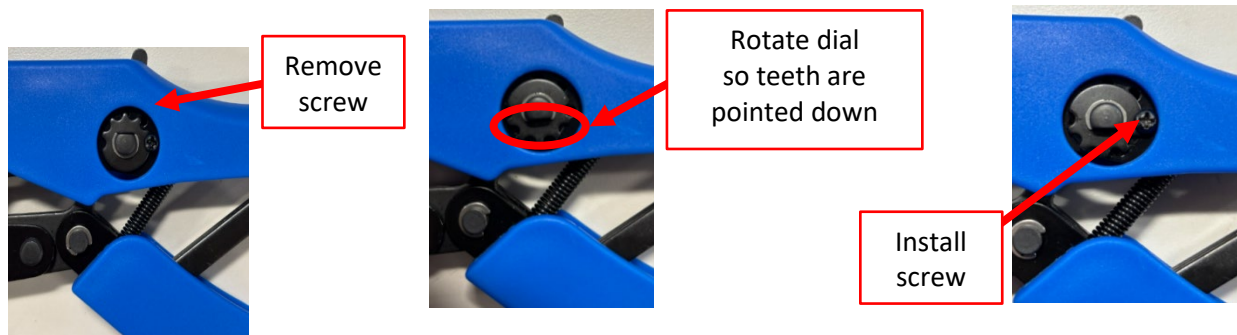
**Note:** To get correct crimp pressure on splice, adjust tool setting as shown below.
