**HYUNDAI**  
**Technical Service Bulletin**

NUMBER  
**26-EC-001H**

MODEL(S)  
**PALISADE HYBRID  
(LX3 HEV)**

**SUBJECT:** ENGINE RUNS CONTINUOUSLY – EVAPORATIVE EMISSIONS  
LEAK TEST FOR EV/HEV MODE ENGAGEMENT

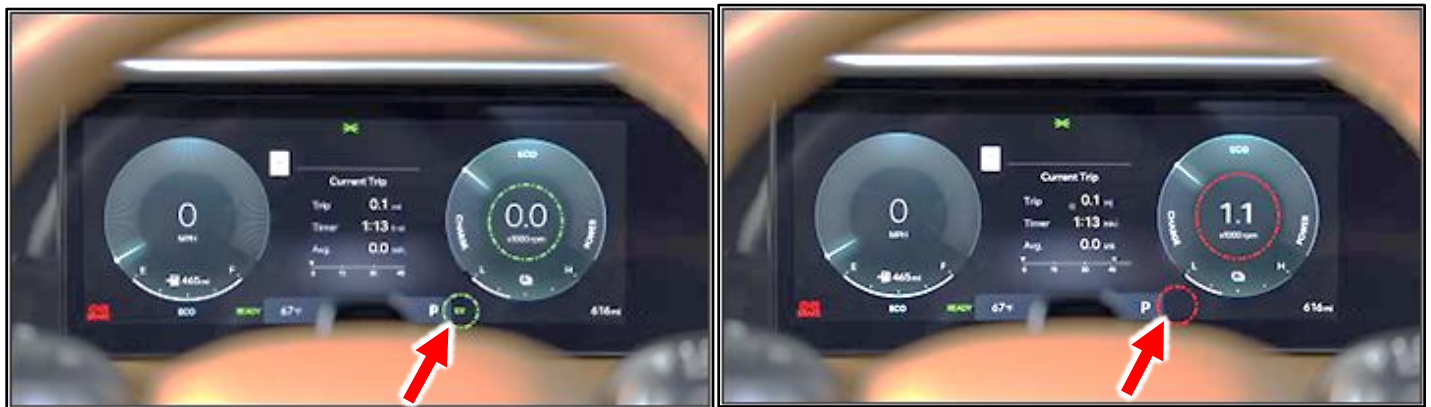
**Description:** Some Palisade Hybrid (LX3 HEV) vehicles may exhibit continuous engine operation due to the vehicle being unable to enter EV/HEV modes. The vehicle may initially start in EV/HEV mode, but will quickly transition to running the engine only and will not revert back to EV/HEV mode. The “EV” light may intermittently flicker on, but the vehicle will not change modes. This bulletin provides instructions to perform the “Evaporative Leakage Test” function on the GDS to enable EV/HEV mode activation.

EV/HEV mode engaged.....EV/HEV mode **NOT** engaged

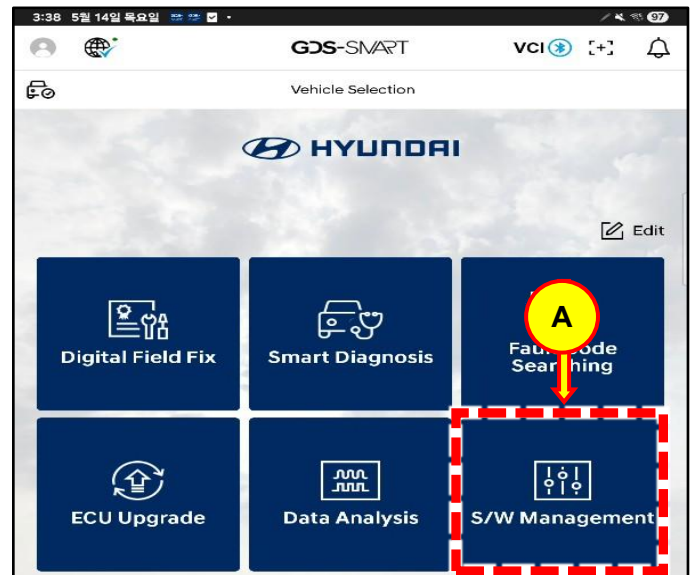
1. Connect the GDS and open the GDS-Smart application.
2. Select the correct VIN, then select **S/W Management (A)**.
3. Select **ENGINE – Engine Control**, then select **Evap. Leakage Test (B)**.
