# Customer Satisfaction Program

## N262572131 Cylinder Head Drilled Improperly

Release Date: August 2026

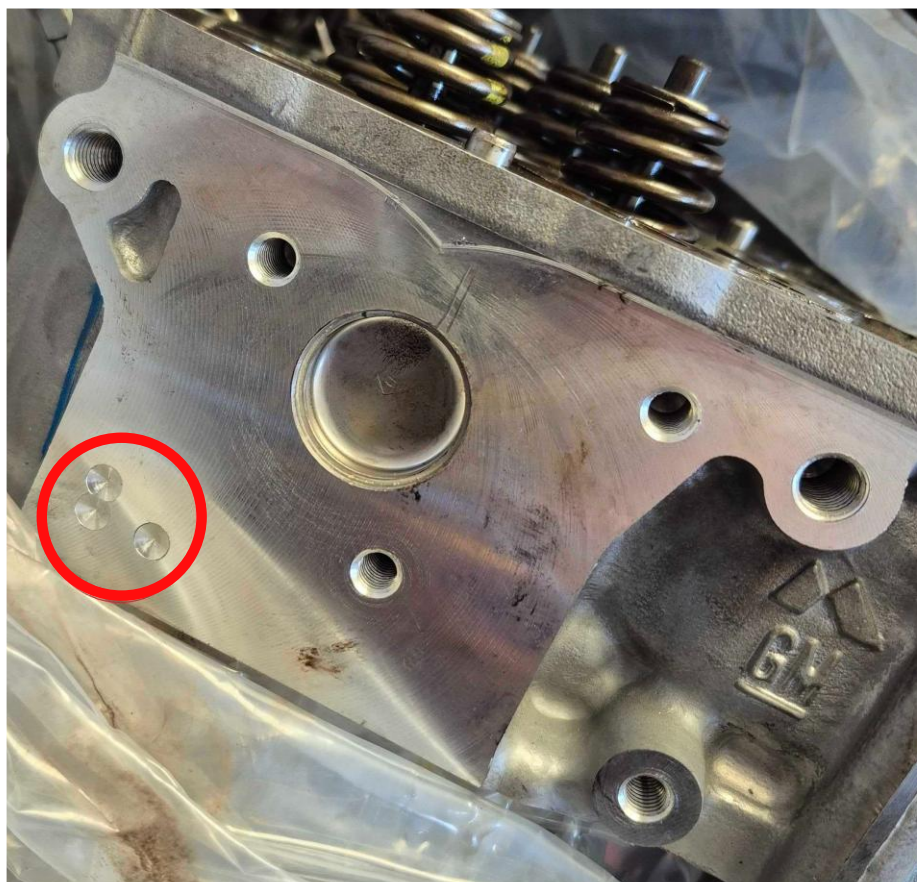
2. Using a borescope (a right angle attachment for the borescope is helpful here if you have one), from underneath the vehicle, inspect the machined surface at the front of the passenger's side head, and at the rear of the driver's side head.
  - If the machined surface (of either cylinder head) has three drill marks, as shown above, **hold this vehicle for further repairs** for that cylinder head. **You must inspect both cylinder heads.**
  - If the machined surface has any number *other* than three drill marks, no further action is required *for that cylinder head only*. **You must inspect both cylinder heads.**

3. If both cylinder heads pass the inspection, you may close this field action. If one or more cylinder heads **FAILS** the inspection, you must hold the vehicle until you receive further instructions. **You must record the number of drill marks observed on each cylinder head on the repair order.**
