| <br><b>HARBINGER</b> | <h1>Technical Service Bulletin</h1> |
| Bulletin Number: TSB-07-00005 | |
| Subject: Thermal Box Replacement | |
| Applicability: 2025 and 2026 MY stripped chassis that were not reworked prior to delivery may experience this potential issue. | |

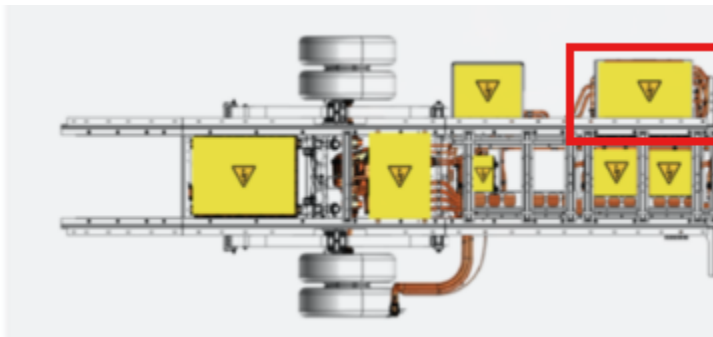
The upgraded thermal box will have newer versions of the mode valve and the LCC heat exchanger, as well as additional low voltage wiring strain relief.

As a response to an High Voltage Interlock Loop (HVIL) fault indicated inside the thermal box or an MDV (mode valve) fault, replace the Thermal Box A-00038191\_C with an upgraded version supplied by Harbinger. Request the thermal box by opening a support ticket in the Harbinger Service Portal. For Service Portal access, email an access request to [service@harbingermotors.com](mailto:service@harbingermotors.com). Techline will confirm whether the vehicle is already updated and initiate the parts delivery if necessary. The support ticket will be advanced to “Authorized”.
