## Technical Service Bulletin

| GROUP<br><b>BODY (INTERIOR<br/>AND EXTERIOR)</b> | NUMBER<br><b>26-BD-008H</b> |

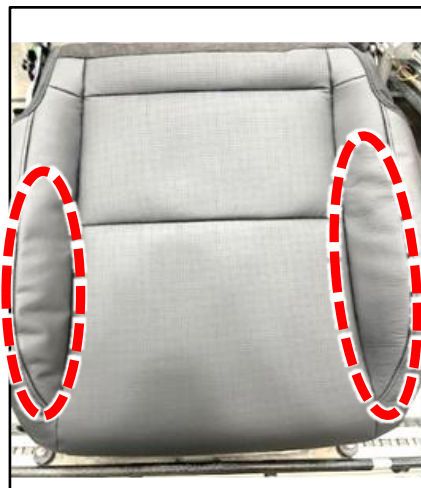
Seat cushions or seat backs damaged by external/outside influence are not covered.

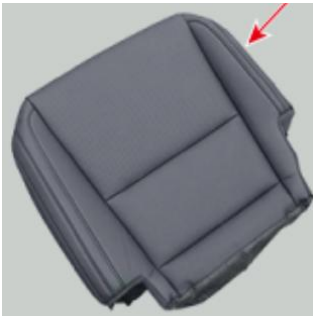
| Model | Part Name | Part Number | Figure |
|---|---|---|---|
| | Covering Assy – RR<br>Seat Cushion, LH | 89160-R6310YZMQH<br>89160-R6310YZNQH<br>89160-R6310YZSQH<br>89160-R6311YZMQH<br>89160-R6311YZNQH<br>89160-R6311YZSQH<br>89160-R6520PZNQH<br>89160-R6520PZPQH<br>89160-R6520PZSQH<br>89160-R6521PZNQH<br>89160-R6521PZPQH<br>89160-R6521PZSQH | |

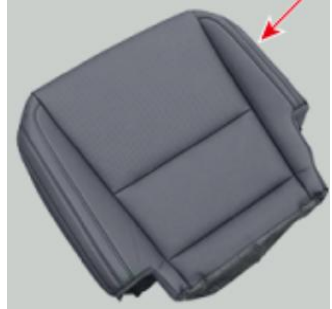
| Model | Part Name | Part Number | Figure |
|---|---|---|---|
| Santa Fe<br>(MX5A) | Covering Assy – RR<br>Seat Cushion, RH | 89260-R6310YZMQH<br>89260-R6310YZNQH<br>89260-R6310YZSQH<br>89260-R6311YZMQH<br>89260-R6311YZNQH<br>89260-R6311YZSQH<br>89260-R6520PZNQH<br>89260-R6520PZPQH<br>89260-R6520PZSQH<br>89260-R6521PZNQH<br>89260-R6521PZPQH<br>89260-R6521PZSQH | |

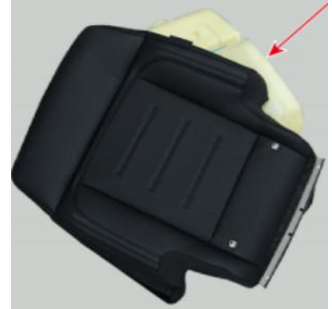
| Model | Part Name | Part Number | Figure |
|---|---|---|---|
| Santa Fe<br>Hybrid<br>(MX5A HEV) | Covering Assy – RR<br>Seat Back, RH | 89460-R6310YZMQH<br>89460-R6310YZNQH<br>89460-R6310YZSQH<br>89460-R6530PZNQH<br>89460-R6530PZPQH<br>89460-R6530PZSQH | |

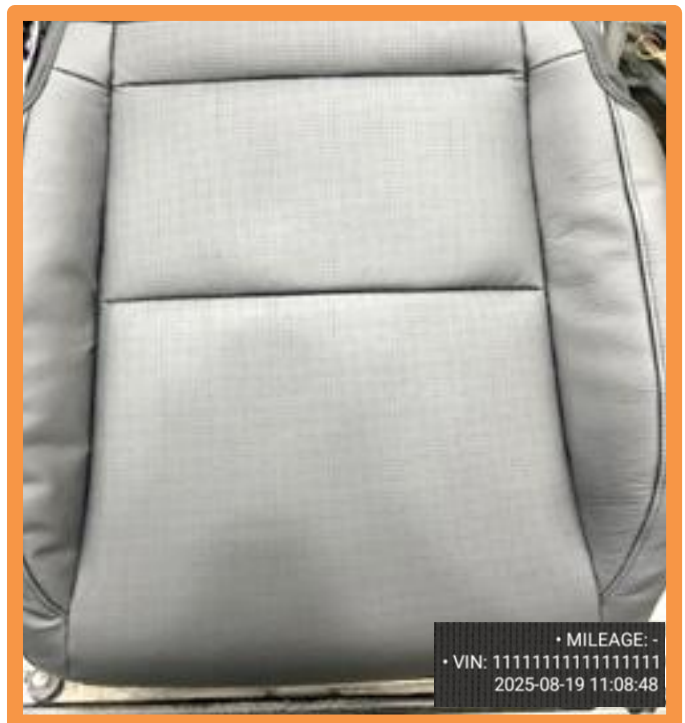
2. Remove and replace the affected seat cover(s) by referring to the shop manual:
  - **Body (Interior / Exterior / Electrical) > Front Seat > Front Seat Cushion Cover > Removal and Installation**
  - **Body (Interior / Exterior / Electrical) > Front Seat > Front Seat Back Cover > Removal and Installation**
  - **Body (Interior / Exterior / Electrical) > Rear Seat > Rear Seat Cushion Cover > Removal and Installation**
  - **Body (Interior / Exterior / Electrical) > Rear Seat > Rear Seat Back Cover > Removal and Installation**
3. Reinstall all parts in the reverse order of the removal process.
4. Confirm the proper operation of the seat(s).
5. The service procedure is now complete.
