| | | <b>MODEL G OUTDOOR FRIDGE<br/>AREA WALL RE-SECURING</b> | | <div><div>4</div><div>3</div><div>2</div><div>1</div><div>0</div></div> <div>2</div> <div>Difficulty<br/>Level</div> | |
| WI: | | WI-107-2026 Model G Outdoor Fridge Area Wall Re-Securing | | | |
| PRODUCT: | | Model G | VIN Range: | 000001 - Current | REVISION: REV-A |

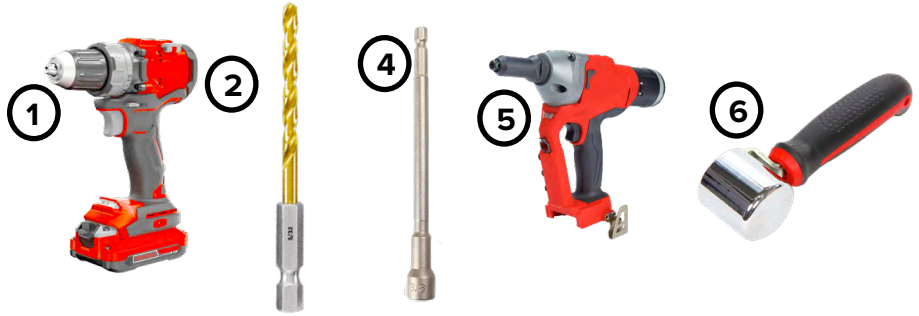
1. Drill/Screw Gun
2. #10 Drill Bit
3. T30 Star Drive Bit (Not Pictured)
4. 3/8" Nut Drive Bit
5. Rivet Gun
6. Small Hand Roller

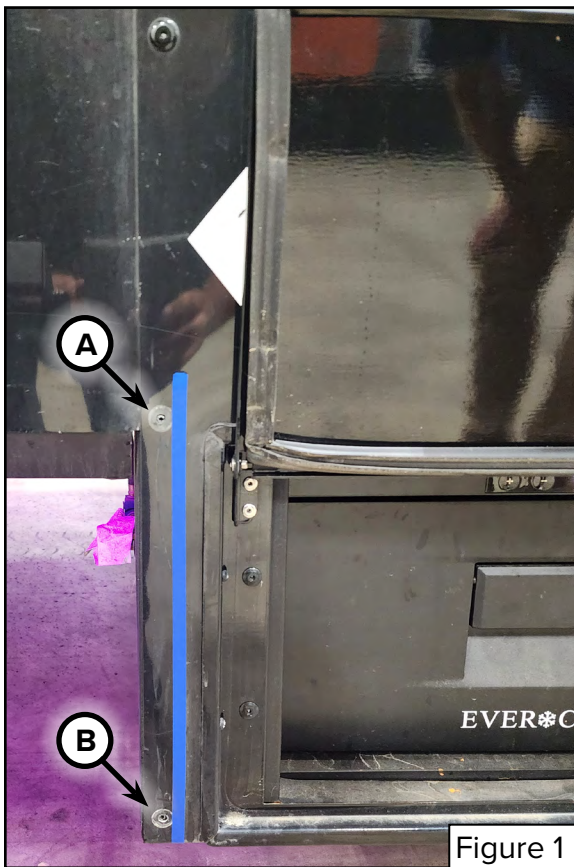
Figure 1

1. Inspect the area of the unit around the outdoor refrigerator near the entry door (Figure 1).
2. If there are broken or missing rivets (Figure 1A, 1B), use the drill and a #10 drill bit, and drill out any remaining rivet heads or shafts.
3. Gently pull the side wall material back from the edge of the structure and slide a piece of 3M double stick tape (P/N 105867) between the outer wall material and the aluminum wall structure (Figure 2A). The piece of double stick tape should extend from the bottom of the wall up past the second rivet, approximately 14 inches.

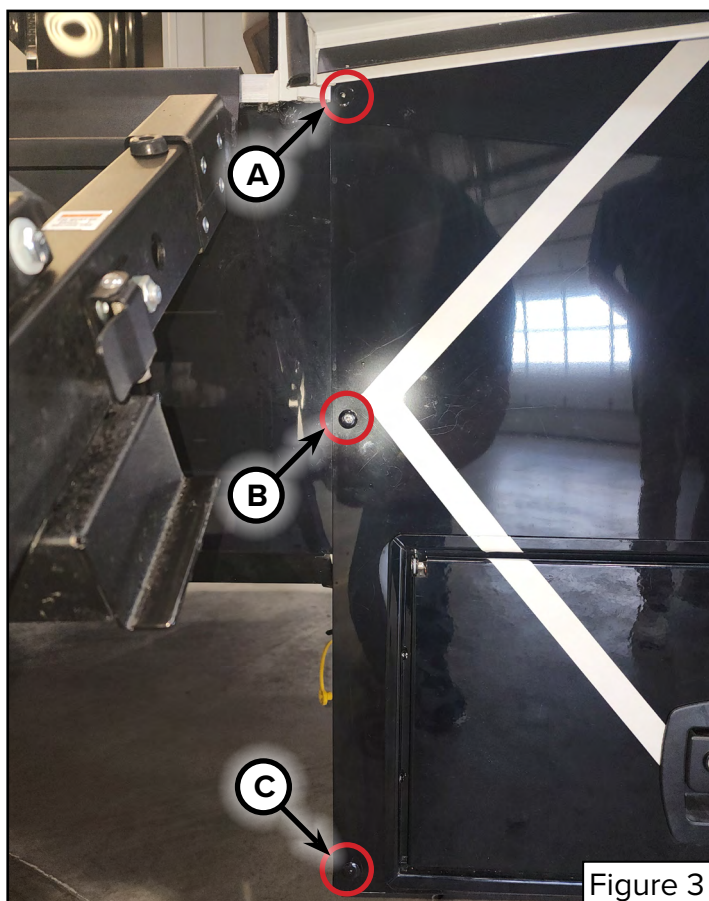
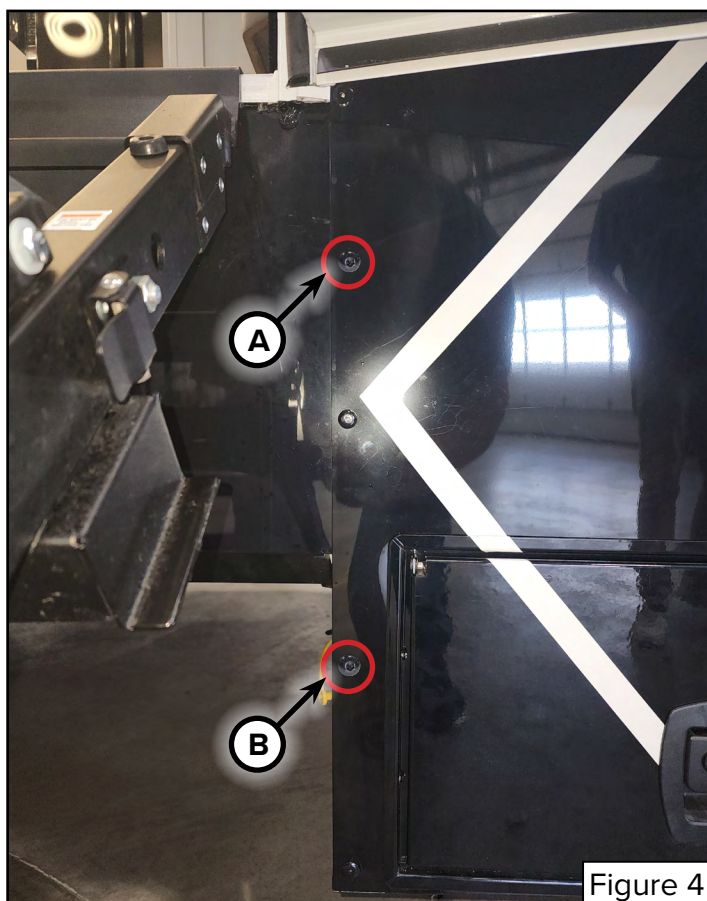
4. Use a hand roller and apply 15 lbs of pressure across the entire length of the wall material where there is double stick tape underneath. Roll over this area several times to ensure proper adhesion.
5. Using the rivet gun, install the new rivets (P/N 101362) into the original rivet holes (Figure 3A, 3B, 3C). You may need up to three (3) rivets.
6. Using the screw gun and the T30 star drive bit, install 1/4" #14 x 7/8 Black screws (P/N 132553) in between the rivets (Figure 4A, 4B). Depending on the floor plant, you may require one (1) or two(2) screws.

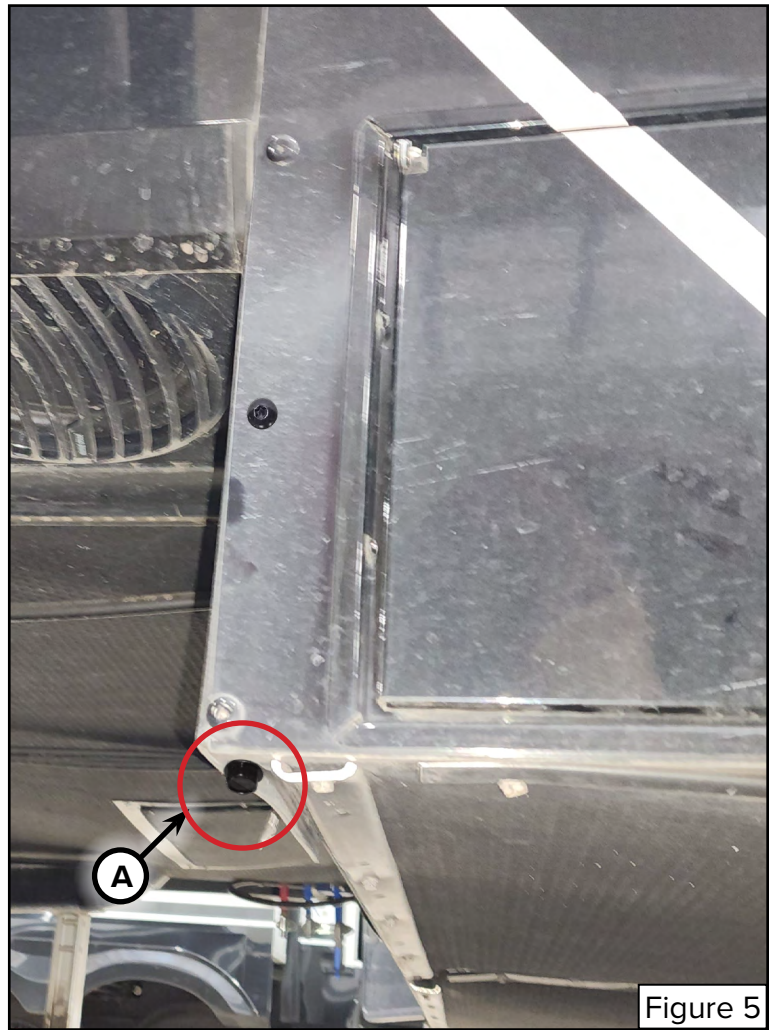
Figure 5

7. Using the screw gun and 3/8" nut driver bit, install one (1) #14 x 1 Black Hex Head Screw (P/N 101332) into the lip of the side wall material that wraps under the side wall structure (Figure 5A).
