# CUSTOMER SATISFACTION NOTIFICATION

### Spark Plugs

Reference: 66D

2026 - 2027 (WL) Jeep Grand Cherokee

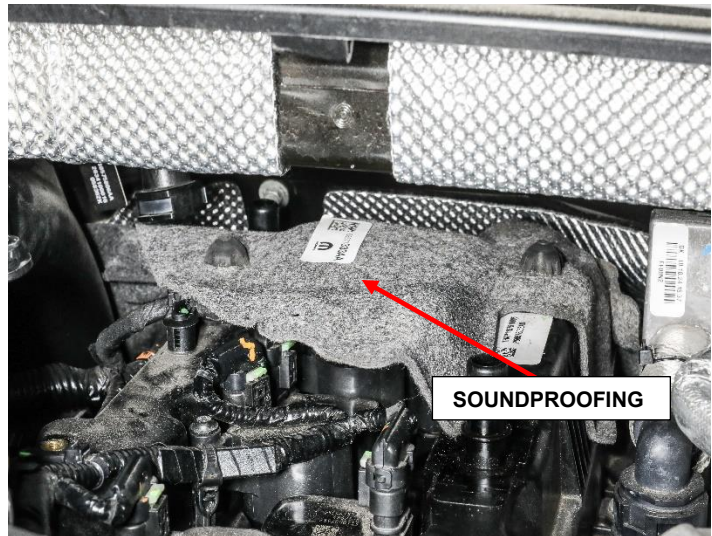
**Figure 3 - Soundproofing**

11. Release the clip and disconnect the CAC inlet tube from the throttle body.
12. Position the CAC inlet tube aside.
13. Remove the top soundproofing from the valve cover (Figure 3).
14. Disconnect the main chamber ignition coil(s) wire harness connector(s) (Figure 4).
15. Blow out the well around ignition coils.

20. Install the main chamber spark plugs and tighten to 18N·m (13ft. lbs.).
21. Reinstall main chamber ignition coils and tighten nuts to 9N·m (80In. lbs.).
22. Reconnect the main ignition coil(s) wire harness connector(s).
23. Install the top soundproofing from the valve cover and attach the retainer (Figure 3).
24. Connect the charge air cooler inlet tube.
25. Install the charge air cooler, inlet tube bolt to valve cover and tighten to 8N·m (71In. Lbs.) (Figure 2).
26. Install the CAC inlet tube bolts and connect it to the turbocharger and tighten to 11N·m (8Ft, Lbs.). (Figure 2).
27. Connect the clip and connect the CAC inlet tube to the throttle body and the CAC hose.
28. Connect the crankcase pressure sensor electrical connector and harness retainer.
29. Connect the inlet temperature sensor wire harness connector and engage lock (Figure 2).
