## SERVICE BULLETIN

**APPLICABILITY:** 2026MY Outback

**NUMBER:** 12-283-26

**SUBJECT:** Loose Fitting Door Weatherstrip / Repair Procedure

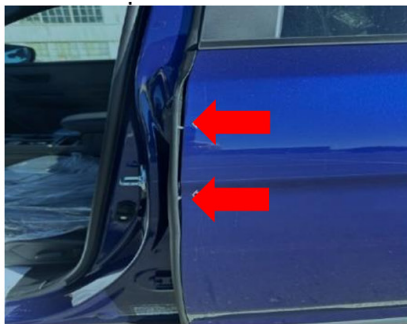
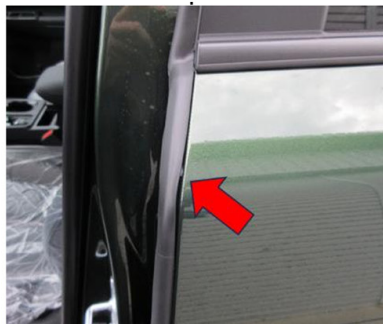
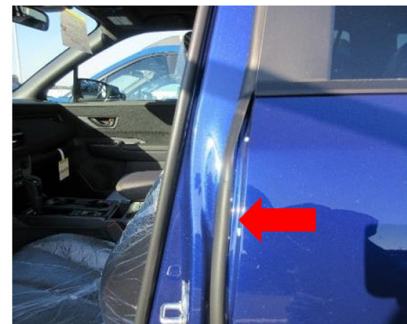
This service bulletin announces a repair procedure for the weatherstrips on the front of the rear doors. This strip can become loose over time from the front door being opened and closed. A new clip has been developed to have high rigidity to prevent the clip from losing tension over time. If the customer reports a loose weather door strip (Example below), follow the procedure outlined in this bulletin.

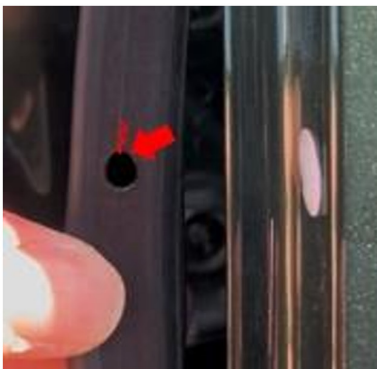
EB-10240

**Step 3:** Inspect the weatherstrip to ensure no damage occurred while removing clips.

- The weatherstrip may tear if being pulled. Also, the weatherstrip clip may be damaged if being removed with excessive force.

**Note:** If damage occurs, replace the weatherstrip if necessary.

- Replace the damaged weatherstrip clip with a new part.
- When fragments of the clip fall in the door panel, be sure to remove them.
