# McLaren Artura Engine Oil Leak Diagnosis Guide - Front of Engine

**Location:** Powertrain

**Topic:** McLaren Artura Engine Oil Leak Diagnosis Guide - Front of Engine

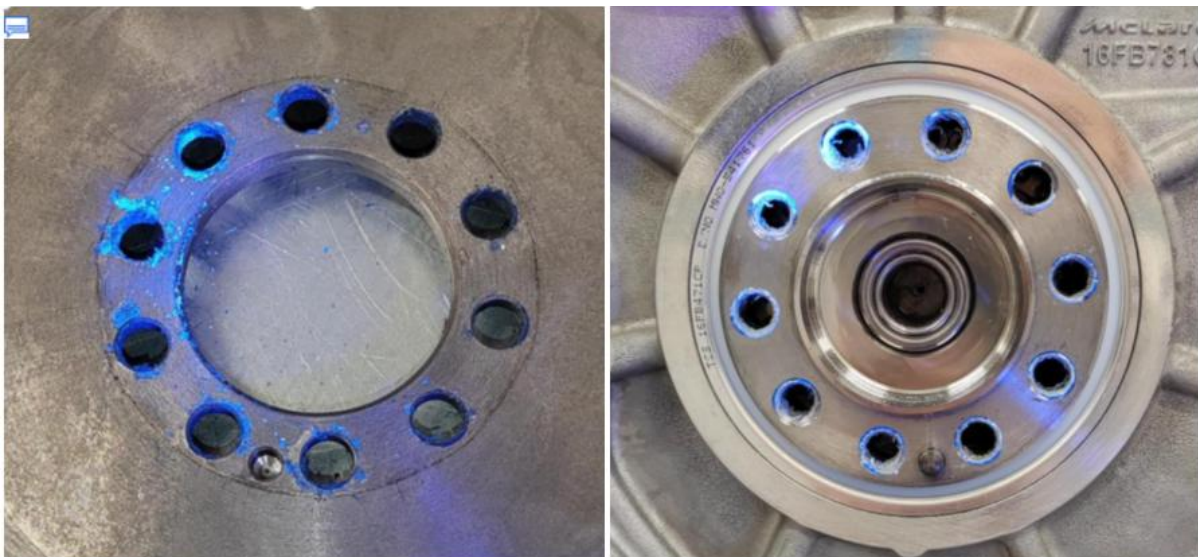
**Care Point:** to avoid engine contamination, prior to attempting front crank seal removal clean the first 2-3 bolt hole threads (crankshaft flange) from residual threadlocker (from the original bolt fitment) and outer surface of crankshaft flange (threadlocker and oil) without pushing any debris into the engine (through holes), clean with standard automotive degreaser/solvent ensuring a thorough clean of the leak area. Do not leave the area like this:

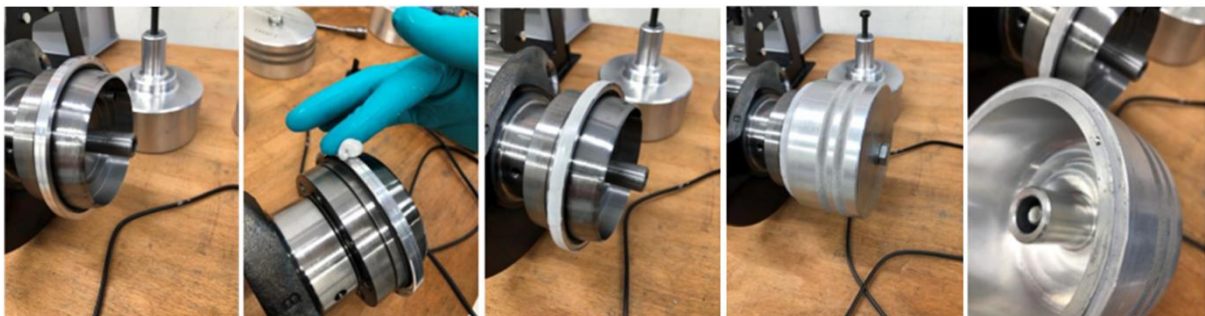
19. With the brand-new front crank seal halfway down the mandrel, apply constant thickness of RTV to the outer surface/OD of the metallic ring of the seal (complete, 360° coverage) as follows (DO NOT contaminate the lip seal or the mandrel with RTV):

**Care Point: Carefully clean (with a dry lint free cloth) the RTV squeeze-out post Front Crank Seal fitment**

**Attention! If any trace of RTV accidentally contaminates the lip seal, replace the Crank Seal and repeat Steps 17 & 18**
