**Date:** August 27, 2026  
**Subject:** Precedent High-Pressure Common Rail (HPCR) Fuel System Diagnostics  
**Location:** e-Tech Library

**Units:** Precedent S-600, S-610DE, S-610M, S-700, S-750i, GenSet SG5000, Advancer S-DRC

**Description:** This bulletin provides a systematic approach to diagnosing issues related to the HPCR pump and other HPCR system components. By following the recommended diagnostic process, a technician can efficiently identify the root cause, including fuel contamination and other potential causes, perform the appropriate inspections, and make informed repair decisions.

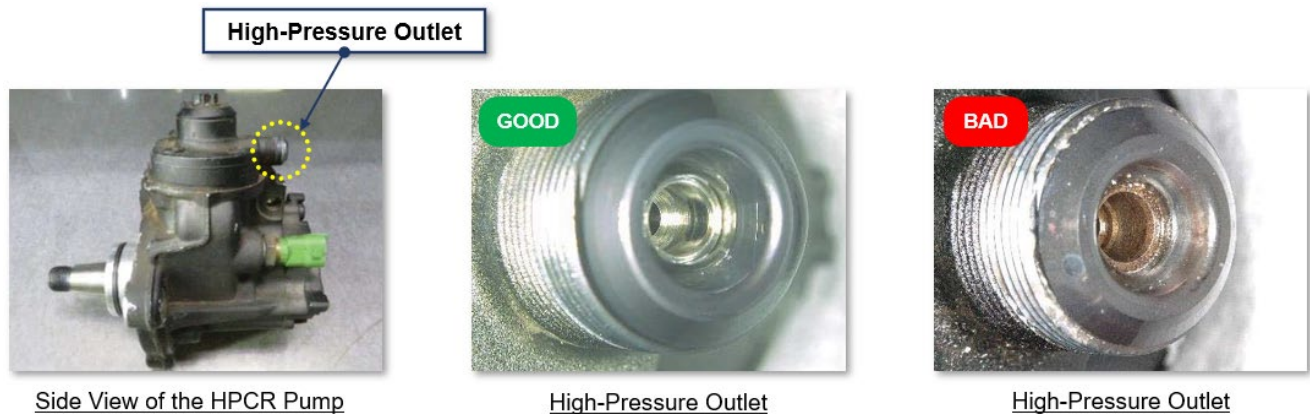
1. Are there signs of rust at the high-pressure pipe connection? If no, proceed to next step. If yes, replace the HPCR pump (as necessary based on the damage condition) and high-pressure pipe. After running the engine, has the mechanical issue been resolved? If yes, repair complete. If no, proceed to Section 7 - Common Rail Inspection.
  - a. Refer to the images below and inspect the HPCR pump outlet for signs of rust. If rust is present, it may indicate abnormal wear of the internal drive components, resulting in reduced performance. In such cases, replacement of the HPCR pump is recommended. When replacing the HPCR pump, also replace the high-pressure pipe connecting the pump to the rail to prevent fuel leakage.

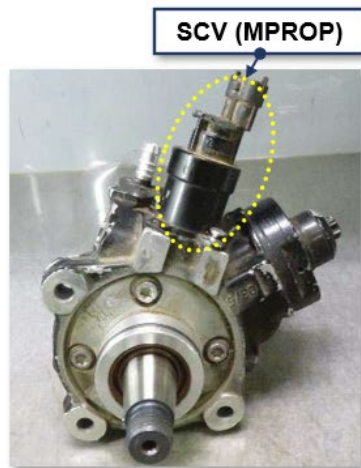
Side View of the HPCR Pump

2. Remove the SCV. Are there signs of contamination or rust inside the pump or on the SCV? If no, proceed to next step. If yes, replace the HPCR pump (as necessary based on the damage condition) and high-pressure pipe. After running the engine, has the mechanical issue been resolved? If yes, repair complete. If no, proceed to Section 7 - Common Rail Inspection.
  - a. Refer to the images below and check the SCV mesh filter and SCV mounting area for signs of rust or contamination. If rust or contamination is present, it may indicate abnormal wear of the internal drive components, resulting in reduced performance. In such cases, replacement of the HPCR pump is recommended. When replacing the HPCR pump, also replace the high-pressure pipe connecting the pump to the rail to prevent fuel leakage.

3. Are the HPCR pump and SCV free from damage? If yes, install the SCV. If no, replace the SCV or HPCR pump as necessary based on the damage condition. After running the engine, has the mechanical issue been resolved? If yes, repair complete. If no, proceed to Section 7 - Common Rail Inspection.

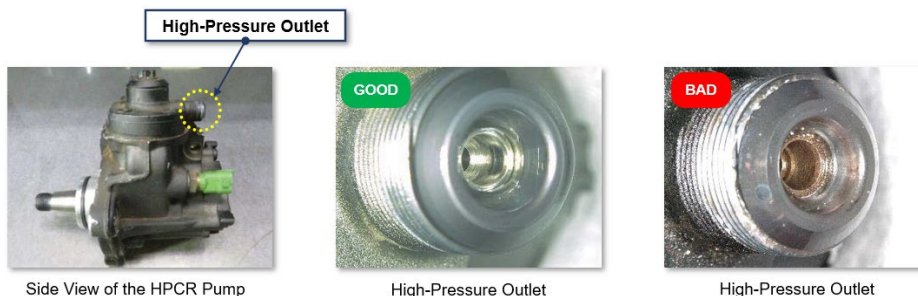
1. Are there signs of rust at the high-pressure pipe connection? If no, proceed to next step. If yes, replace the HPCR pump (as necessary based on the damage condition) and high-pressure pipe. After running the engine, have the active error codes been cleared? If yes, repair complete. If no, proceed to Section 14 - Group A Diagnostics - Common Rail Inspection.
  - a. Refer to the images below and inspect the HPCR pump outlet for signs of rust. If rust is present, it may indicate abnormal wear of the internal drive components, resulting in reduced performance. In such cases, replacement of the HPCR pump is recommended. When replacing the HPCR pump, also replace the high-pressure pipe connecting the pump to the rail to prevent fuel leakage.

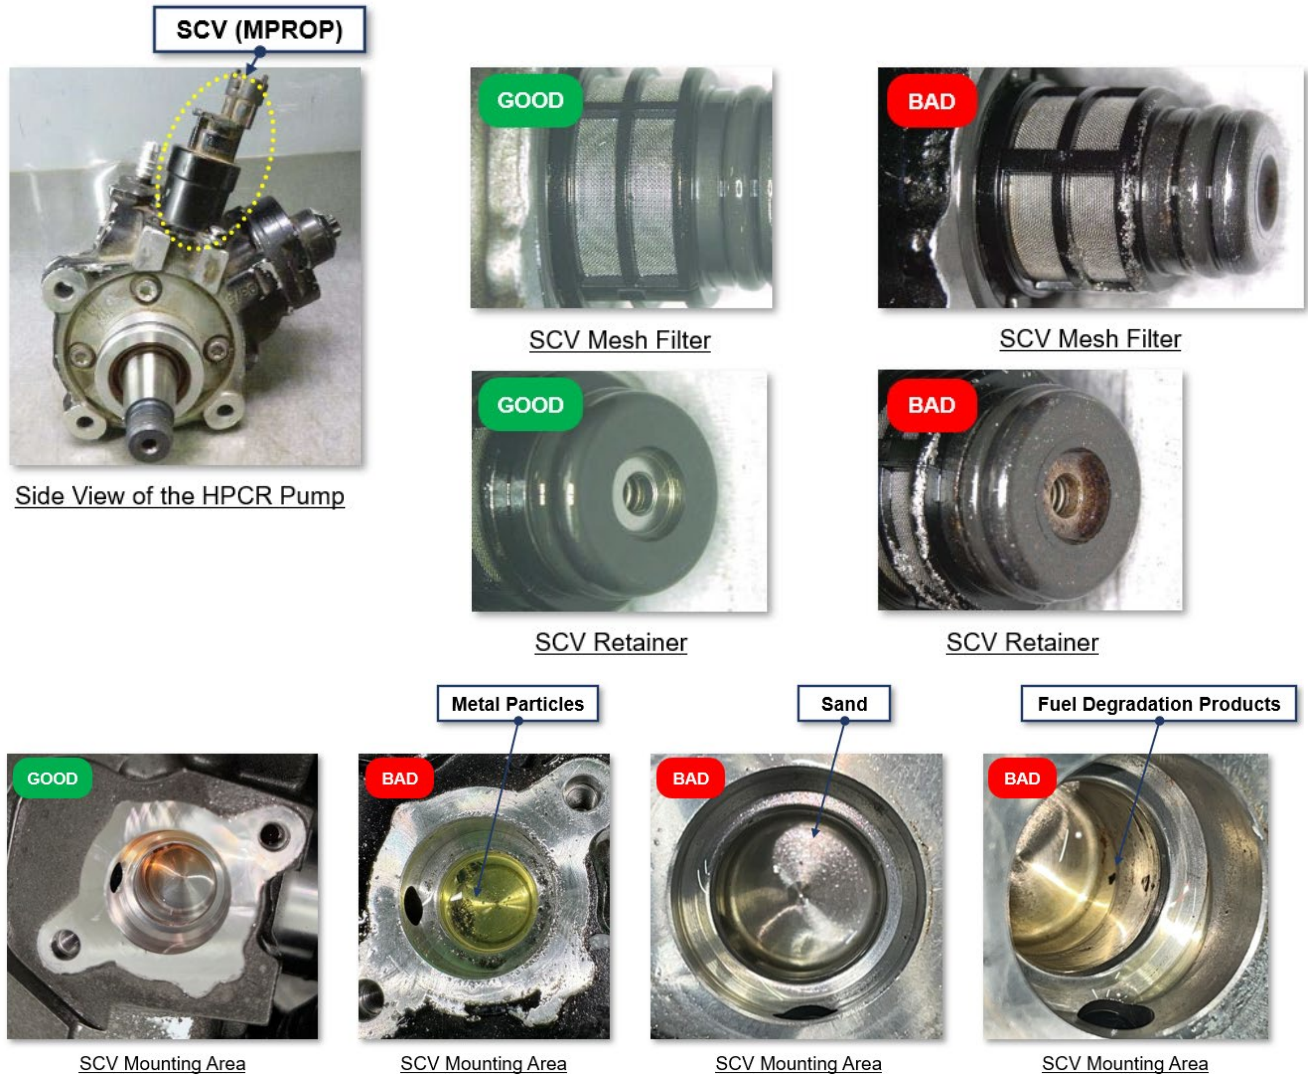
2. Remove the Suction Control Valve (SCV). Are there signs of contamination or rust inside the pump or on the SCV? If no, proceed to next step. If yes, replace the HPCR pump (as necessary based on the damage condition) and high-pressure pipe. After running the engine, have the active error codes been cleared? If yes, repair complete. If no, proceed to Section 14 - Group A Diagnostics - Common Rail Inspection.
  - a. Refer to the images below and check the SCV mesh filter and SCV mounting area for signs of rust or contamination. If rust or contamination is present, it may indicate abnormal wear of the internal drive components, resulting in reduced performance. In such cases, replacement of the HPCR pump is recommended. When replacing the HPCR pump, also replace the high-pressure pipe connecting the pump to the rail to prevent fuel leakage.

3. Are the HPCR pump and SCV free from damage? If yes, install the SCV.

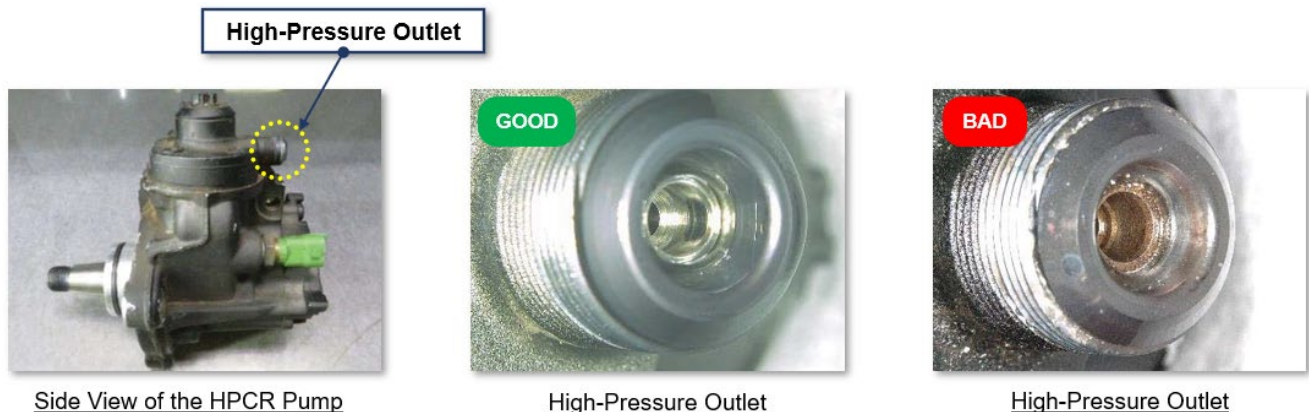
1. Are there signs of rust at the high-pressure pipe connection? If no, proceed to next step. If yes, replace the HPCR pump (as necessary based on the damage condition) and high-pressure pipe. After running the engine, have the active error codes been cleared? If yes, repair complete. If no, verify no inspection items have been missed.
  - a. Refer to the images below and inspect the HPCR pump outlet for signs of rust. If rust is present, it may indicate abnormal wear of the internal drive components, resulting in reduced performance. In such cases, replacement of the HPCR pump is recommended. When replacing the HPCR pump, also replace the high-pressure pipe connecting the pump to the rail to prevent fuel leakage.

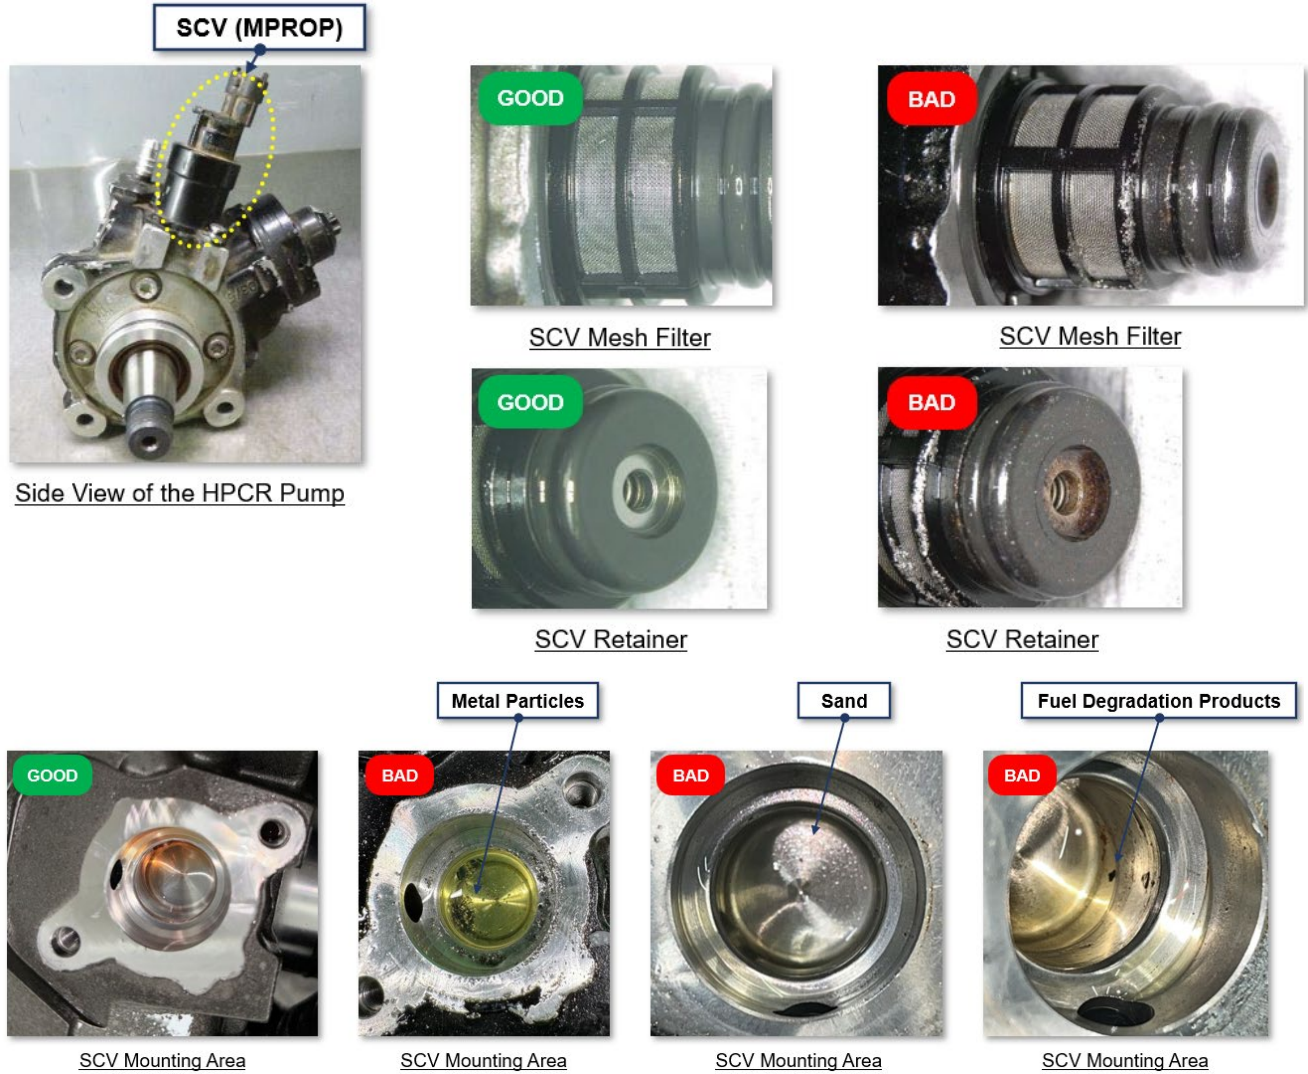
2. Remove the SCV. Are there signs of contamination or rust inside the pump or on the SCV? If no, proceed to next step. If yes, replace the HPCR pump (as necessary based on the damage condition) and high-pressure pipe. After running the engine, have the active error codes been cleared? If yes, repair complete. If no, verify no inspection items have been missed.
  - a. Refer to the images below and check the SCV mesh filter and SCV mounting area for signs of rust or contamination. If rust or contamination is present, it may indicate abnormal wear of the internal drive components, resulting in reduced performance. In such cases, replacement of the HPCR pump is

recommended. When replacing the HPCR pump, also replace the high-pressure pipe connecting the pump to the rail to prevent fuel leakage.

3. Are the HPCR pump and SCV free from damage? If yes, install the SCV and monitor without replacing parts. If no, replace the SCV or HPCR pump as necessary based on the damage condition. After running the engine, have the active error codes been cleared? If yes, repair complete. If no, verify no inspection items have been missed.
