**Noises at the Rear Three-Point Belt on the Left and/or Right-Retrofitting the Rear Noise Protection Caps on the Left and Right (SY 59/26)**

Model Line: **Cayenne (X1A/X1B)**

Model Year: **2026**

Concerns: **Rear three-point belt (N196, N197)**

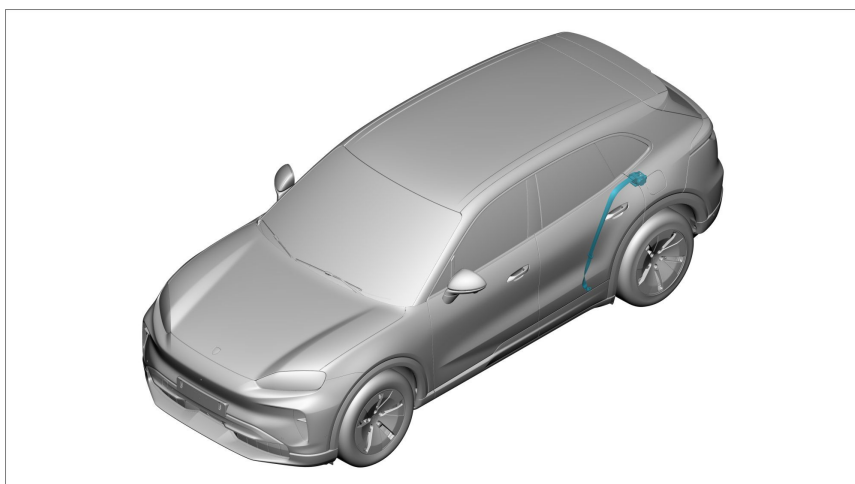
Installation position of the rear three-point belt (N196, N197)

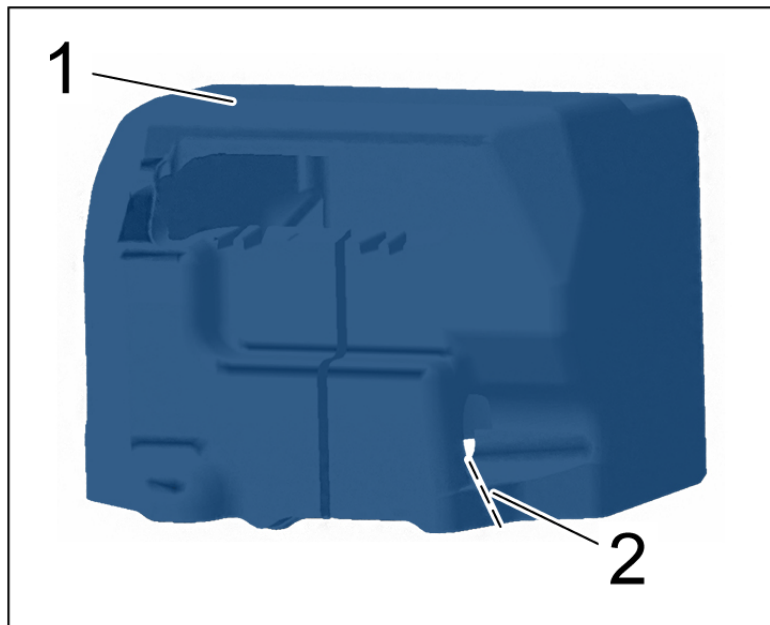
Noise protection cap

- 1 Expose the belt retractors for the rear three-point belts on the left and right.  
For instructions, see:  
**69121900 Removing and installing the rear three-point belt (N196, N197)**
- 2 Cut through the noise protection caps -1- at the marking -2- using a carpet knife.

The cut in the noise protection caps means that the electrical plug connection does not have to be disconnected.

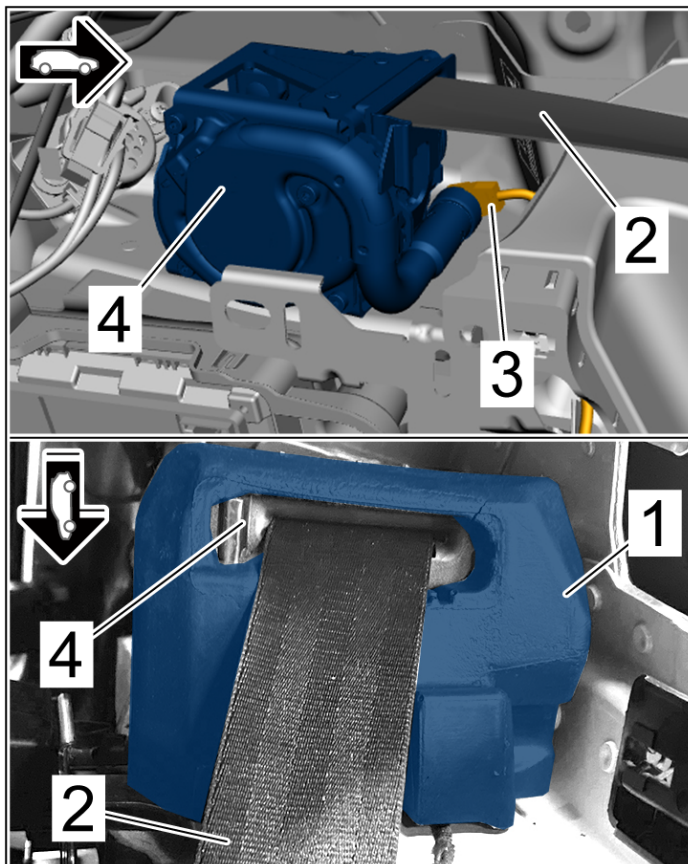
Retrofitting the noise protection cap (shown on the left side)

- 1 Guide the noise protection cap -1- past the belt strap -2- and electrical plug connection -3- and position it on the rear belt retractor -4-.
