| <b>Document Title:</b> | Max Solar Battery Monitor Replacement | | |
| <b>Document Type:</b> | Technical Document | <b>Make and Model:</b> | Ember Overland and Touring Edition |
| <b>Document #:</b> | TD-26-04 | <b>Model Year:</b> | 2026 and 2027 |

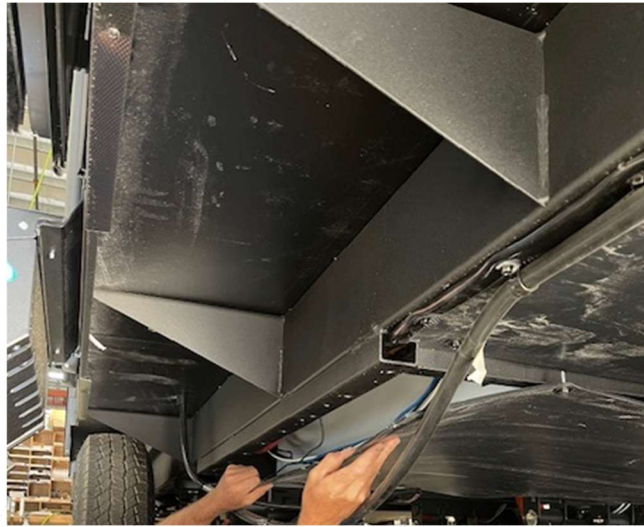
3. Loosen the underbelly along the doorside in front of the tires.  
**IMPORTANT:** This step is not applicable if the model is an OV190MSL or Touring Edition; please skip to step 9.  
*Note: The removal or full drop of the underbelly is not necessary.*  
*Note: Some models may require LP line securement clamps to be removed.*

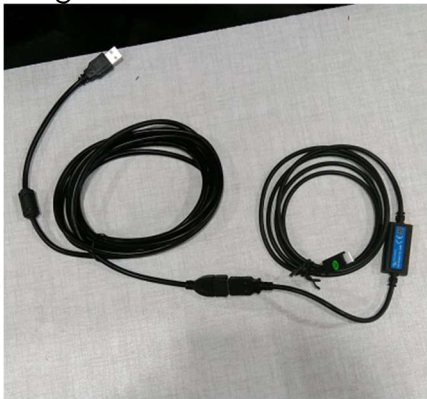
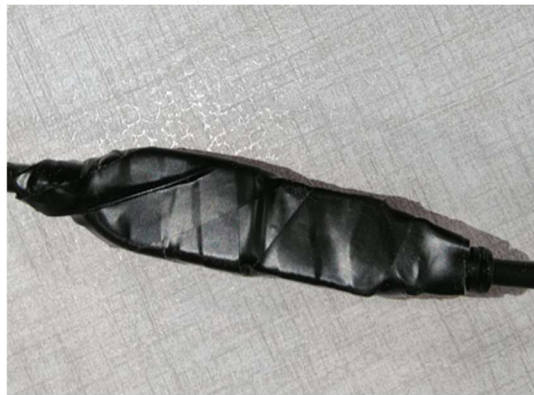
4. Connect the USB cable extension to the V.E. Direct cable. Wrap electrical tape around the connection to prevent it from coming apart in the coach's chassis area.

**IMPORTANT:** This step is not necessary if the model is an OV190MSL or Touring Edition models.

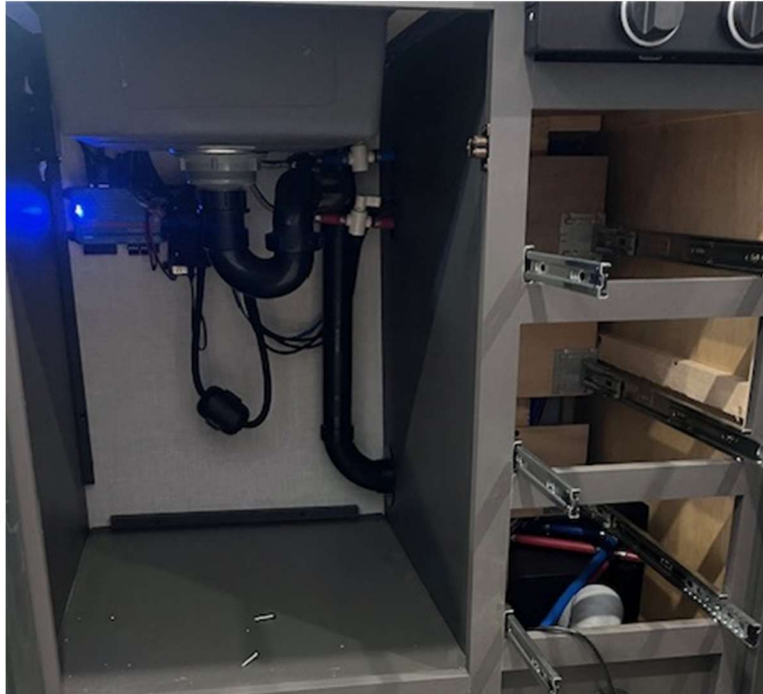
6. Feed the USB cable end along the other communication cables to the kitchen base area. Then pass the cable through the hole up into the kitchen base.

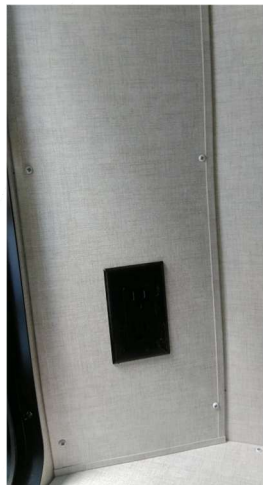
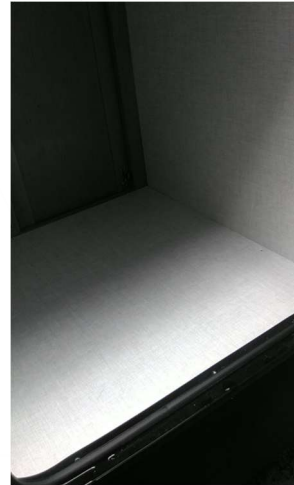
7. In the kitchen, remove the kitchen drawers to access the hole from the underbelly and continue to run the wire following the other communication cables to the Cerbo.
8. **OV201FBQ ONLY:** In the exterior storage compartment, remove the recept panel and remove the shelf. Feed the USB cable end through the hole in the floor, then through the hole in the cabinets, to under the kitchen sink where the Cerbo is located.

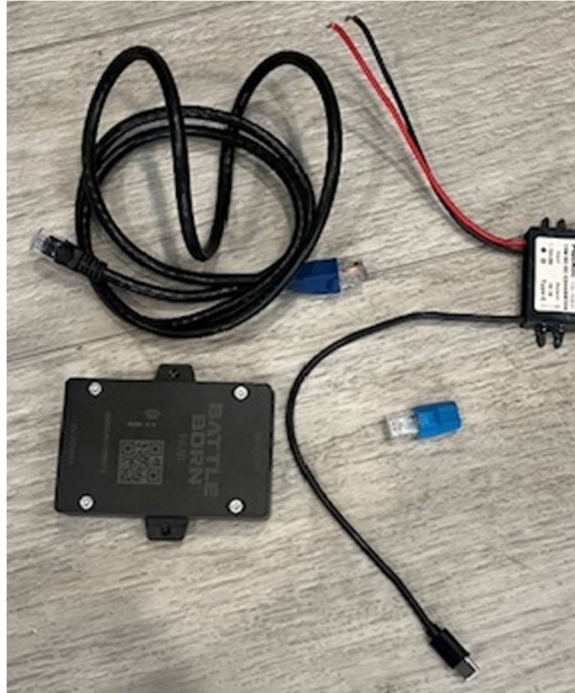
9. **OV190MSL and Touring Edition ONLY:** The Cerbo is located under the doorside or off doorside nightstand. Feed the VE. Direct to USB cable from Cerbo to the inverter battery area.
10. Connect the USB cable to the Cerbo.
11. Remove HUB, the communication cable from the HUB to Cerbo, the BUS terminator, and HUB power device.
