**A. VEHICLE INSPECTION PROCEDURE**

### C. INSPECTION AND REPAIR PROCEDURE

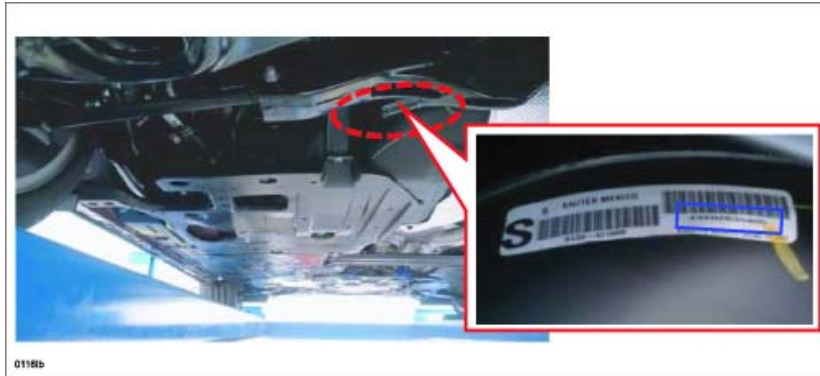
1. Lift the vehicle up.
2. Read the lot number on the label on the fuel tank.

- If the lot number cannot be read on the label, wash it off.
- If the lot number still cannot be read after washing it off, go to step 4.

3. Use the Lot Number Calculation Tool to determine if the fuel tank requires further inspection.
  - If the lot number is within the affected range, go to next step.
  - If the lot number is outside the affected range, work is complete.
4. Visually check the welding condition all around the joint portion between the ICV and the fuel tank. Make sure a double bead is created all around the joint.

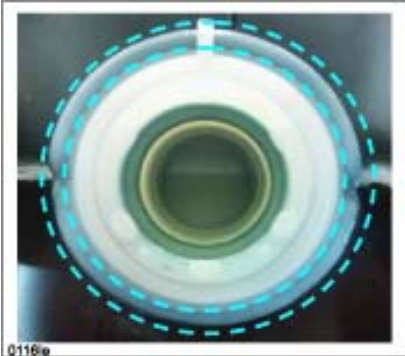
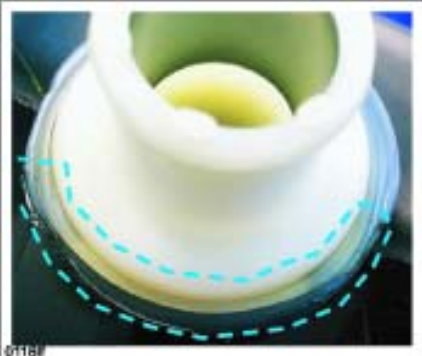
GOOD	NO GOOD

<p>Double bead (*) is created all around.</p>	<p>Double bead (*) is NOT created all around.</p>

\*Double Bead: If the ICV is press fit (welded) to the heated fuel tank correctly, the double bead is created.

- If the welding condition is “GOOD”, work is complete.
  - If the welding condition is “NO GOOD”, go to next step.
5. Visually check all around the joint portion between ICV and the fuel tank for fuel leak
- NOTE:** If a leak/trace of a leak has been found on the fuel tank, contact [PTL@mazdausa.com](mailto:PTL@mazdausa.com) with photos, dealer code, RO, VIN, and dealership address. A prepaid shipping label will be provided to send the fuel tank to MNAO. MNAO does not expect any fuel tanks to exhibit a leak/trace of a leak.
