## A. VEHICLE INSPECTION PROCEDURE

## C. INSPECTION AND REPAIR PROCEDURE

## D. CAMPAIGN LABEL INSTALLATION

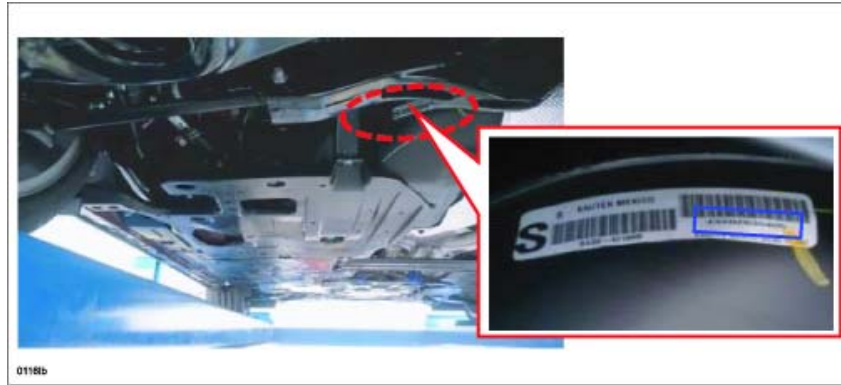
1. Lift the vehicle up.
2. Read the lot number on the label on the fuel tank.

- If the lot number cannot be read on the label, wash it off.
- If the lot number still cannot be read after washing it off, go to step 4.

3. Use the Lot Number Calculation Tool to determine if the fuel tank requires further inspection.
  - If the lot number is within the affected range, go to next step.
  - If the lot number is outside the affected range, work is complete.
4. Remove the fuel tank according to the instructions on MS3 (FUEL TANK REMOVAL/INSTALLATION).
5. Visually check the welding condition all around the joint portion between the recirculation pipe and the fuel tank. Make sure a double bead is created all around the joint.

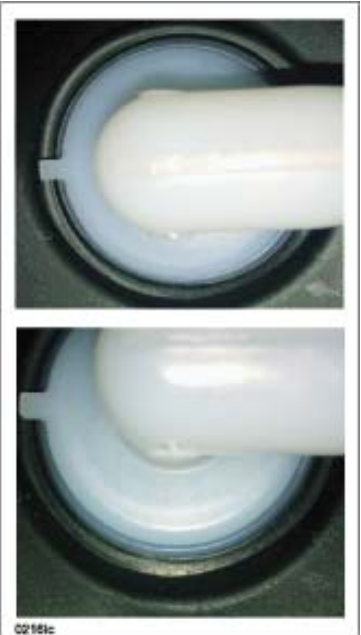
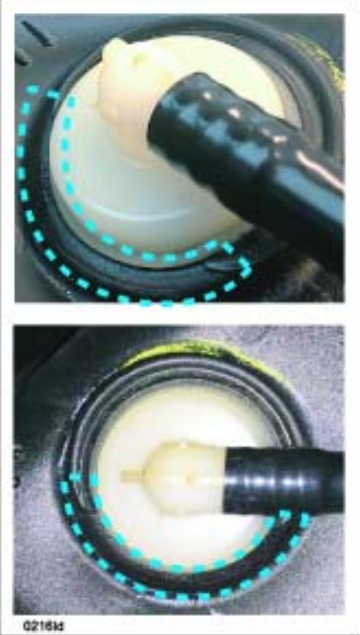
GOOD	NO GOOD

Double bead (*) is created all around.	Double bead (*) is NOT created all around.

\* Double Bead: If the heated recirculation pipe is press fit (welded) to the heated fuel tank correctly, the double bead is created.

- If the welding condition is "GOOD", install the removed fuel tank. Work is complete.
- If the welding condition is "NO GOOD", go to next step.

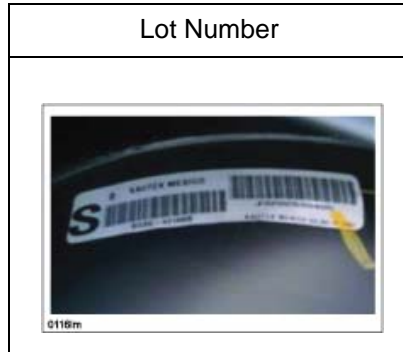
7. Take photos of lot number and affected portion of the fuel tank.
  - Take a photo of the entire recirculation pipe with the joint portion for all cases regardless of leak or not.
  - Take a photo from three angles so that the location of the improper welding (without bead) and its extent can be seen.
